REPORT OF INVESTIGATION

Underground Coal Mine

Fall of Face, Rib, Pillar, or Highwall  
August 29, 2019

Enlow Fork Mine  
Consol Pennsylvania Coal Company LLC  
Prosperity, Washington County, Pennsylvania  
ID No. 36-07416

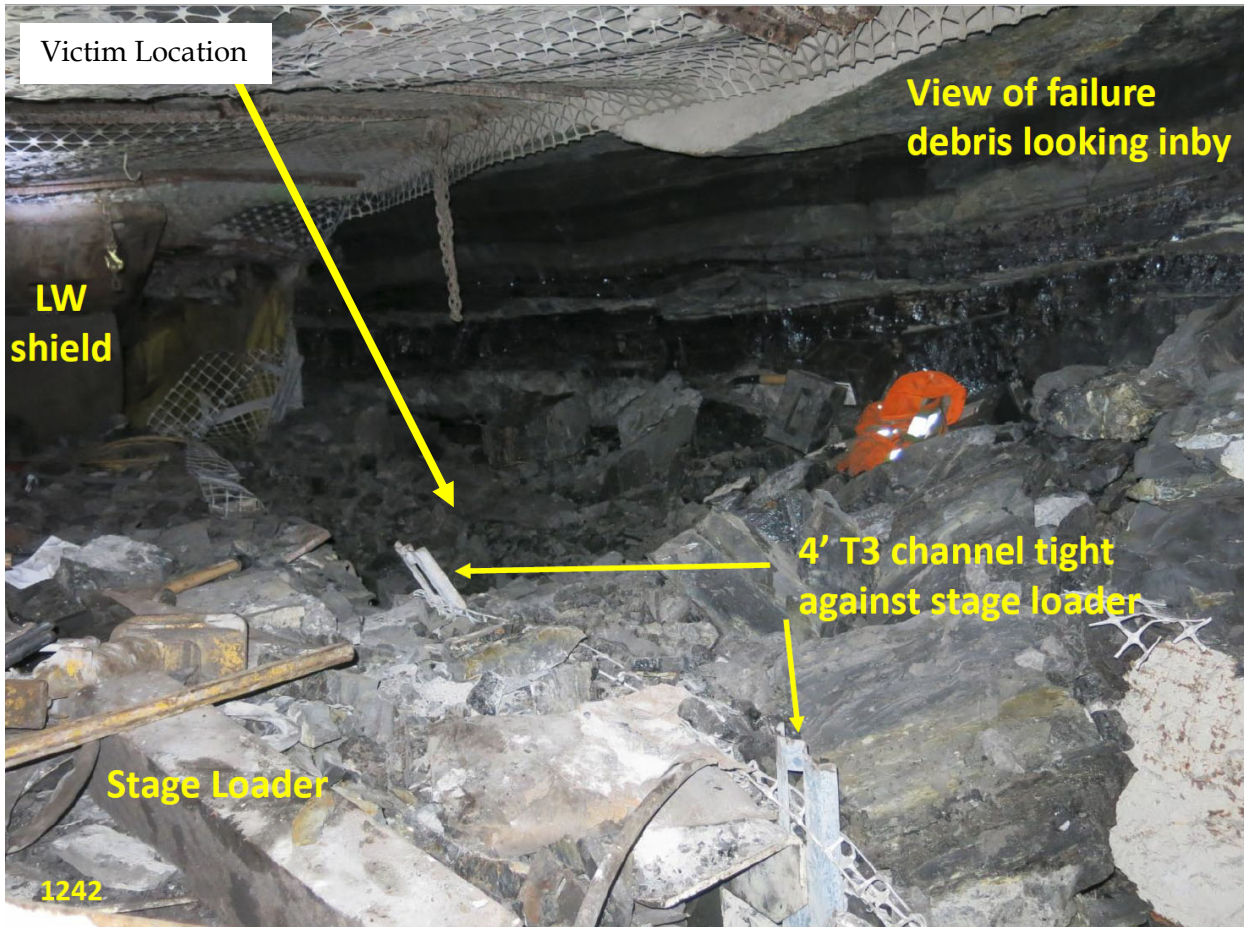
Appendix C  
Accident Scene Photograph

The accident occurred at the headgate of the G1 longwall panel on the south side of the No. 1 entry at crosscut 17½. Based on excavated debris, the victim was located adjacent to the stage loader approximately 14 feet inby the crosscut 17½ pillar corner. The rib failure extended 25 feet from the outby pillar corner at crosscut 17½ to a point 5 feet inby the longwall shield tips.

The ribs consisted of coal and a significant amount of rock. Approximately the top half of the rib consisted of rock and coal while the bottom half was coal. Fragments of material from the rib failure showed numerous compaction slickensides. It is likely that the rib conditions at the accident site were a result from increased stress levels that caused the lower portion of the rib to roll, or fall out. This would reduce vertical support for the upper portion of the rib.

Investigators saw five T3 channels in the failed rib debris. Three T3 channels were pressed tight against the side of the stage loader at points 8, 12, and 19½ feet from the inby pillar corner. All three were oriented vertically and were behind mesh, indicating that they were installed on advance with 3-foot long mechanically anchored bolts. Two other channels and bolts were visible in displaced fall blocks. Based on observations, investigators determined that the average maximum spacing of the first pass rib support was 5 feet. One other bolt tip, without the anchor shell, was visible protruding from the failed rib debris.

No 4-foot secondary bolts were observed in the rubble, though the tip of one bolt of unknown length was visible protruding from the fall debris. The empty ends of two bolt holes were observed in the rib, but their depth coincided with the depth of failure, indicating that they were originally 3 feet deep. Observations just outby the accident site showed that the rib mesh was secured by just a single row of secondary rib bolts installed with a highly variable spacing ranging from 6 to 12 feet. Bolts installed in this manner would have been too widely spaced to prevent a large rib failure like the one that occurred.

Corrective Action: The mine operator developed an action plan to continue mining the G1 longwall panel. The provisions in the action plan required floor to roof support to be installed in strategic locations in the No. 1 entry along the south rib. MSHA agreed to the action plan.

After an evaluation by Technical Support, which involved observing pull tests conducted by a bolt manufacturer, the mine operator submitted, and MSHA approved a revision to the roof control plan. The revised roof control plan contains enhanced minimum requirements that provide adequate rib support during advancement and longwall mining. The revised plan requires first pass rib bolting in areas where there is more than 700 feet of cover and the mining height is higher than seven feet. In these areas, bolts must be metal, not more than five feet apart (horizontally), at least 36 inches long, and installed with 48-inch long T3 channel, or other surface control. Also where this cover and mining height exist, second pass rib bolts and mesh are required on the walkway side of headgate entries. Second pass bolts must be metal, at least 60 inches long with at least 24 inches grouted length of resin, spaced no more than five feet horizontally, and installed in a "W" pattern unless conditions warrant a different pattern. Corners must have additional 60-inch bolts and mesh.
