REPORT OF INVESTIGATION

Surface Coal Facility

Electrocution  
August 7, 2019

Kanawha Eagle Mining, LLC  
South Hollow Prep Plant and Loadout  
Winifrede, Kanawha County, West Virginia  
ID No. 46-03085

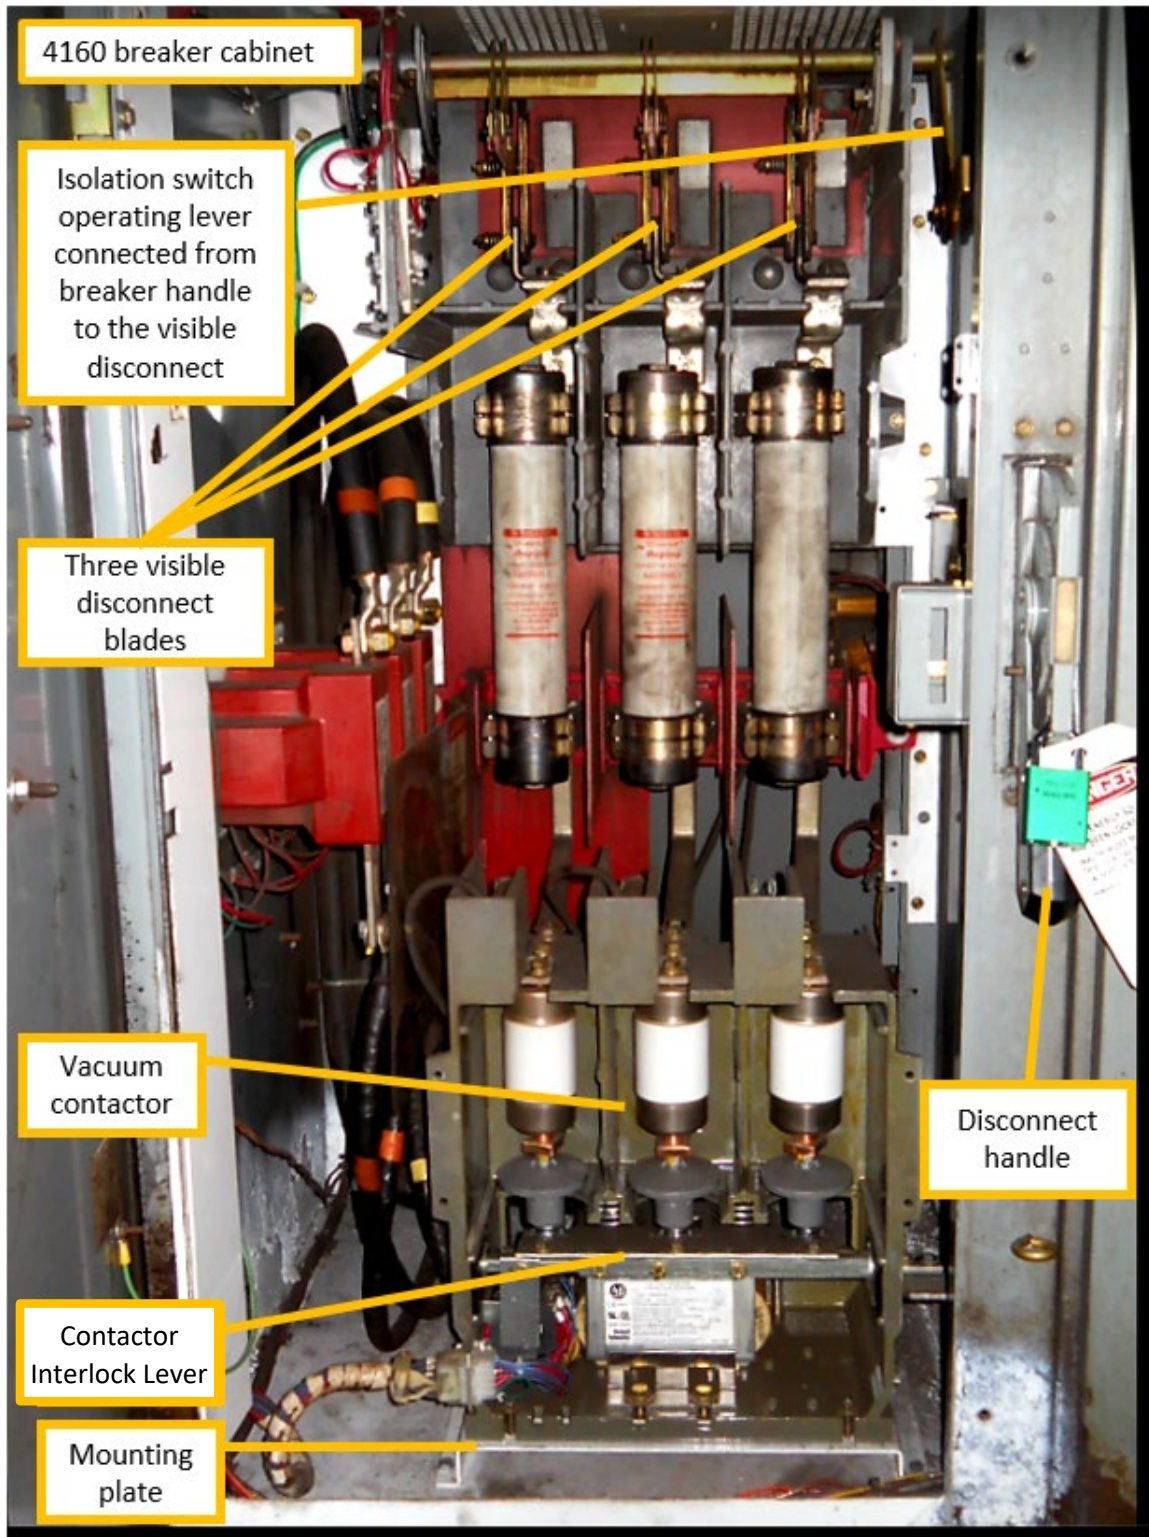
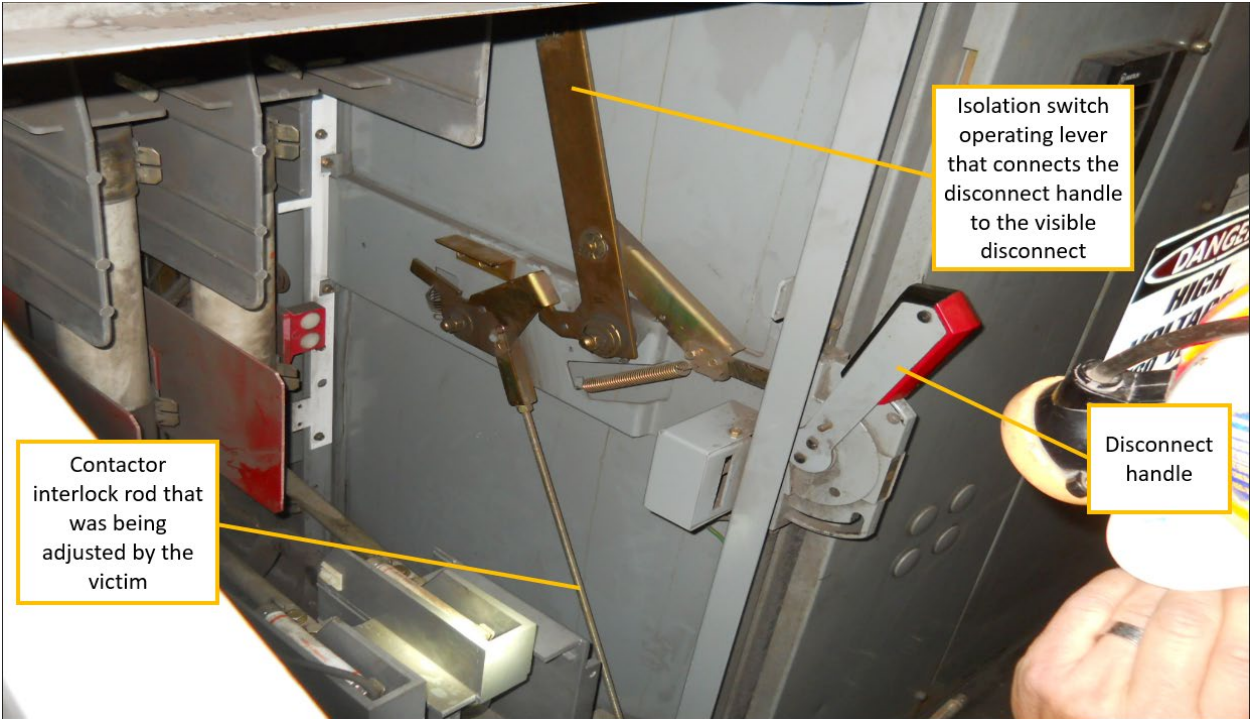
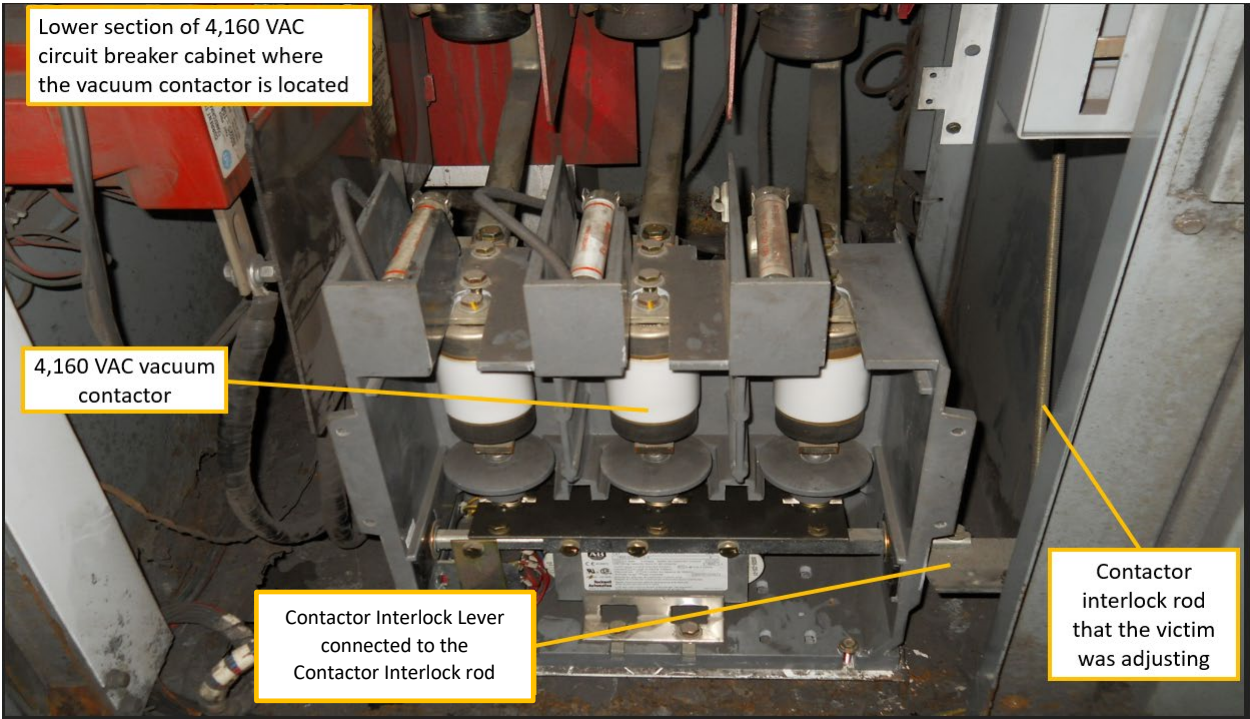
Photos of the Unit 171 4,160 VAC Cabinet

Muncy pulled the Unit 171 visual disconnect handle down to the open position (see Appendix A) which opened the three visual disconnect blades. Muncy then put on his high voltage gloves and removed the 4,160 VAC fuses from the circuit that supplies electrical power to the Unit 171 cabinet. Atkins, assisting Muncy, removed the de-energized 4,160 VAC phase conductors along with the control transformer connections and began removing the vacuum contactor. Atkins had not completed the removal of the vacuum contactor when his shift ended at 7:00 a.m. Muncy told Atkins to inform Davis and Travis Myers, Plant Electrician, who were both about to begin work for the day shift, of their progress in replacing the vacuum contactor. Muncy remained in the 8<sup>th</sup> floor MCC room by himself to continue replacing the vacuum contactor. Atkins met Davis and Travis Myers on the 3<sup>rd</sup> floor and advised them of the progress on the vacuum contactor removal. Davis and Travis Myers traveled to the 8<sup>th</sup> floor MCC room and discussed the job with Muncy. Davis completed the removal of the vacuum contactor and began installing the replacement vacuum contactor.

When investigators arrived they found the visible disconnect was in the closed position. The 8<sup>th</sup> floor MCC room was de-energized, however, because the electrical power had been turned off at the substation. Investigators determined that when the victim installed the vacuum contactor, the original mounting plate was re-used to mount the replacement vacuum contactor. However, the replacement vacuum contactor and mounting plate were misaligned. When Davis attached the contactor interlock rod from the vacuum contactor to the disconnect handle mechanism, it would not allow the visible disconnect to close. The contactor interlock rod has a connection point that allows adjustments to be made to the effective length of the contactor interlock rod.

When the accident occurred, the visible disconnect was closed (disconnect handle in the up position) during the adjustment process and the input side of the vacuum contactor became energized. Further testing revealed that adjustment of the contactor interlock rod requires a miner to open and close the visual disconnect to check the adjustments. To perform these adjustments safely and comply with the appropriate standards, the electricians performing the work would need to first travel to the substation, open the circuit breaker, open the visual disconnect to ensure that electrical power was deenergized in the cabinet, and lock and tag the visual disconnect (separate lock and tag for each electrician). The electricians would then have to ground the de-energized power conductors prior to performing adjustments.

1. New main disconnects were installed on the 1<sup>st</sup> and 8<sup>th</sup> floor MCC rooms with a "captured key" type system at the plant substation. This new system requires the main disconnect to be opened to gain access to the key to unlock single key locks installed on all 4,160 VAC circuit breaker cabinets inside the plant.

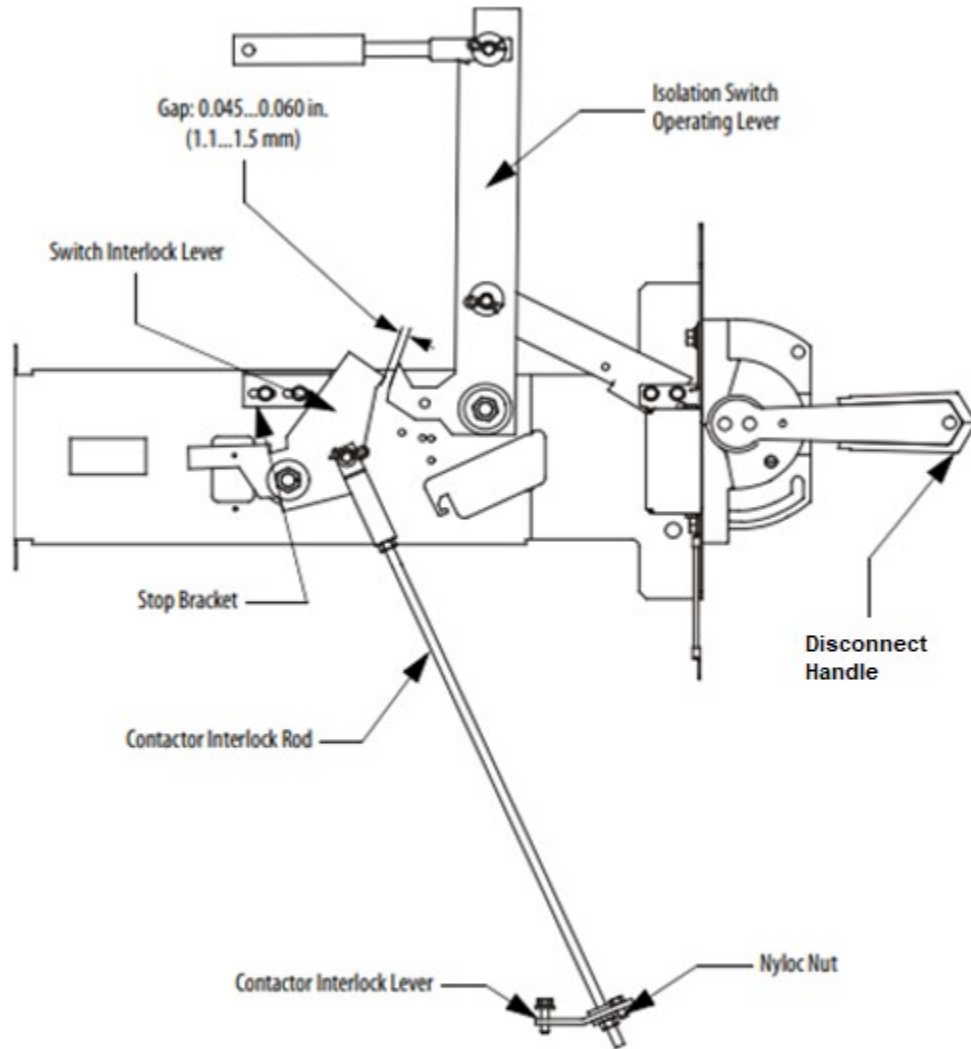
## Appendix B Disconnect Handle Schematic

Bill Clendenen, Plant Foreman and certified electrician, arrived at the 8<sup>th</sup> floor MCC room to check the progress of the job. Davis completed installation of the vacuum contactor and closed the cabinet door. Travis Myers replaced the three high voltage fuses in the back of the cabinet which energized the cabinet with 4,160 VAC. Davis then attempted to close the disconnect handle but the disconnect handle would not move. The handle was stuck in the open position and he could not close it. Scott Williams, Plant Foreman and certified electrician, arrived at the 8<sup>th</sup> floor MCC room and discussed the ongoing repairs with Clendenen. Meanwhile, Davis opened the cabinet door and began adjusting the contactor interlock rod (see Appendix B).

While Davis was adjusting the contactor interlock rod, Muncy noticed the disconnect handle had moved slightly upward from the fully open position (see Appendix B). Muncy looked towards the visible disconnect and he noticed the disconnect blades had moved towards the 4,160 volt buss. Muncy stated to Davis that it looks like the fingers are partially closed, something does not look right. At that moment, Davis came in contact with part of the energized circuit within the slope belt breaker cabinet. Clendenen, Scott Williams, Travis Myers and Muncy heard an electrical arc and all of them turned to see Davis lying on the floor. Clendenen threw Muncy a pair of high voltage gloves which he used to pull Davis clear of the breaker cabinet.
