REPORT OF INVESTIGATION

Underground Coal Mine

Fatal Machinery Accident
December 23, 2019

Marshall County Mine
Marshall County Coal Company
Cameron, Marshall County, West Virginia
I.D. No. 46-01437

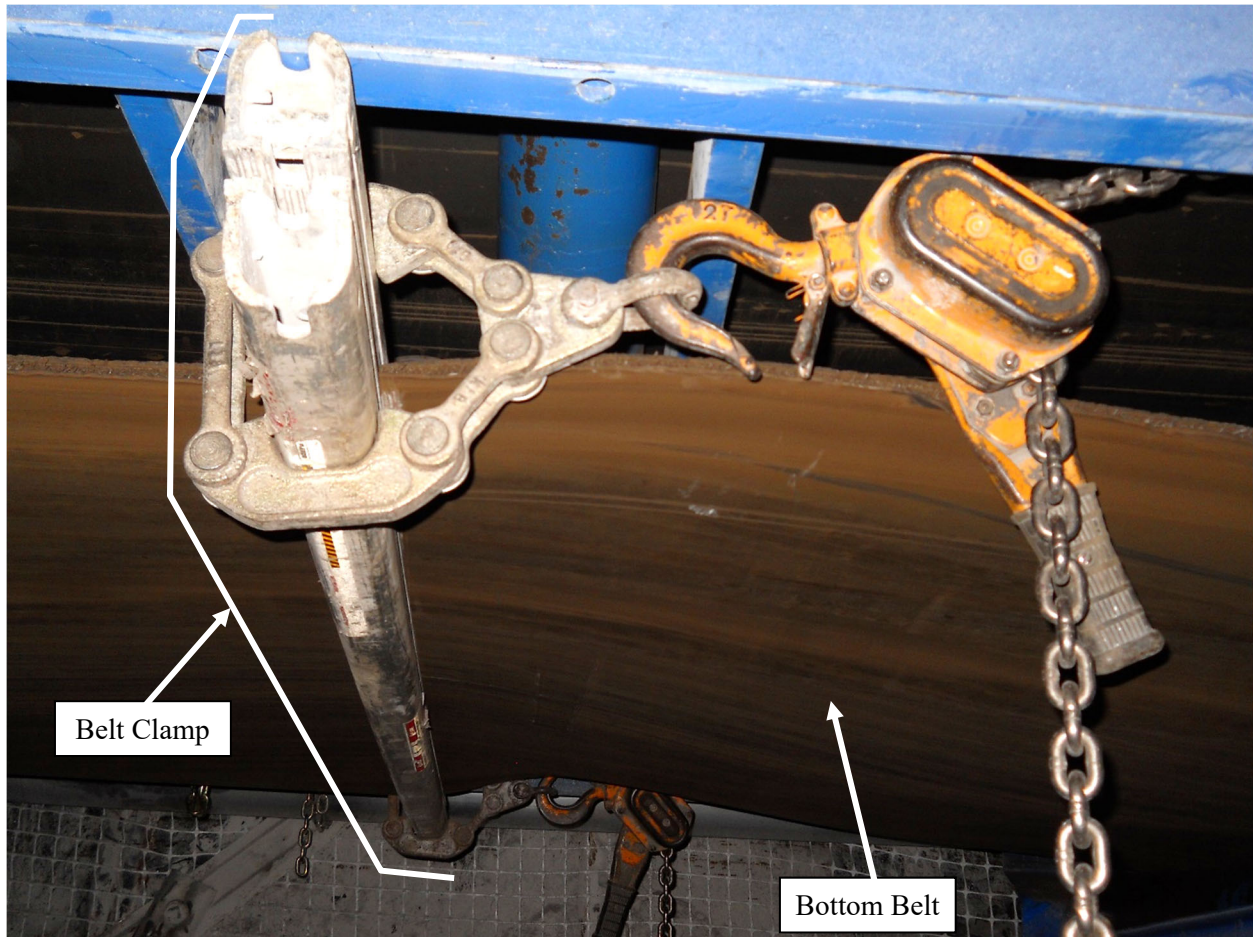
Appendix A
Photograph of Belt Clamp at 49 Block

On December 23, 2019, Starkey, General Inside Laborer (GIL) was assigned to help the belt crew because several regular crew members were absent. The crew traveled to the Cameron Corridor Section to move the belt. Greg Jones, Belt Foreman, and Trey Scott, Beltman, positioned the belt so that a belt splice was just outby the tailpiece, at approximately 3:30 p.m., and turned off the belt. Jones directed Justin Nething and Vincent Gillies, Beltmen, to remove the belt drive power and lock and tag it out, which they did. Nething and Gillies traveled to the 49 block track chute and clamped the bottom belt in preparation for adding belt to the Cameron Corridor belt (see Appendix A).

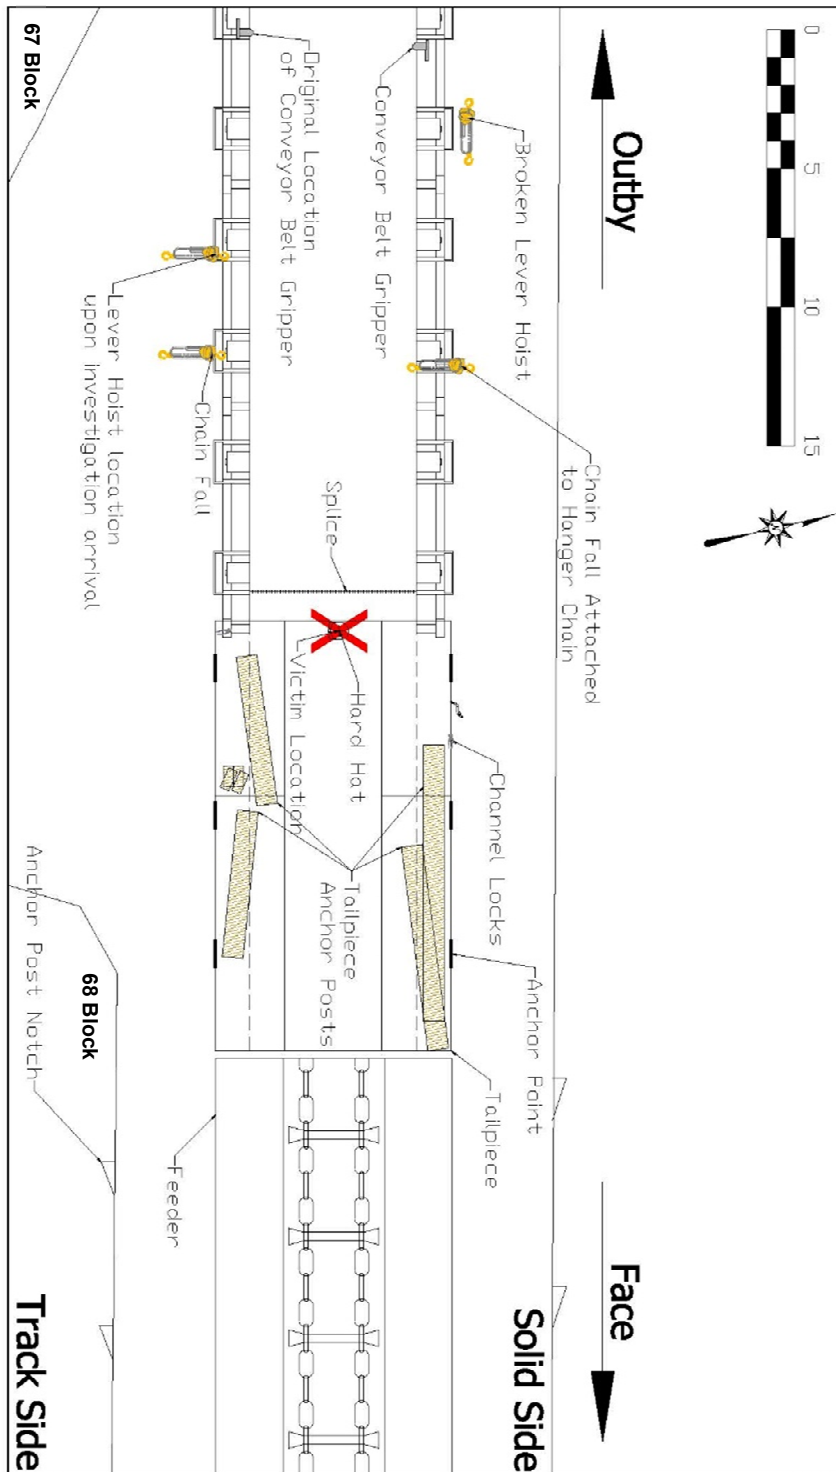
Appendix B
Drawing of the Accident Scene at 67 Block

The next step in the process was the removal of the tailpiece anchors (see Appendix B). During normal operation, these anchors hold the tailpiece in place because there is a large amount of tension in the belt between the belt drive and tailpiece. Devan Potts, Beltman, connected the feeder to the tailpiece and trammed it toward the face, away from the belt drive which was located at 1 block. This reduced the tension on the tailpiece anchors so the belt crew could remove them, but it increased the amount of tension in the belt. Potts then trammed the feeder outby and the tension in the belt pulled the tailpiece and moved it in an outby direction. When the tailpiece moved outby, it removed some of the tension from the belt between the clamp at 49 block and the tailpiece at 67 block. This allowed the belt to sag in some areas due to the weight of the belt. However, even though the belt sagged, a significant amount of tension remained in the belt between 49 and 67 blocks.

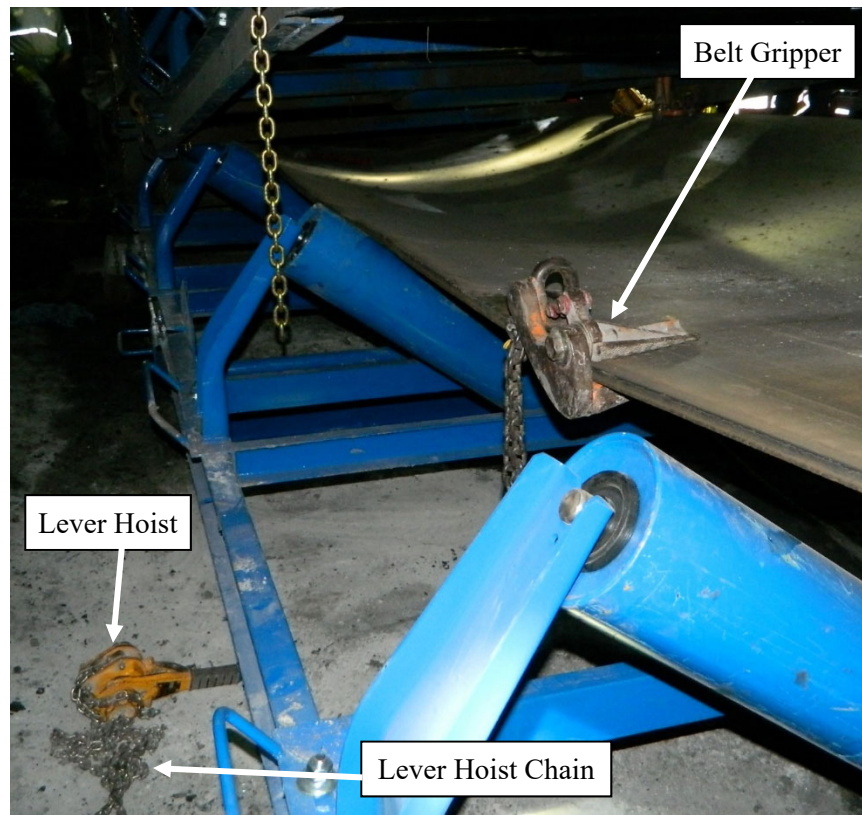
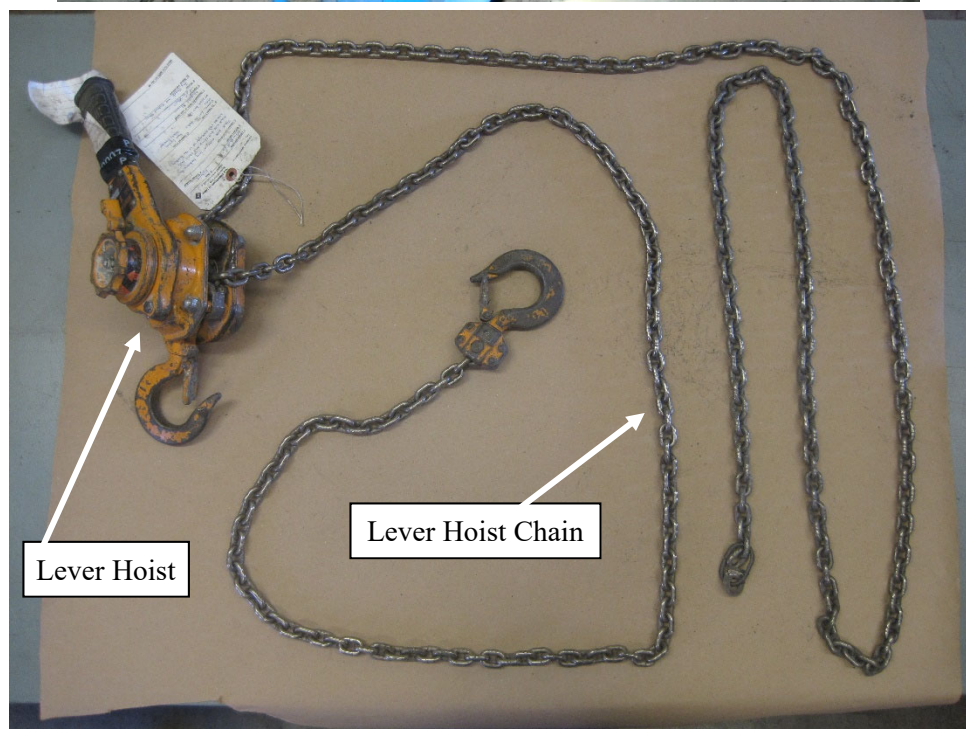
Appendix C
Photographs of Lever Hoist, Lever Hoist Chain, and Belt Gripper at 67 Block

Jones noticed that the belt was sagging between the bottom rollers rather than just outby the tailpiece where the splice was located. The crew wanted the sag in the belt to be at the splice location so they could easily remove the splice pin. The crew attached belt grippers on the bottom belt at 67 block (see Appendix C). The crew then attached lever hoist chains to the belt grippers and tightened the lever hoists to prevent additional sagging between the bottom rollers when the tailpiece was moved further outby.

As previously explained, the tailpiece movement outby transferred the belt tension load to the belt grippers, lever hoist chains, and lever hoists on the bottom belt. The devices held the tension in approximately 2,760 feet of bottom belt between 67 block and 49 block. Jones and the other crew members stated they did not recognize the significant amount of tension that remained in the belt. Eventually, the stored energy from the clamped belt overcame the capacity of these devices and they failed. This sudden tension release caused the belt to become tight, pinning Starkey against the tailpiece.

The MSHA Approval and Certification Center, Mechanical and Engineering Safety Division (A&CC) examined the belt grippers and the lever hoists used by the mine operator at the time of the accident. The A&CC used documentation and information from the manufacturers, obtained during the investigation, as a basis to evaluate the general condition of the devices and draw conclusions as to their use. Investigators determined that on one side of the belt, the lower jaw of one belt gripper failed. On the other side of the belt, the lever hoist chain failed. One of these failed first and caused the failure of the other.

The load limit (tension is an example of a load) for the belt grippers and lever hoist chains was 2,000 lb. pull each. The tension calculated in the belt, as configured at the time of the accident, exceeded the manufacturers' load limits for the belt grippers and lever hoist chains used.

Additionally, the documentation for the belt grippers states that their primary function is to provide a means to pull or maneuver loose belt into position for splicing or repair. Loose belt would have little to no tension.

Corrective Action: The mine operator revised and expanded their belt move procedure. The revised procedure requires the belt splice to be positioned at least 100 feet outby the tailpiece. It also requires all belt tension to be removed, which eliminates the need to clamp the belt near the tailpiece. Miners were trained in the revised procedure.
