REPORT OF INVESTIGATION

Underground Coal Mine

Fatal Machinery Accident  
December 23, 2019

Marshall County Mine  
Marshall County Coal Company  
Cameron, Marshall County, West Virginia  
I.D. No. 46-01437

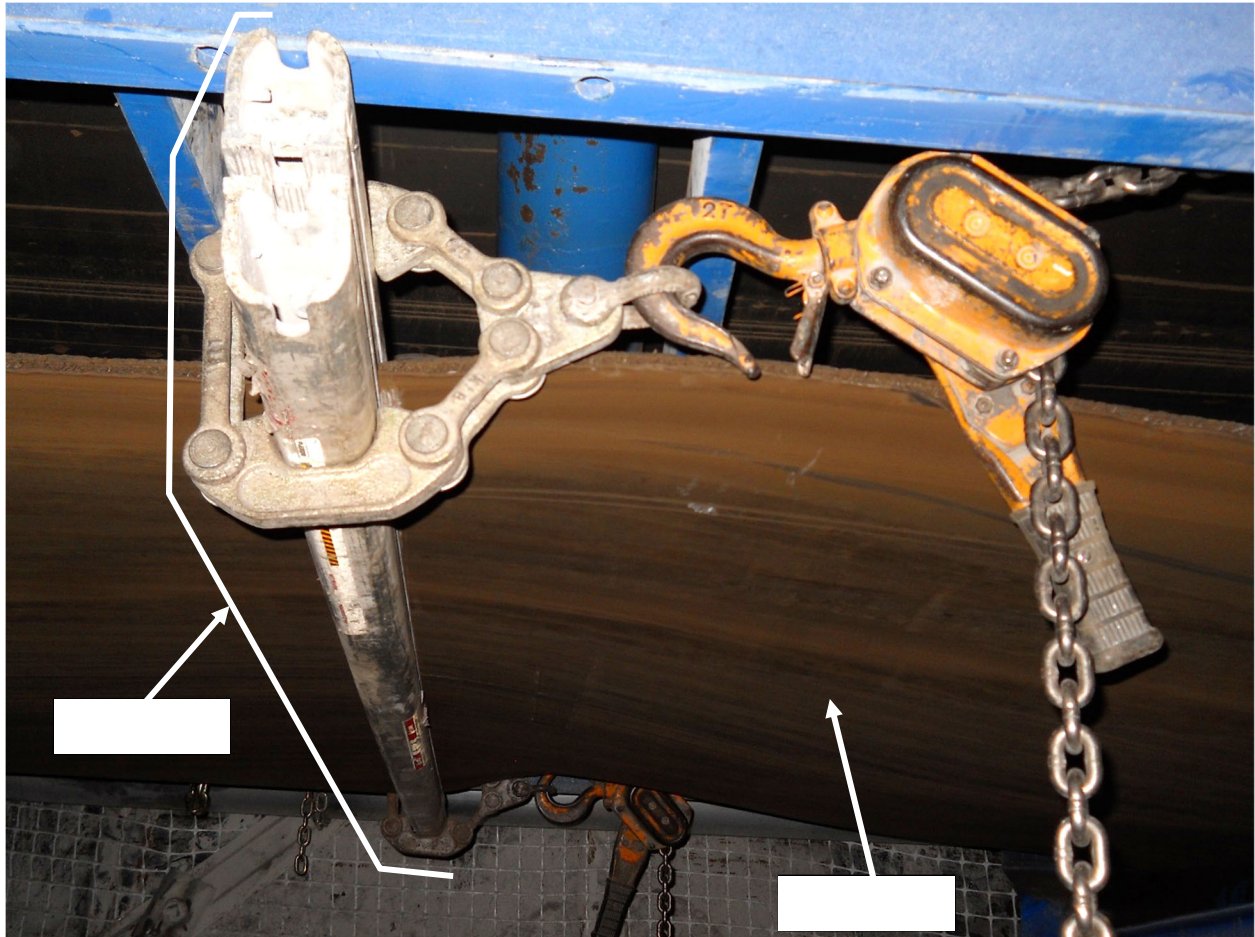
Appendix A  
Photograph of Belt Clamp at 49 Block

On December 23, 2019, Starkey, General Inside Laborer (GIL) was assigned to help the belt crew because several regular crew members were absent. The crew traveled to the Cameron Corridor Section to move the belt. Greg Jones, Belt Foreman, and Trey Scott, Beltman, positioned the belt so that a belt splice was just outby the tailpiece, at approximately 3:30 p.m., and turned off the belt. Jones directed Justin Nething and Vincent Gillies, Beltmen, to remove the belt drive power and lock and tag it out, which they did. Nething and Gillies traveled to the 49 block track chute and clamped the bottom belt in preparation for adding belt to the Cameron Corridor belt (see Appendix A).

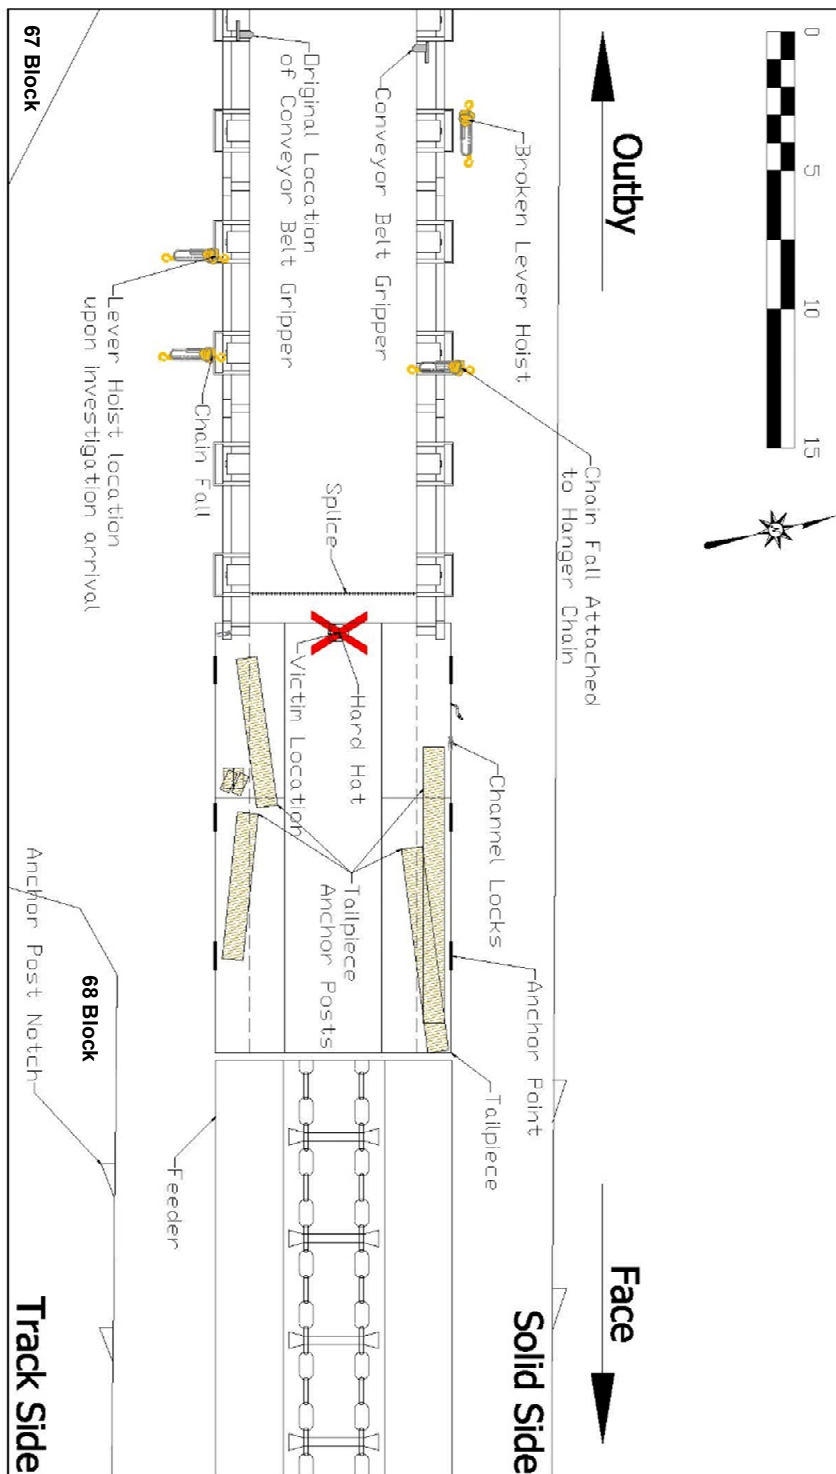
Appendix B  
Drawing of the Accident Scene at 67 Block

The next step in the process was the removal of the tailpiece anchors (see Appendix B). During normal operation, these anchors hold the tailpiece in place because there is a large amount of tension in the belt between the belt drive and tailpiece. Devan Potts, Beltman, connected the feeder to the tailpiece and trammed it toward the face, away from the belt drive which was located at 1 block. This reduced the tension on the tailpiece anchors so the belt crew could remove them, but it increased the amount of tension in the belt. Potts then trammed the feeder outby and the tension in the belt pulled the tailpiece and moved it in an outby direction. When the tailpiece moved outby, it removed some of the tension from the belt between the clamp at 49 block and the tailpiece at 67 block. This allowed the belt to sag in some areas due to the weight of the belt. However, even though the belt sagged, a significant amount of tension remained in the belt between 49 and 67 blocks.

Jones noticed that the belt was sagging between the bottom rollers rather than just outby the tailpiece where the splice was located. The crew wanted the sag in the belt to be at the splice location so they could easily remove the splice pin. The crew attached belt grippers on the bottom belt at 67 block (see Appendix C). The crew then attached lever hoist chains to the belt grippers and tightened the lever hoists to prevent additional sagging between the bottom rollers when the tailpiece was moved further outby.

Potts moved the feeder an additional distance outby to remove tension from the small section of belt between the tailpiece and the belt grippers. This caused the belt to sag to the mine floor, however, the splice was inaccessible because of the tailpiece frame. Potts moved the feeder and the tailpiece outby again to position the splice where they could access it through an opening in the side of the tailpiece. When Potts moved the tailpiece these two additional times, the remaining belt tension was transferred to the belt grippers, lever hoist chains, and lever hoists.

As previously explained, the tailpiece movement outby transferred the belt tension load to the belt grippers, lever hoist chains, and lever hoists on the bottom belt. The devices held the tension in approximately 2,760 feet of bottom belt between 67 block and 49 block. Jones and the other crew members stated they did not recognize the significant amount of tension that remained in the belt. Eventually, the stored energy from the clamped belt overcame the capacity of these devices and they failed. This sudden tension release caused the belt to become tight, pinning Starkey against the tailpiece.

Corrective Action: The mine operator revised and expanded their belt move procedure. The revised procedure requires the belt splice to be positioned at least 100 feet outby the tailpiece. It also requires all belt tension to be removed, which eliminates the need to clamp the belt near the tailpiece. Miners were trained in the revised procedure.

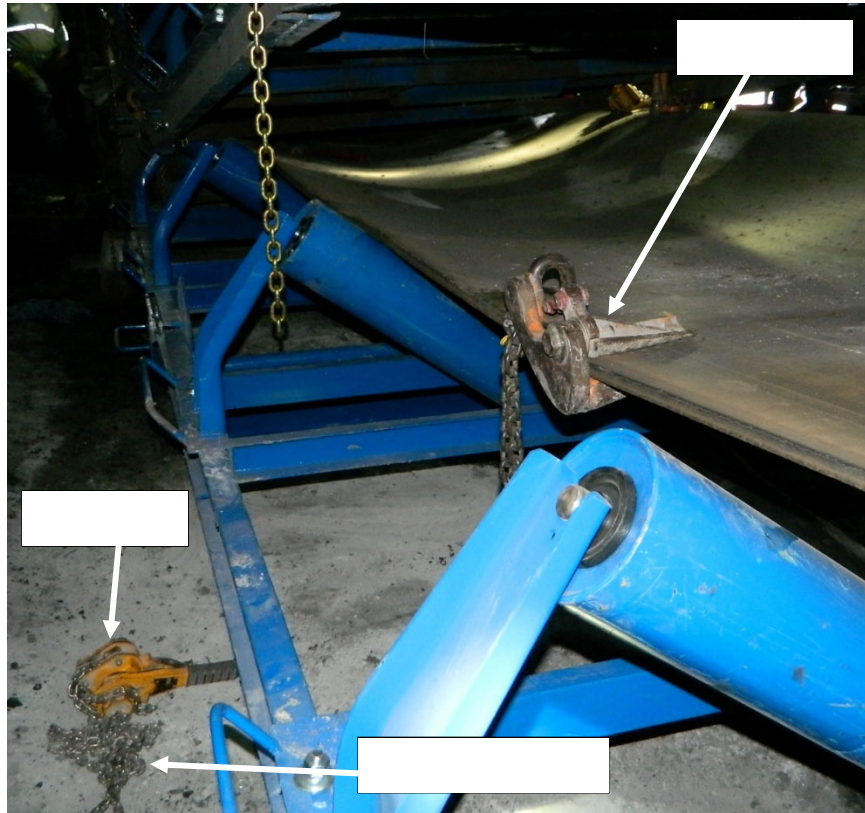
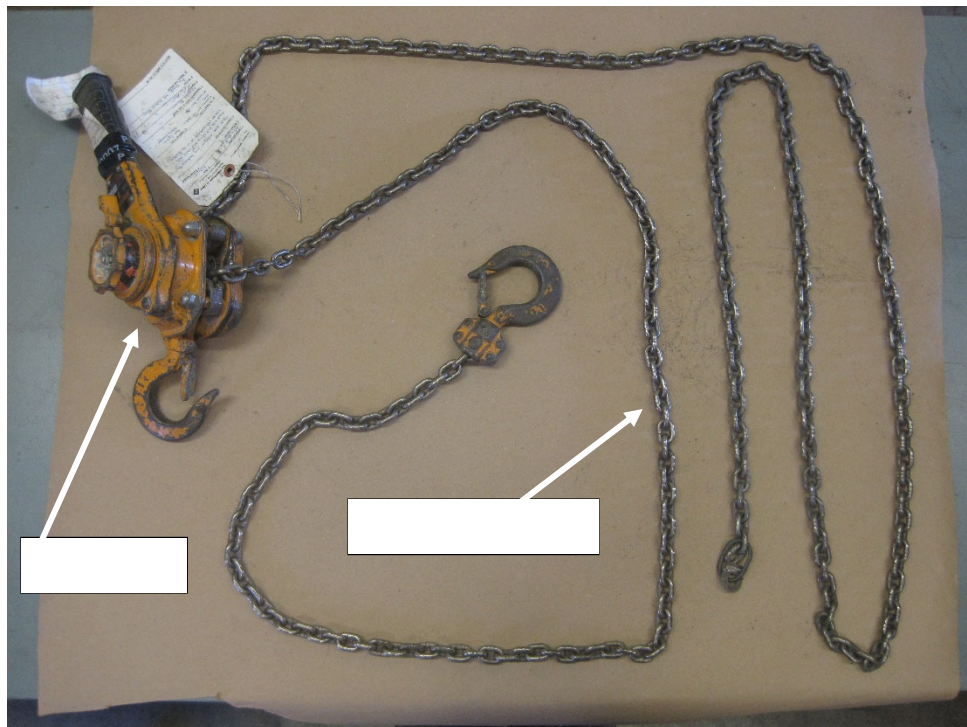
Appendix C  
Photographs of Lever Hoist, Lever Hoist Chain, and Belt Gripper at 67 Block

The MSHA Approval and Certification Center, Mechanical and Engineering Safety Division (A&CC) examined the belt grippers and the lever hoists used by the mine operator at the time of the accident. The A&CC used documentation and information from the manufacturers, obtained during the investigation, as a basis to evaluate the general condition of the devices and draw conclusions as to their use. Investigators determined that on one side of the belt, the lower jaw of one belt gripper failed. On the other side of the belt, the lever hoist chain failed. One of these failed first and caused the failure of the other.

The load limit (tension is an example of a load) for the belt grippers and lever hoist chains was 2,000 lb. pull each. The tension calculated in the belt, as configured at the time of the accident, exceeded the manufacturers' load limits for the belt grippers and lever hoist chains used.

Additionally, the documentation for the belt grippers states that their primary function is to provide a means to pull or maneuver loose belt into position for splicing or repair. Loose belt would have little to no tension.
