REPORT OF INVESTIGATION

Fatal Powered Haulage Accident
January 14, 2019

Irtec (Z142)
Caryville, Tennessee

Toms Fork Mine
TENNCO INC.
Balkan, Bell County, Kentucky
I.D. No. 15-19844

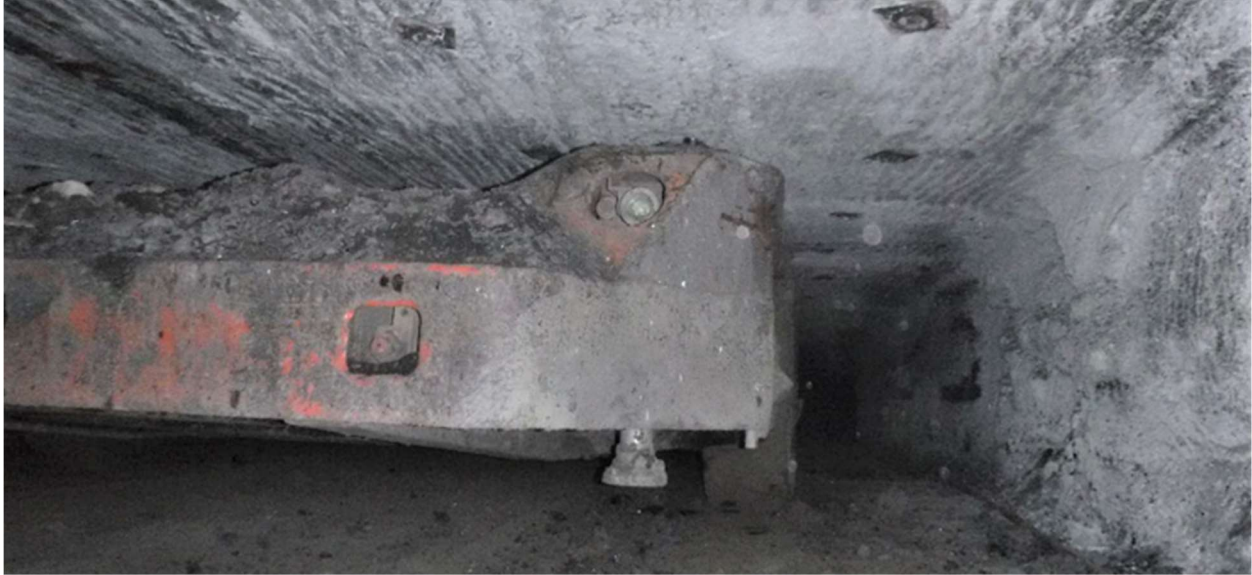
PHOTOGRAPH OF ACCIDENT SCENE

On Monday, January 14, 2019, at approximately 11:10 a.m., Jeffery N. Slone, a 56-year-old survey crew member with 30 years of mining experience, was fatally injured when he was struck by a shuttle car traveling to the coal feeder. At the time of the accident, Slone was taking measurements of the mining height as part of his surveying duties.

The accident occurred because the mine operator did not have effective policies, procedures, and controls to protect miners who are on foot from being contacted by moving mobile face equipment.

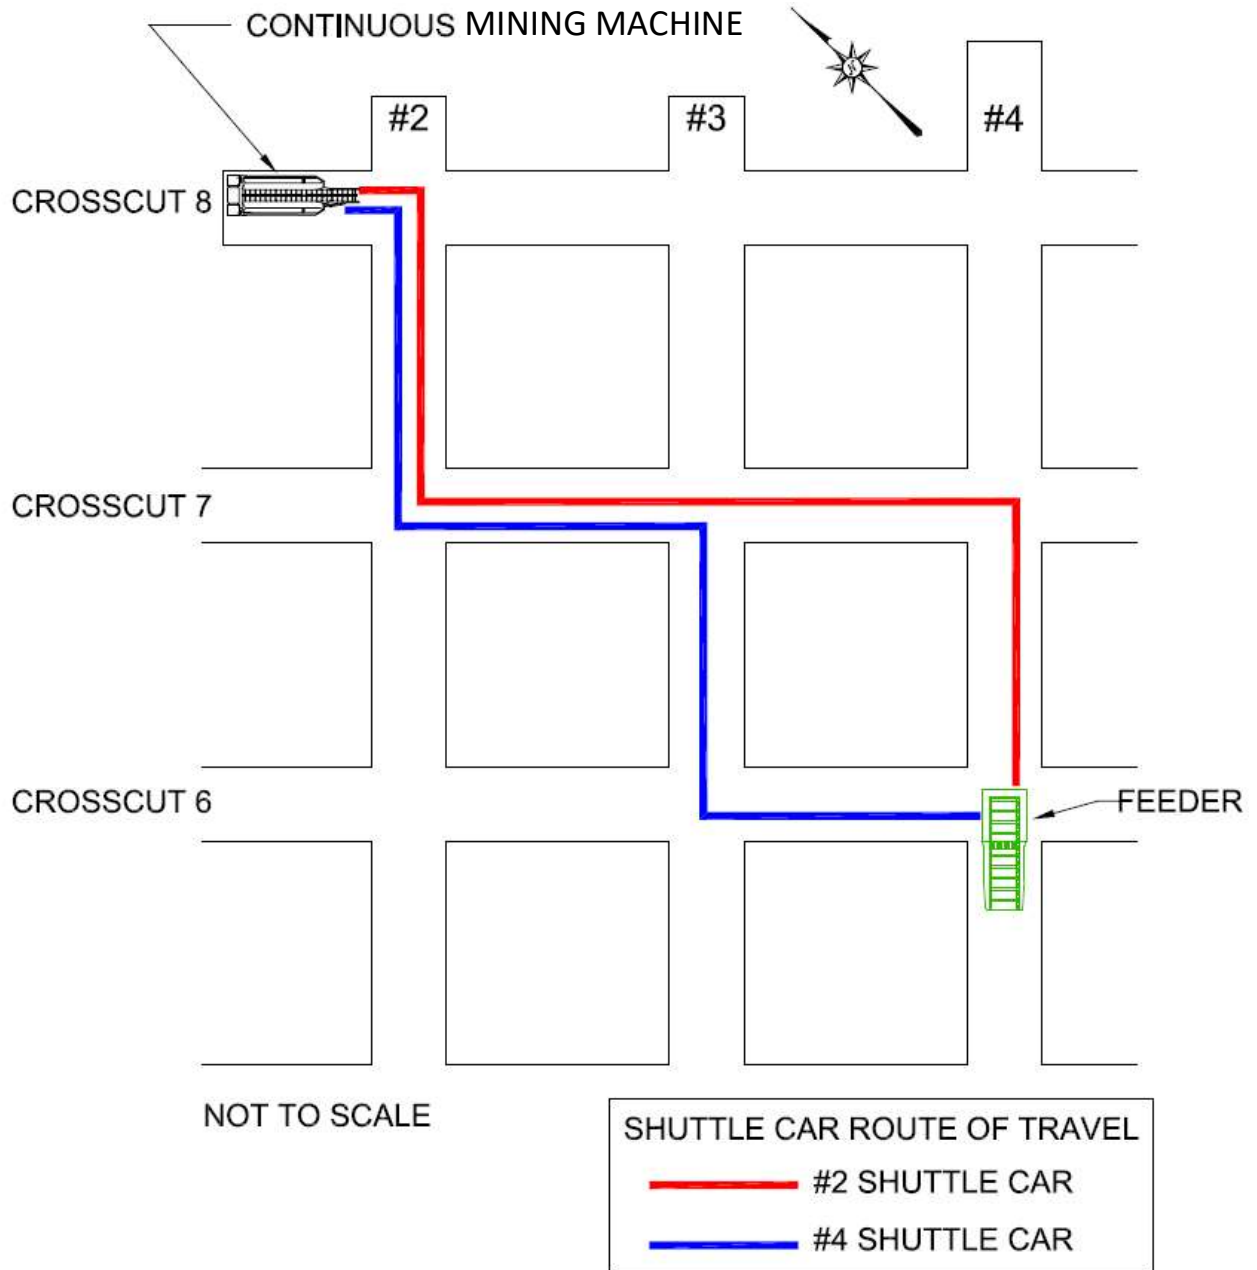
APPENDIX A
Travel Routes of Shuttle Cars

After lunch, Richard Lane, Shuttle Car Operator, began operating the No. 4 shuttle car and James Barnett, Roof Bolter, began operating the No. 2 shuttle car. Lane drove his shuttle car to the continuous mining machine which was in the left crosscut off the No. 2 entry (see Appendix A).

After being loaded with coal, Lane drove his shuttle car toward the feeder. At approximately 11:10 a.m., Lane turned into the No. 3 entry and traveled about 10 feet past the inby corner of the pillar and stopped. Lane saw that his shuttle car's trailing cable was caught around the service jack of Barnett's shuttle car. Lane and Barnett exited their shuttle cars and freed the cable. Lane continued to the left side of the feeder and Barnett traveled to the continuous mining machine.

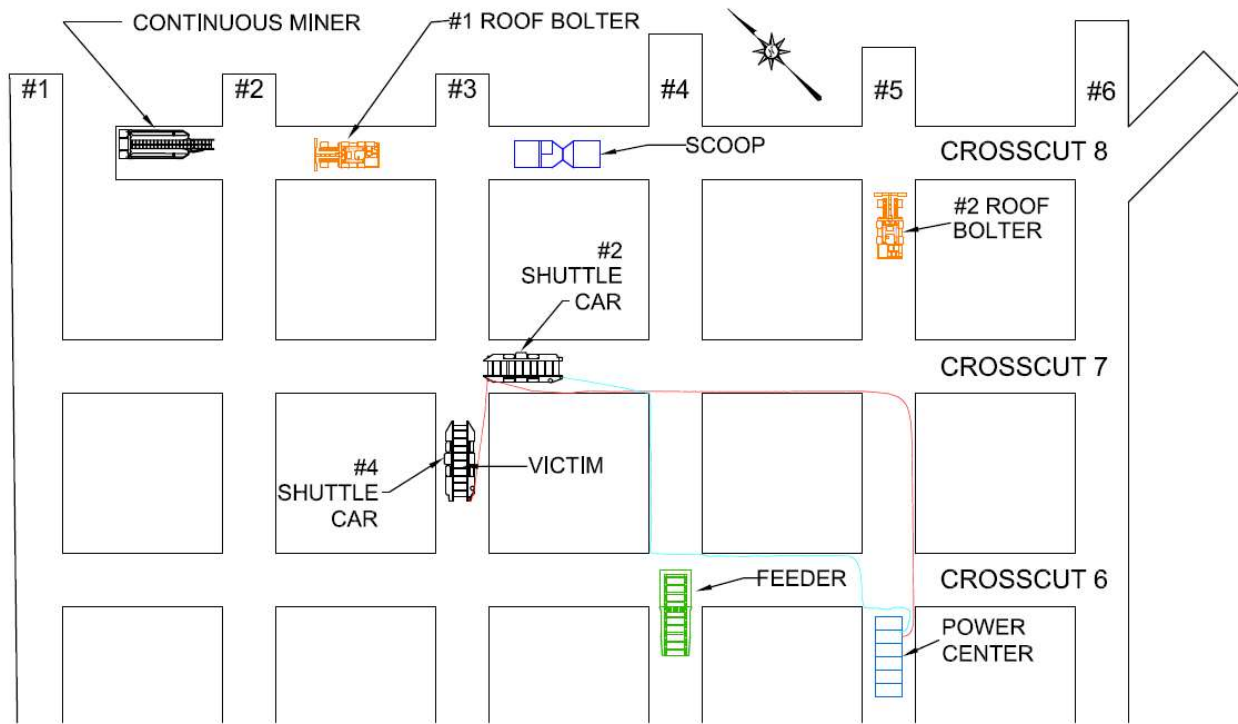
APPENDIX C
Locations of Shuttle Cars at the Time of the Accident

Investigators believe the accident occurred at approximately 11:10 a.m., when Lane turned the No. 4 shuttle car into the No. 3 entry at the switch-out location. The No. 4 shuttle car is 28 feet long and Slone's map was found about 30 feet from the inby corner of the pillar (see Appendix C). This would indicate that Slone had already been struck when Barnett and Lane exited their cars to free the shuttle car cable.
