REPORT OF INVESTIGATION

Fatal Machinery Accident
March 7, 2019

HWM 61
South Fork Coal Company
Rupert, Greenbrier County, West Virginia
ID No. 33-04642

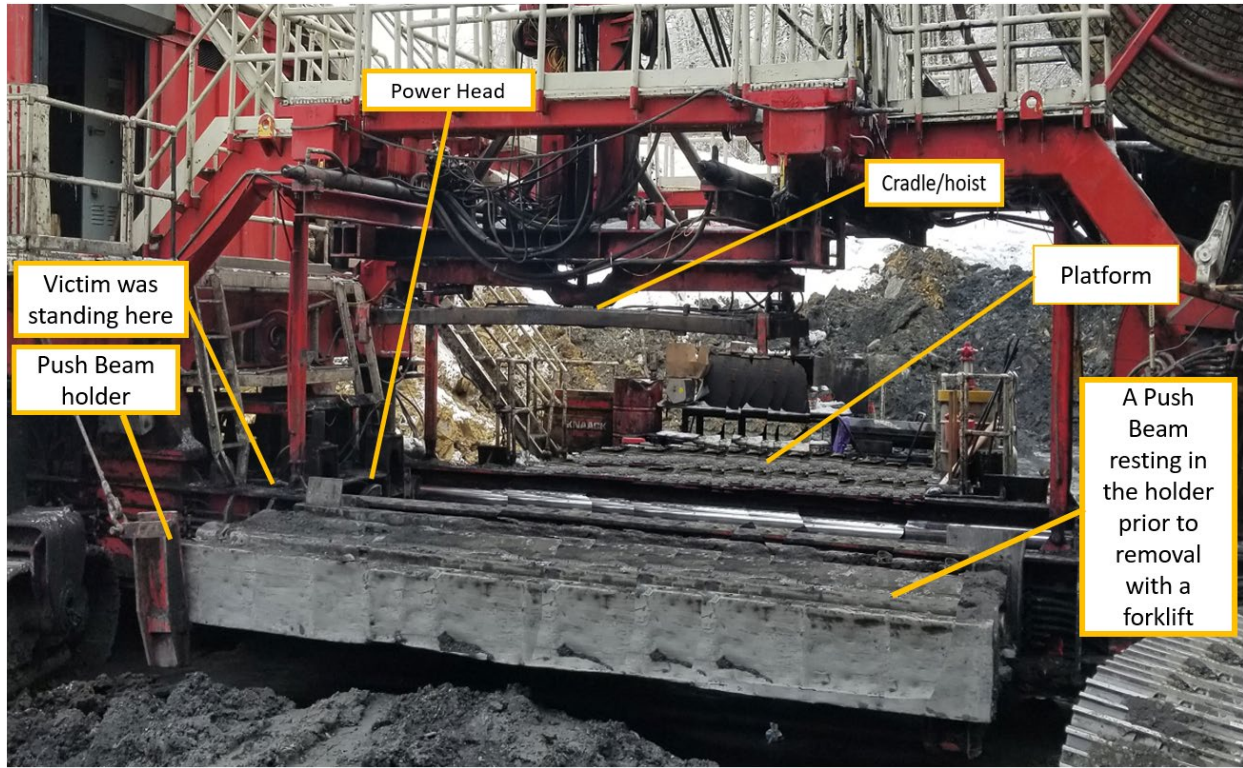
Appendix A
Photographs

the power head retracts, pulling the push beam and the cutter module backward so that it is under the cradle/hoist. The cradle/hoist lifts the push beam and places it in the holder. A forklift removes the push beam from the holder and places it in a storage area. This process continues until all of the push beams and cutter module are removed from the hole that was mined (see Appendix A).
