REPORT OF INVESTIGATION

Surface Coal Mine

Fatal Machinery Accident  
March 7, 2019

HWM 61  
South Fork Coal Company  
Rupert, Greenbrier County, West Virginia  
ID No. 33-04642

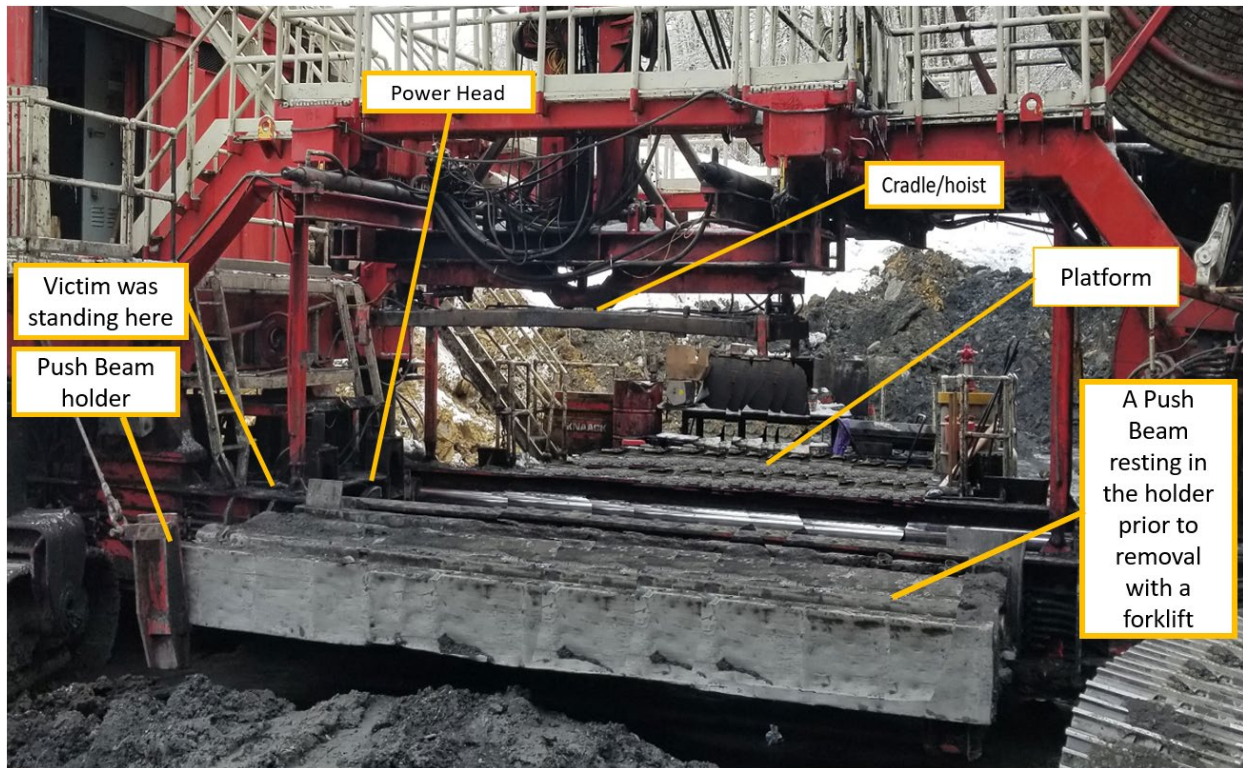
Appendix A  
Photographs

the power head retracts, pulling the push beam and the cutter module backward so that it is under the cradle/hoist. The cradle/hoist lifts the push beam and places it in the holder. A forklift removes the push beam from the holder and places it in a storage area. This process continues until all of the push beams and cutter module are removed from the hole that was mined (see Appendix A).

The highwall mining machine was found with a push beam resting in the holder and the cradle/hoist positioned over top of this beam (see Appendix A).

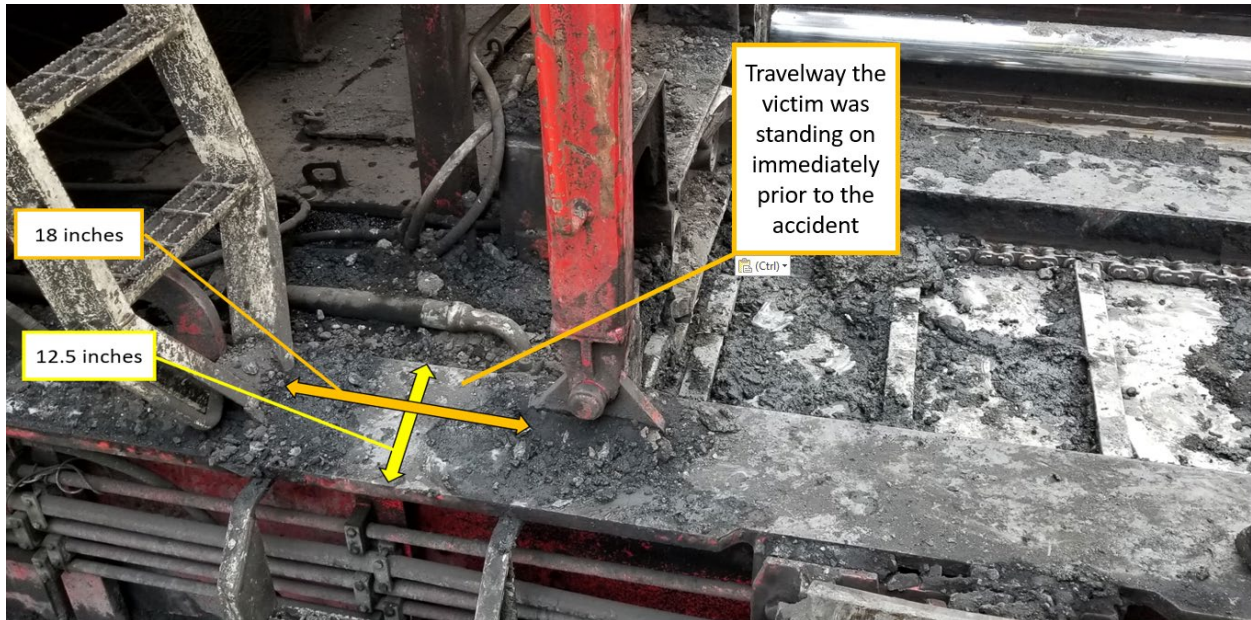
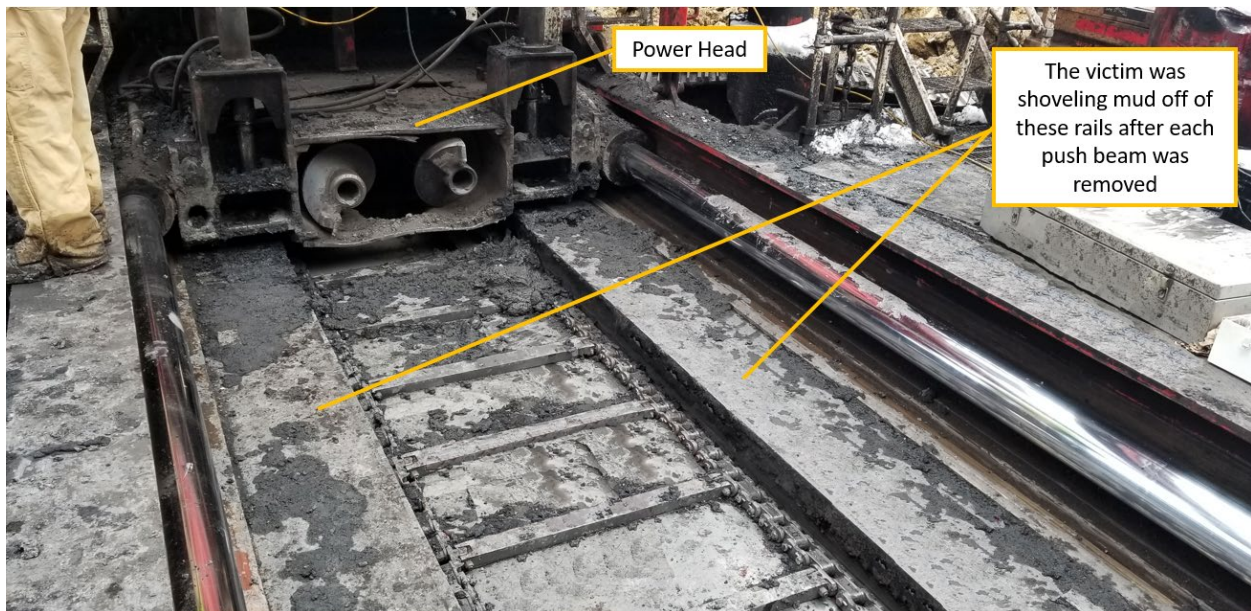
Appendix A cont'd.

Investigators determined that the victim was standing on a small section (18 inches by 12.5 inches) of metal (travelway) between the ladder leading up to the second level of the machine and the steps that lead to the ground. It was common practice for a miner to stand in this small area, to shovel the mud that accumulates on the rails, as the push beams are removed from the mined hole. The mud has to be removed after each push beam is removed, to allow the power head to extend and properly connect to the next beam.

The small section where the victim was standing was not intended to be a work area because of the proximity of the moving push beams. This area was designated for miners to step on momentarily as they got on and off the machine. Each push beam was moving approximately 12 to 18 inches in front of the victim as it was raised, moved horizontally, and lowered by the cradle/hoist to the holder. The Superior Highwall Miners Safety, Operation, and Maintenance Manual, states on page one:

Investigators determined that the victim was repeatedly standing in a pinch area. The foremen and other miners knew the victim was standing in this location and told investigators they believed the area was a safe location for him to wait for the push beam to be moved to the holder. During interviews, they stated that it was common for someone to be in this location. They stated that this area was a travelway and the support post was between the landing area and the moving push beam.

The area where the fatal accident occurred has been brightly painted and posted with warning signs. Also, physical barriers have been installed to prevent entry. The back access steps on the holder side that provide access to this area from the ground have been removed. A handrail has been installed across the access steps at the second level so no one can enter from the top area. Cameras were installed with monitors located in the operator's compartment so the highwall mining machine operator can see if persons enter the red zone areas.
