REPORT OF INVESTIGATION

Underground Coal Mine

Fatal Machinery Accident
January 05, 2019

Mine No. 1
Hamilton County Coal, LLC
Dahlgren, Hamilton County, Illinois
I.D. No. 11-03203

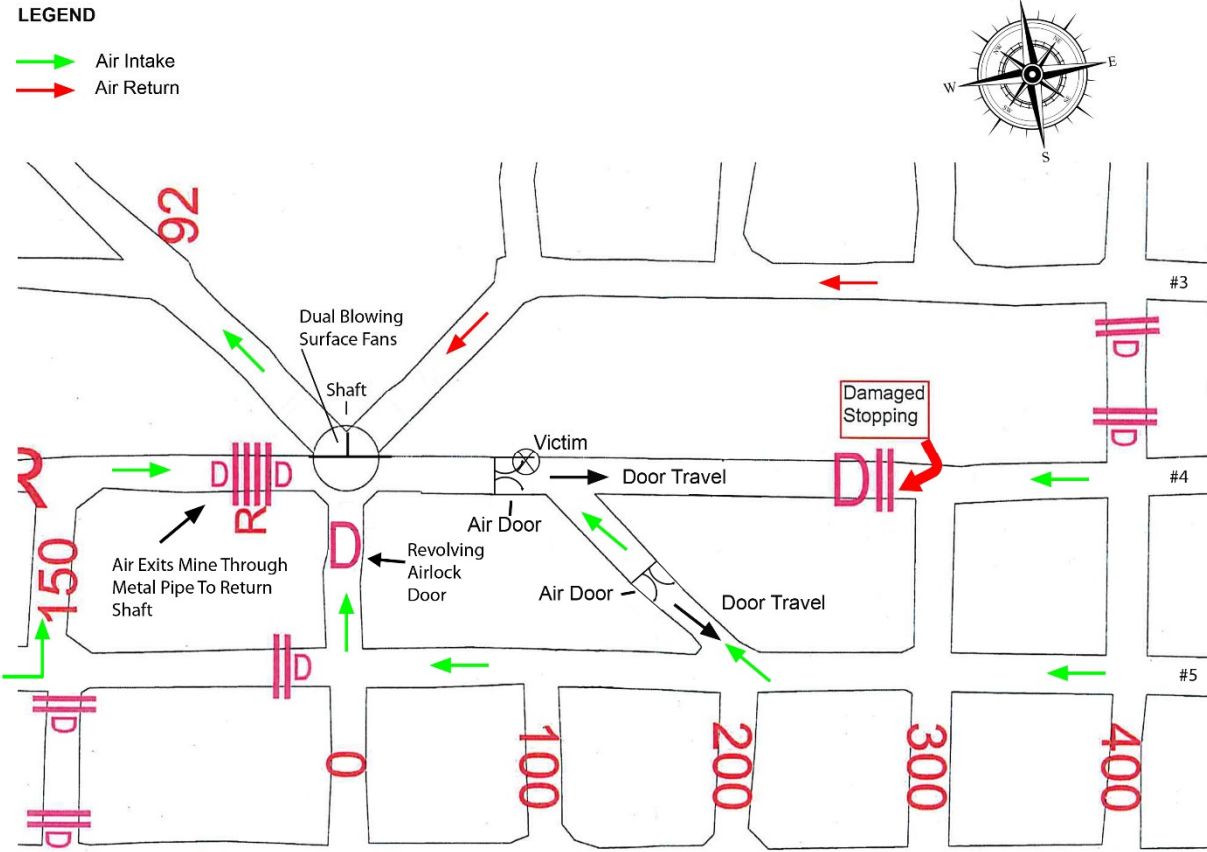
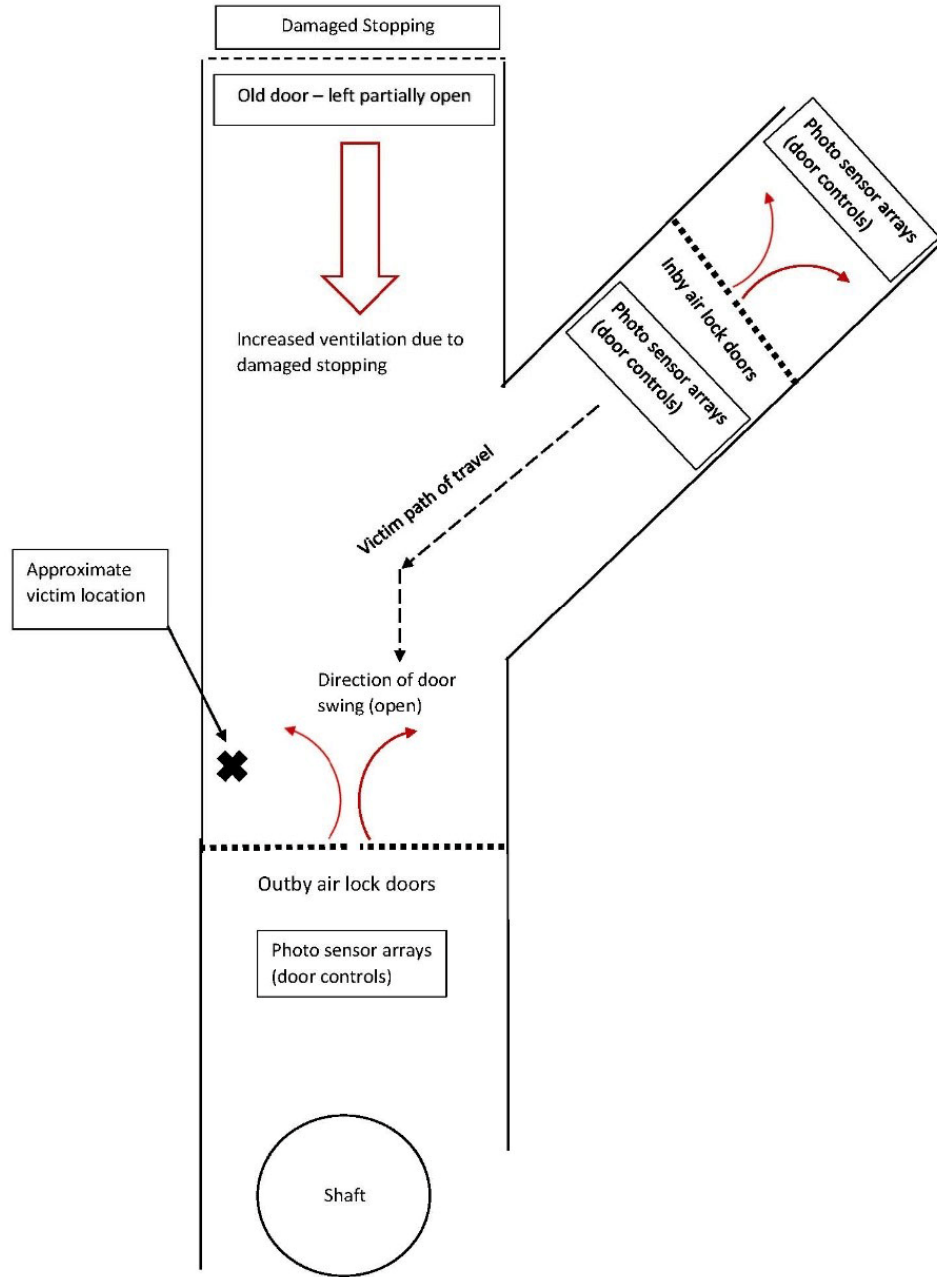
Drawing of Bottom Area

The accident occurred at the set of outby pneumatic airlock doors located on the East Main, Entry 4, between footage markers 0-100, just east of the Main Shaft bottom area (see Appendix A). When investigators arrived, the pneumatic doors involved in the accident were in the open position and the slide access door was open. Electrical power had been disconnected, locked, and tagged out.

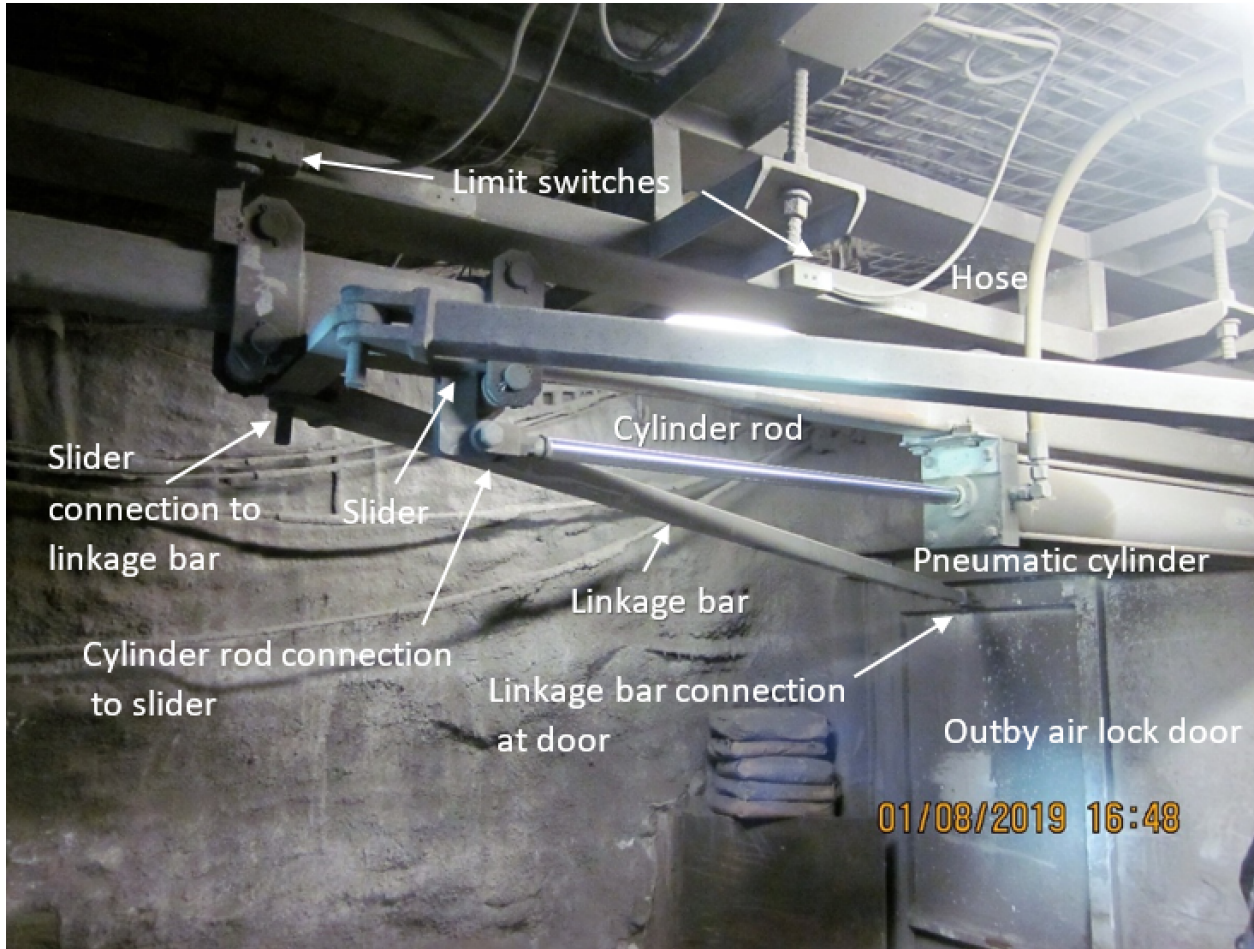
Parts of Airlock Doors Pneumatic System

There are two pneumatic systems at this airlock, one for the inby airlock doors, and the other for the outby airlock doors. Each pneumatic system is comprised of a compressor, air tank (accumulator), two pneumatic hoses with flow restriction valves in-line, and a pneumatic cylinder. The cylinder rod connects via a bolted connection to the slide mechanism. The slide mechanism, which rolls on a steel beam mounted to the roof of the entry, connects to the linkage bars via a pinned connection. The linkage bars then connect to the doors with a pinned connection (see Appendix C).

Mechanical Engineers from MSHA Technical Support observed the outby doors and its components on January 8, 2019. They evaluated the components of the pneumatic system for damage. The investigators did not observe damage on any component of the system, including the pneumatic cylinder, cylinder rod, linkages, hoses, valves, air tank (accumulator), or door. The electronic controls appeared to be functioning properly as the door functioned as designed when tested. Investigators did not observe damaged components in the pneumatic system or mechanical components. The pneumatic system and all mechanical components operated as designed.

Mine personnel placed pressure gauges on both ports of the outby door cylinder to monitor pressures while the door was being tested. The air tank maintained a pressure of 140 pounds per square inch (psi). Testing was then performed on the cylinder while the door was in a fault condition. The rod side of the cylinder remained within its designed operating pressures of 105 to 120 psi. The piston side of the cylinder went to zero which means that there was no dampening effect to allow the doors to open in a controlled manner after the slide access door was open. Testing showed investigators that the pneumatic system operated as designed, that there were no overpressures or other problems solely with the pneumatic system, and that the problem with the doors was created by the high air pressure environment.

The increased ventilation pressure due to the damaged stopping was outside the designed operating parameters for this system. At the time of the accident, the airlock door system operated within its designed logic parameters and entered a fault condition when the door would not open. When the victim opened the sliding door on the outby door, the ventilation pressure moved toward equilibrium. The pneumatic air pressure on the rod side of the cylinder (pushing open the door) was now greater than the force provided by the ventilation pressure (holding the door closed). The residual air pressure on the piston side of the cylinder that normally dampens this movement had completely vented to the atmosphere; this allowed the outby door to open in an uncontrolled rapid manner.

Corrective Action: The mine operator replaced the pneumatic system with a hydraulic system on the airlock doors that is capable of safely operating the doors in the high mine ventilation pressure area near the shaft bottom.
