REPORT OF INVESTIGATION

Underground Coal Mine

Fatal Machinery Accident
January 05, 2019

Mine No. 1
Hamilton County Coal, LLC
Dahlgren, Hamilton County, Illinois
I.D. No. 11-03203

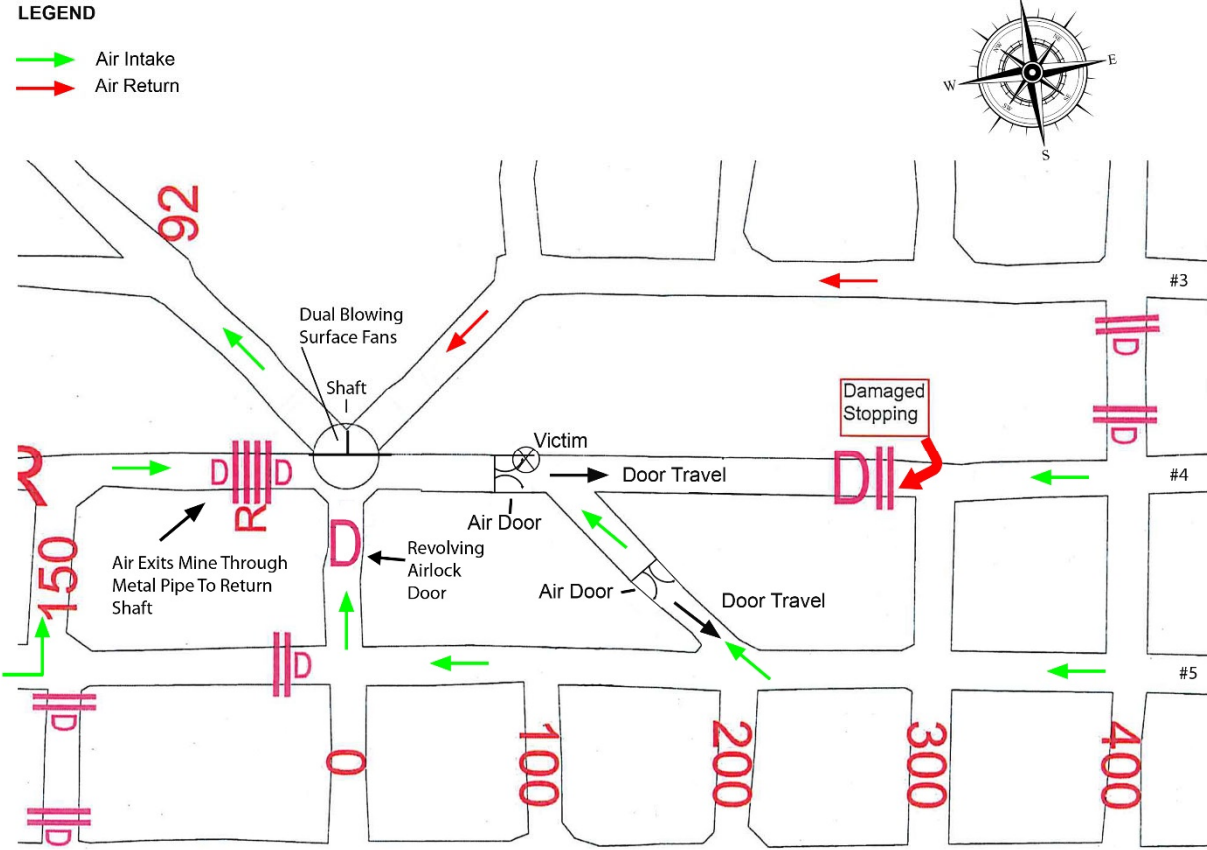
Drawing of Bottom Area

The accident occurred at the set of outby pneumatic airlock doors located on the East Main, Entry 4, between footage markers 0-100, just east of the Main Shaft bottom area (see Appendix A). When investigators arrived, the pneumatic doors involved in the accident were in the open position and the slide access door was open. Electrical power had been disconnected, locked, and tagged out.

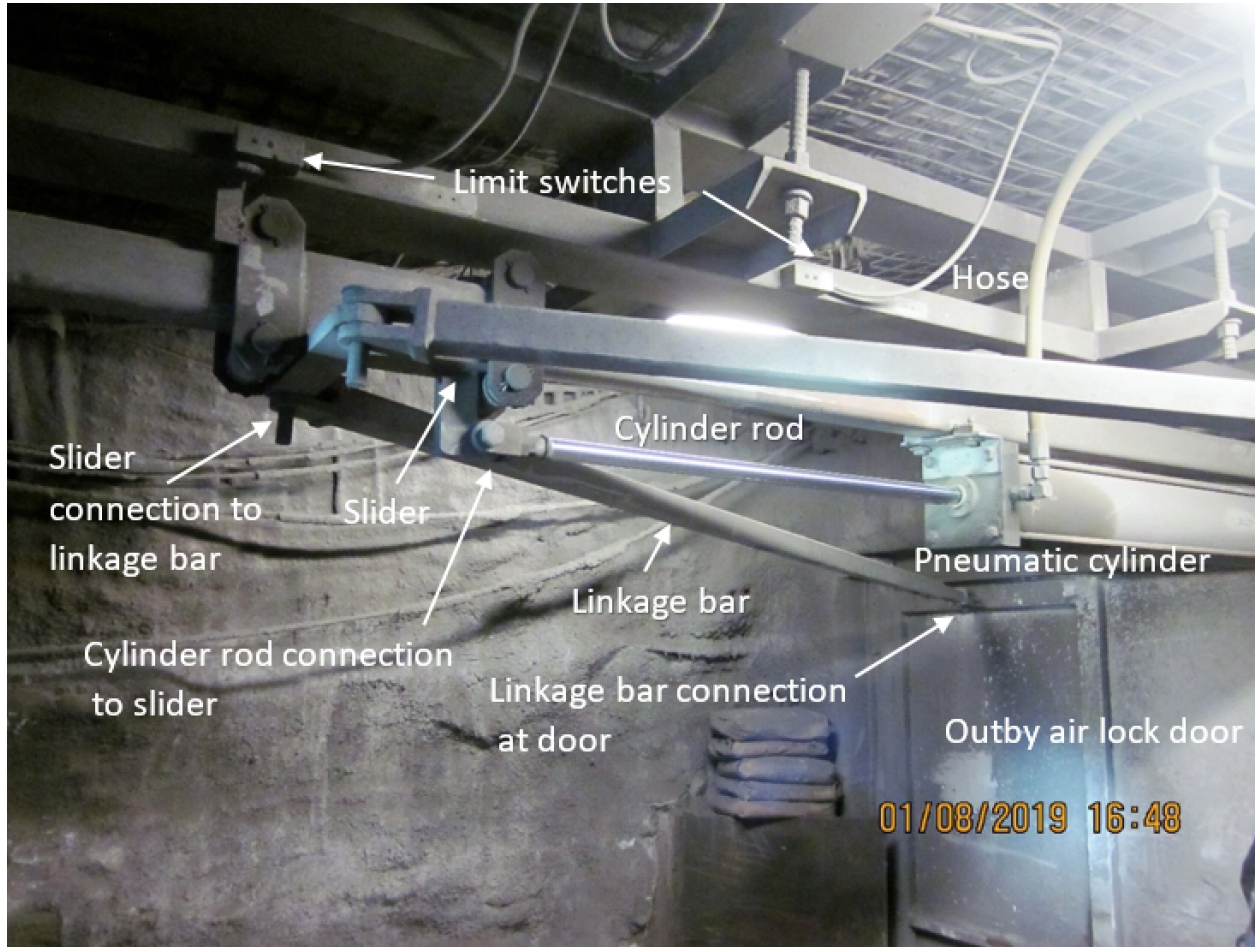
Parts of Airlock Doors Pneumatic System

There are two pneumatic systems at this airlock, one for the inby airlock doors, and the other for the outby airlock doors. Each pneumatic system is comprised of a compressor, air tank (accumulator), two pneumatic hoses with flow restriction valves in-line, and a pneumatic cylinder. The cylinder rod connects via a bolted connection to the slide mechanism. The slide mechanism, which rolls on a steel beam mounted to the roof of the entry, connects to the linkage bars via a pinned connection. The linkage bars then connect to the doors with a pinned connection (see Appendix C).

Mechanical Engineers from MSHA Technical Support observed the outby doors and its components on January 8, 2019. They evaluated the components of the pneumatic system for damage. The investigators did not observe damage on any component of the system, including the pneumatic cylinder, cylinder rod, linkages, hoses, valves, air tank (accumulator), or door. The electronic controls appeared to be functioning properly as the door functioned as designed when tested. Investigators did not observe damaged components in the pneumatic system or mechanical components. The pneumatic system and all mechanical components operated as designed.

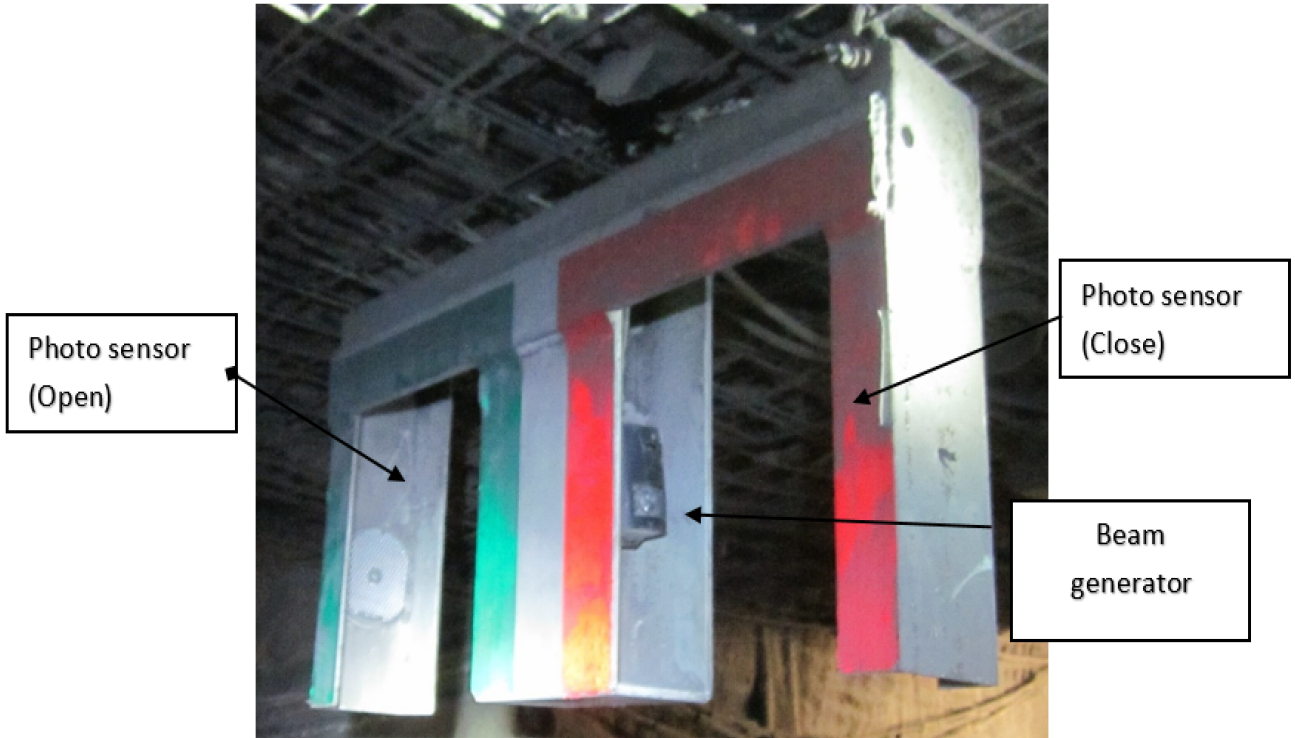
Photo Sensors - Pneumatic Airlock Doors

The photo sensor has two sides: open or close. The open sensor is marked with green and the close sensor is marked with red. The beam generator generates a beam; the beam reflects back to a sensor in the beam generator. When the beam is broken, the PLC opens or closes the doors. The PLC also activates the lights and audible alarms. Miners operate the doors by placing their hand into the appropriate side of the photo sensor mount located near the doors (see Appendix D).

Photo sensors to open or close air lock doors
