REPORT OF INVESTIGATION

Fatal Explosion Methane Gas
July 31, 2019

Paradise #9 Mine
KenAmerican Resources, LLC
Bremen, Muhlenberg County, Kentucky
ID No. 15-17741

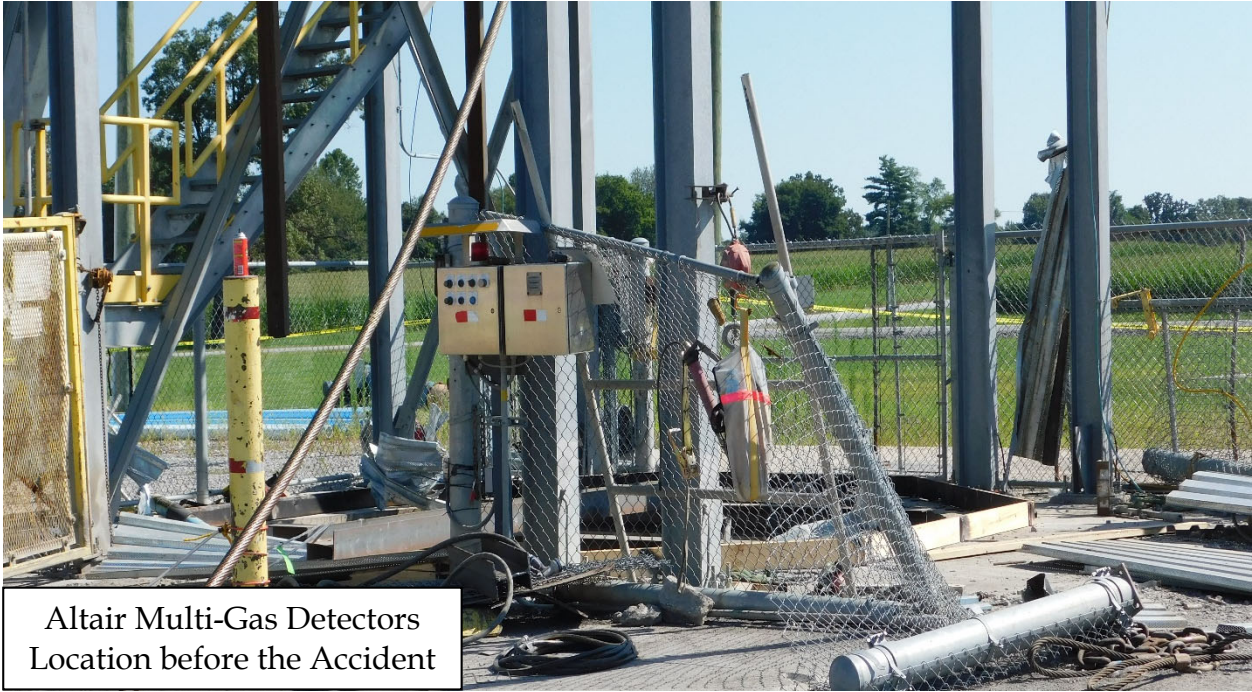
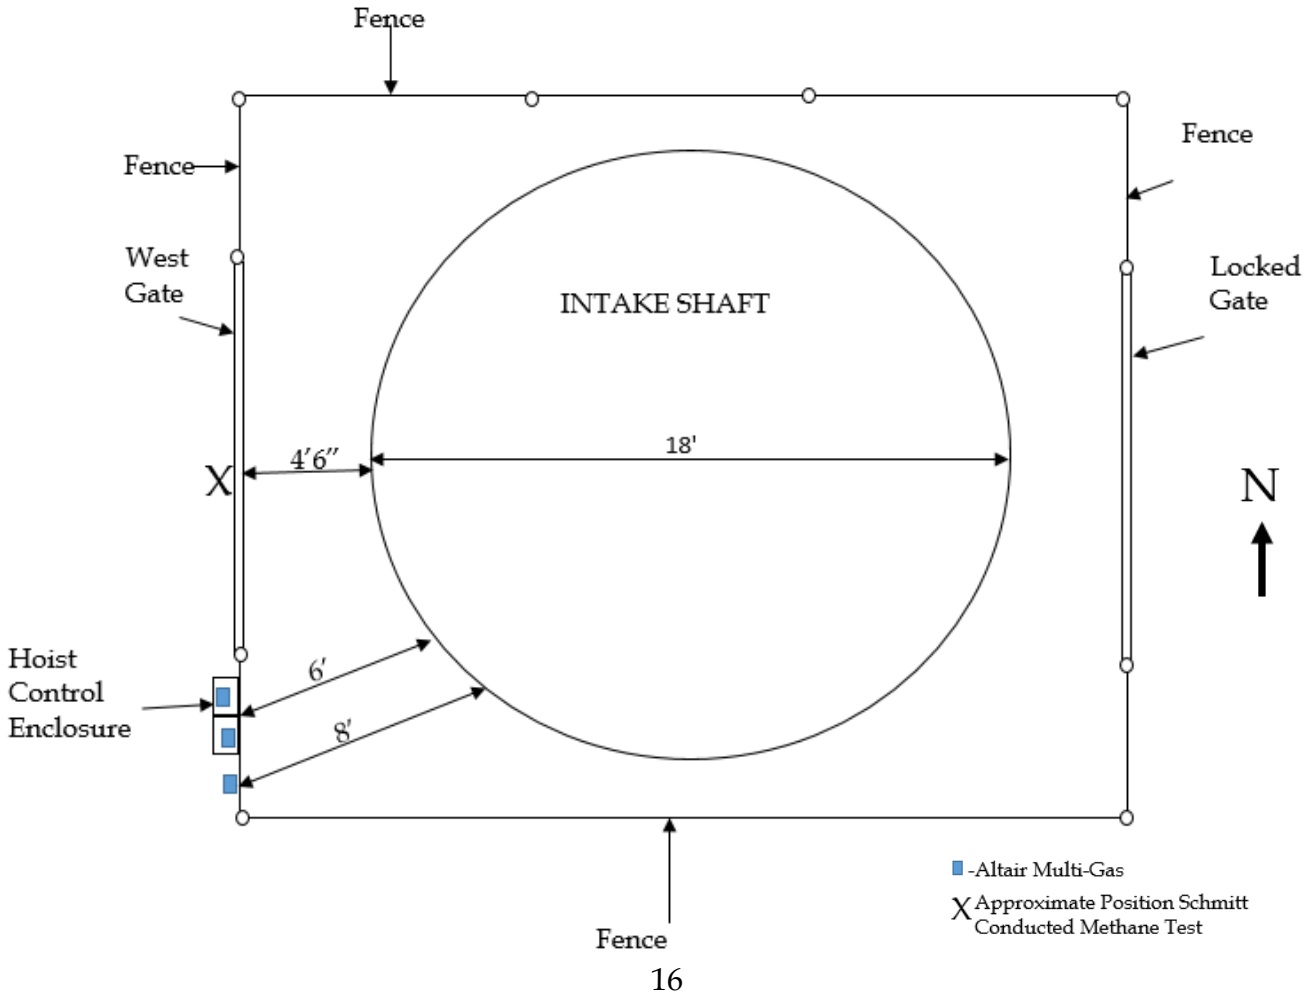
Altair Multi-Gas Detectors Location before the Accident

The MSA Altair 4X MGDs used at the mine were hand-held devices configured to detect concentrations of oxygen, methane, and carbon monoxide. Three Altair 4X MGDs were found at the accident scene. Two of the MGDs were laying on top of the hoist control box and one was found hanging on the chain link fence approximately two feet away from the control box (see Appendix B). On August 22, 2019, MSHA Technical Support personnel conducted testing on the three MGDs recovered from the accident scene.

Investigators determined that the exhibit 3 MGD was energized at the beginning of the shift and remained on throughout the shift. Sarensen stated that he put a MGD on the hoist control box because it had no belt clip, and that this MGD alarmed two times during the shift because of CO from the use of oxygen/acetylene torches.

APPENDIX B
Altair Multi-Gas Detectors Locations
