REPORT OF INVESTIGATION

Open Pit Metal Mine  
(Copper)

Joy Global DBA Komatsu Mining Corp Group (P001)  
Mesa, Arizona

Freeport-McMoRan Tyrone Inc.  
Tyrone Mine  
Grant County, New Mexico  
ID No. 29-00159

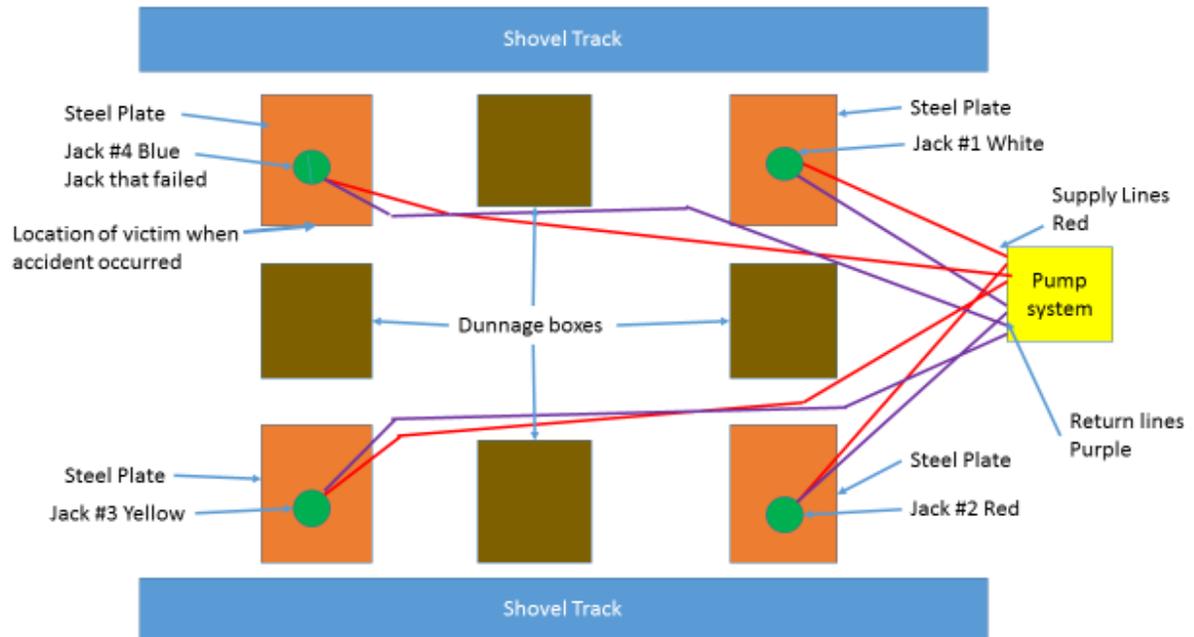
## Accident Diagram

On the day of the accident, Rivers, Begay, Jarrett, and Thygerson prepared to lift the shovel using the bottle jack system. Rivers and Begay were standing near the bottle jacks while Thygerson and Jarrett were at the pump when the accident occurred. Begay estimated that Rivers was approximately three feet from the No. 4 bottle jack and in direct line with the relief valve when it was ejected from the bottle jack.
