REPORT OF INVESTIGATION

Underground Coal Mine

Fatal Fall of Rib Accident  
May 22, 2019

CVB No. 1  
Rex Coal Company, Inc.  
Cumberland, Harlan County, Kentucky  
I.D. No. 15-18869

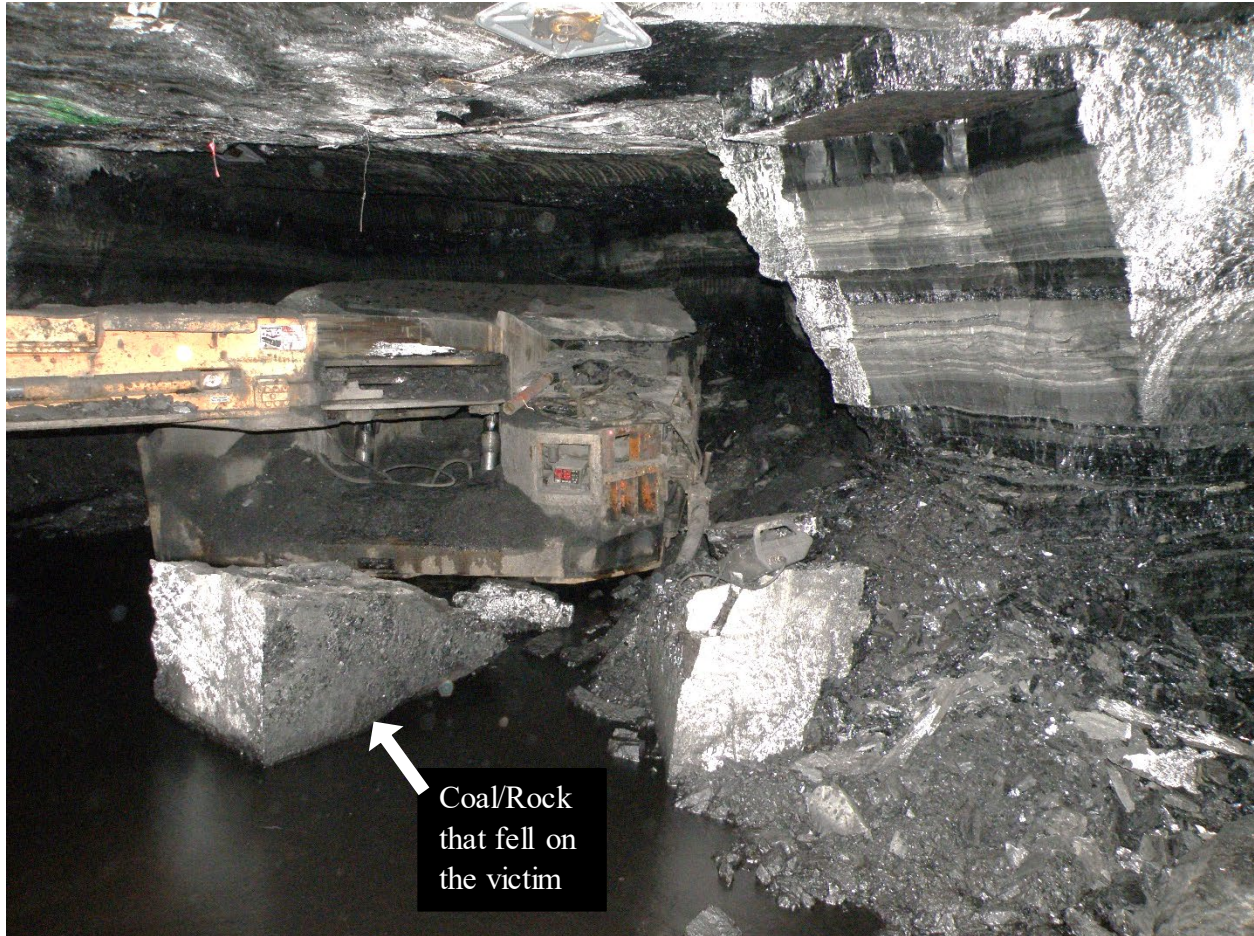
## PHOTOGRAPH OF ACCIDENT SCENE

The rock strata at the accident scene consisted of coal, cannel coal, and sandy shale (see Appendix C). The rock that fell onto the victim came from the upper layer of sandy shale, which was 24 inches in width at the scene of the accident. At the scene of the accident, the coal seam was starting to rise in elevation. The elevation in the coal seam at the scene of the accident caused instability, in that the inby crosscut pillar corner leaned toward the continuous mining machine operator's location.

Post-accident interviews of the 002 MMU miners and supervisor indicated that the rib that caused the accident did not appear hazardous prior to falling.

1. Root Cause: The mine operator did not effectively control the ribs and pillar corners on the 002 MMU in areas where the miners were working and traveling to protect them from hazards related to falls of the ribs. A portion of a coal/rock rib weighing about 2,000 pounds and measuring 48-to-54 inches long, 24 inches wide, and 28 inches thick fell on the 002 MMU. The rib struck a miner and pinned him to the mine floor. The miner passed away from injuries due to the rib fall.

Corrective Action: On May 24, 2019, the mine operator submitted, and MSHA approved, a revision to the roof control plan. The new provisions of the plan require that all ribs be bolted at the same time roof bolts are installed in all areas of the mine and in a consistent pattern. Furthermore, in accordance to the new plan provisions, each pillar corner must be supported with a combination of rib bolts and straps (or equivalent material).

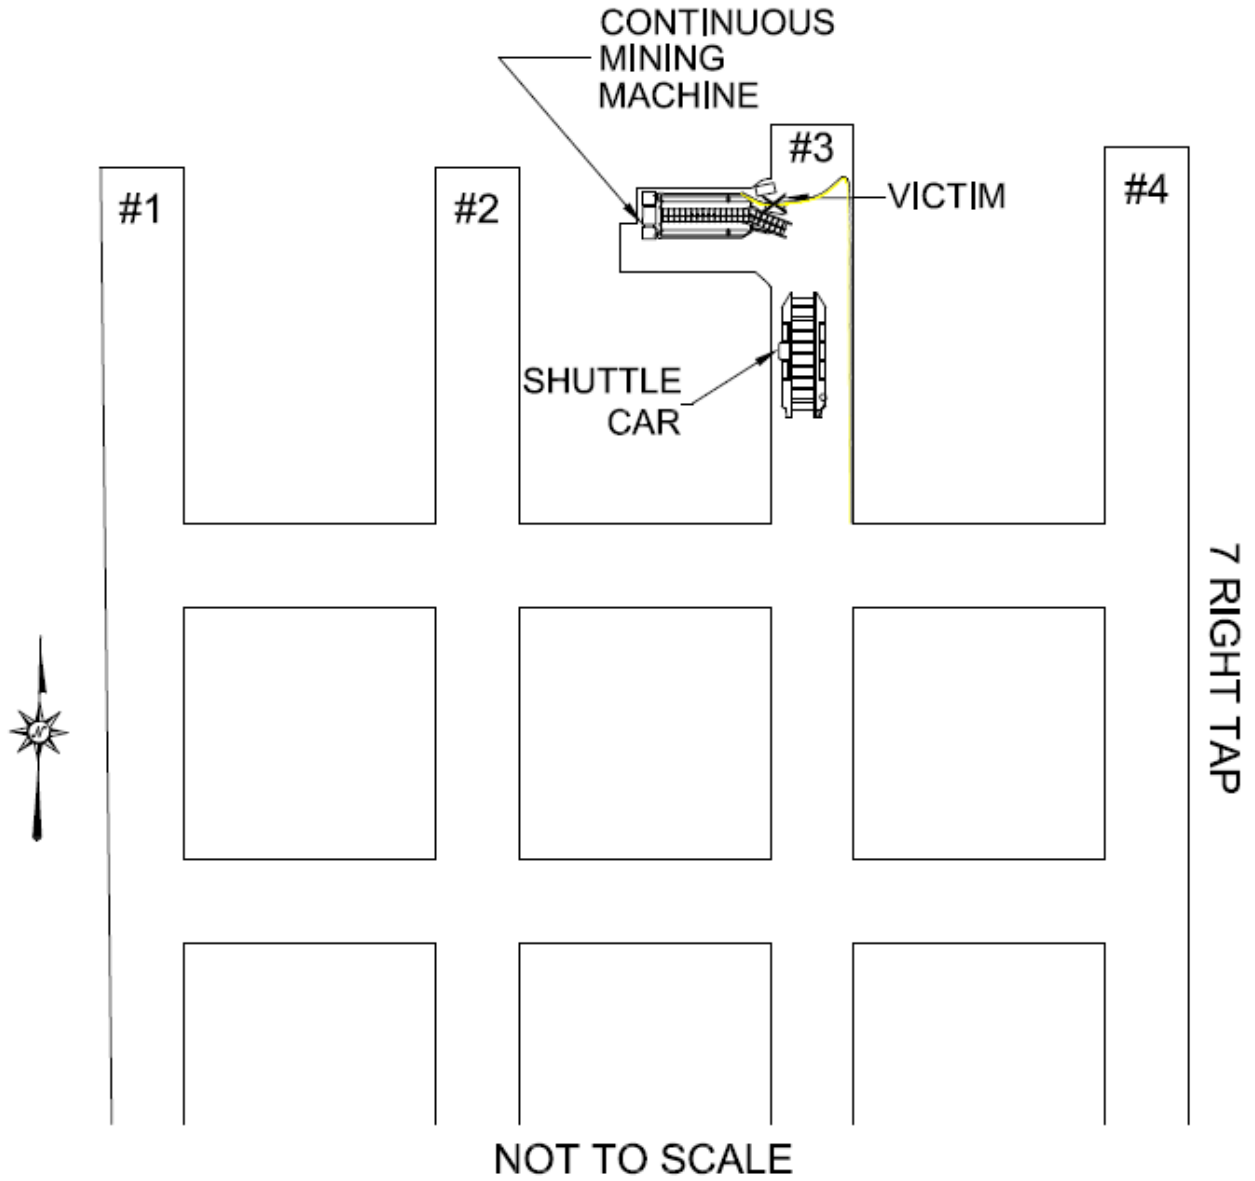
APPENDIX A  
Location of Accident

The accident occurred at the intersection of the No. 3 heading and the No. 3 left crosscut (see Appendix A). During the shift before the accident, the No. 3 heading was mined and the No. 3 left crosscut was mined approximately 20 feet. These mined areas were roof bolted but no rib bolts were installed.
