REPORT OF INVESTIGATION

Surface Metal Mine  
(Iron Ore)

Fatal Powered Haulage Accident  
November 5, 2019

ArcelorMittal Minorca Mine Inc.  
ArcelorMittal Minorca Mine Inc.  
Virginia, St. Louis County, Minnesota  
ID No. 21-02449

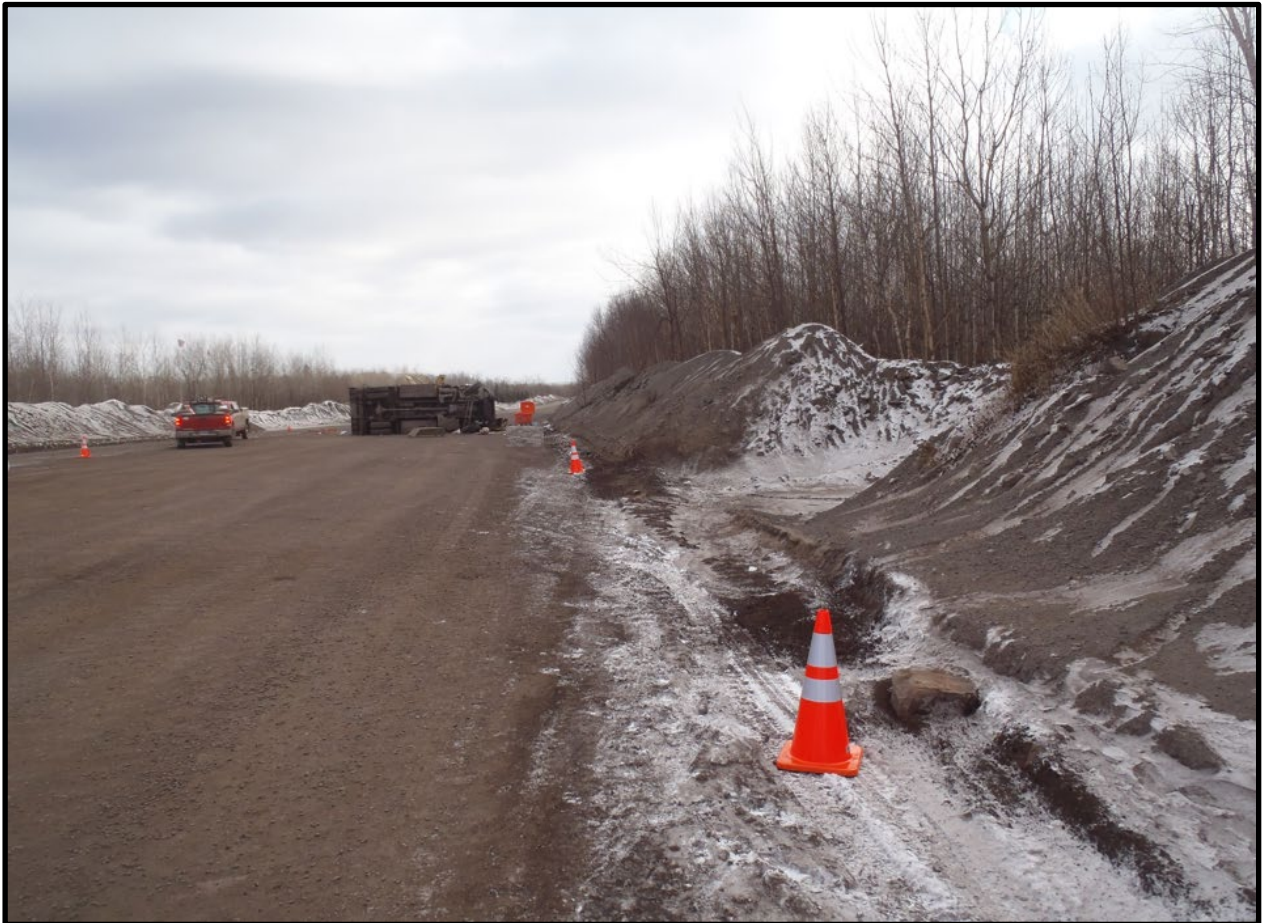
## Appendix B

The accident occurred on the "East Pits" haul road leading to the Laurentian and Lynx pits. The haul road was hard-packed dirt, wide and relatively level with an approximate one percent grade (see Appendix B). Berms, approximately ten feet high, alongside the roadway were made of hard-packed spoil material. Cold dry weather conditions created a frozen, but not icy, roadway.
