REPORT OF INVESTIGATION

Underground Coal Mine

Fatal Rib Fall Accident  
October 18, 2019

Mine Name: #1  
Calvary Enterprises, LLC  
Harold, Floyd County, Kentucky  
I.D. No. 15-19835

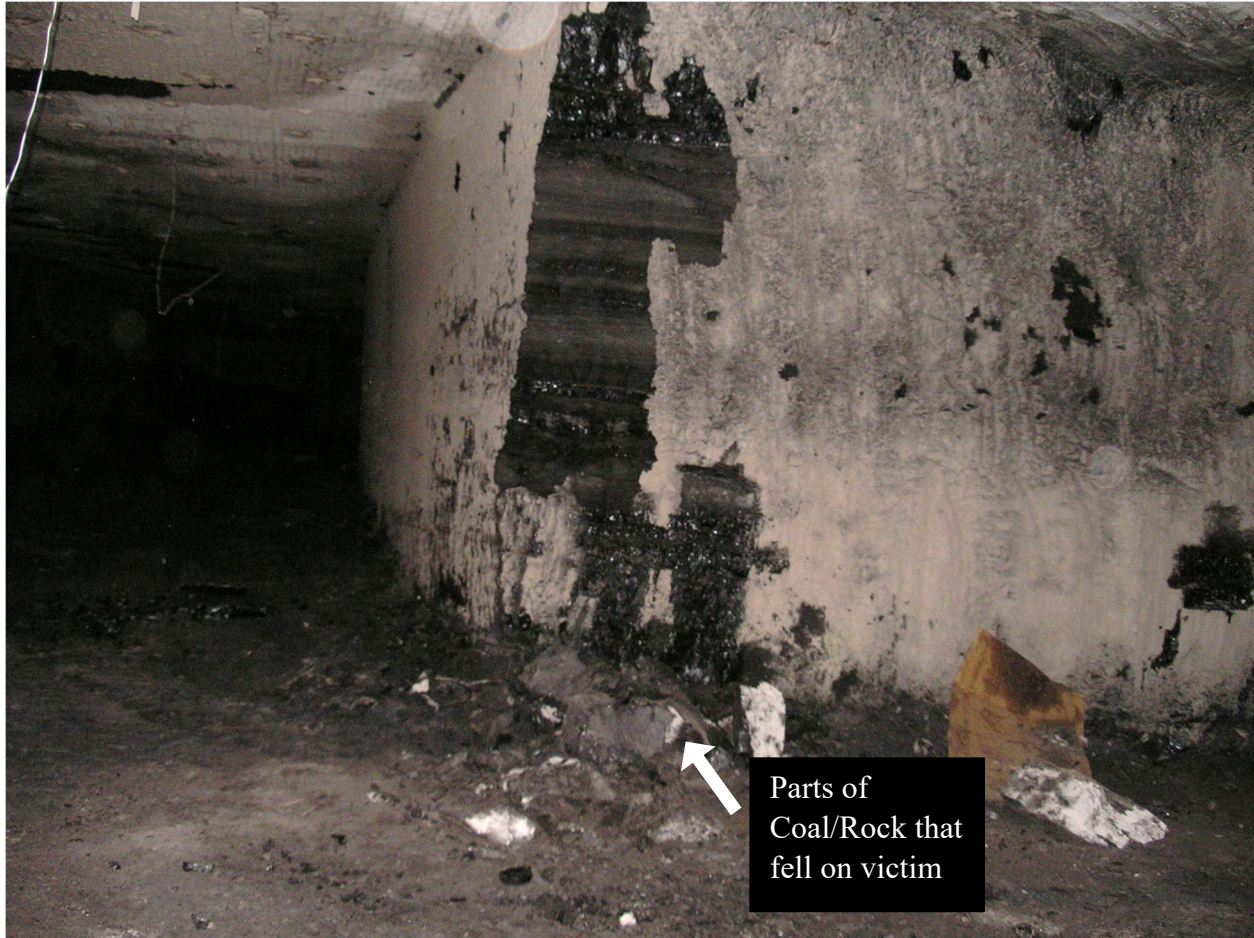
## PHOTOGRAPH OF ACCIDENT SCENE

On Friday, October 18, 2019, James R. Senters, a 60-year-old electrician with 12 years of mining experience, was working between a coal pillar and a personnel carrier when coal/rock fell from the rib and pinned him against the carrier. The coal/rock rib that fell weighed approximately 1,250 pounds and measured 79 inches long, 26 inches wide, and 8 inches thick.

The accident occurred because the mine operator did not effectively control the coal/rock ribs on the 001 Mechanized Mining Unit (MMU).

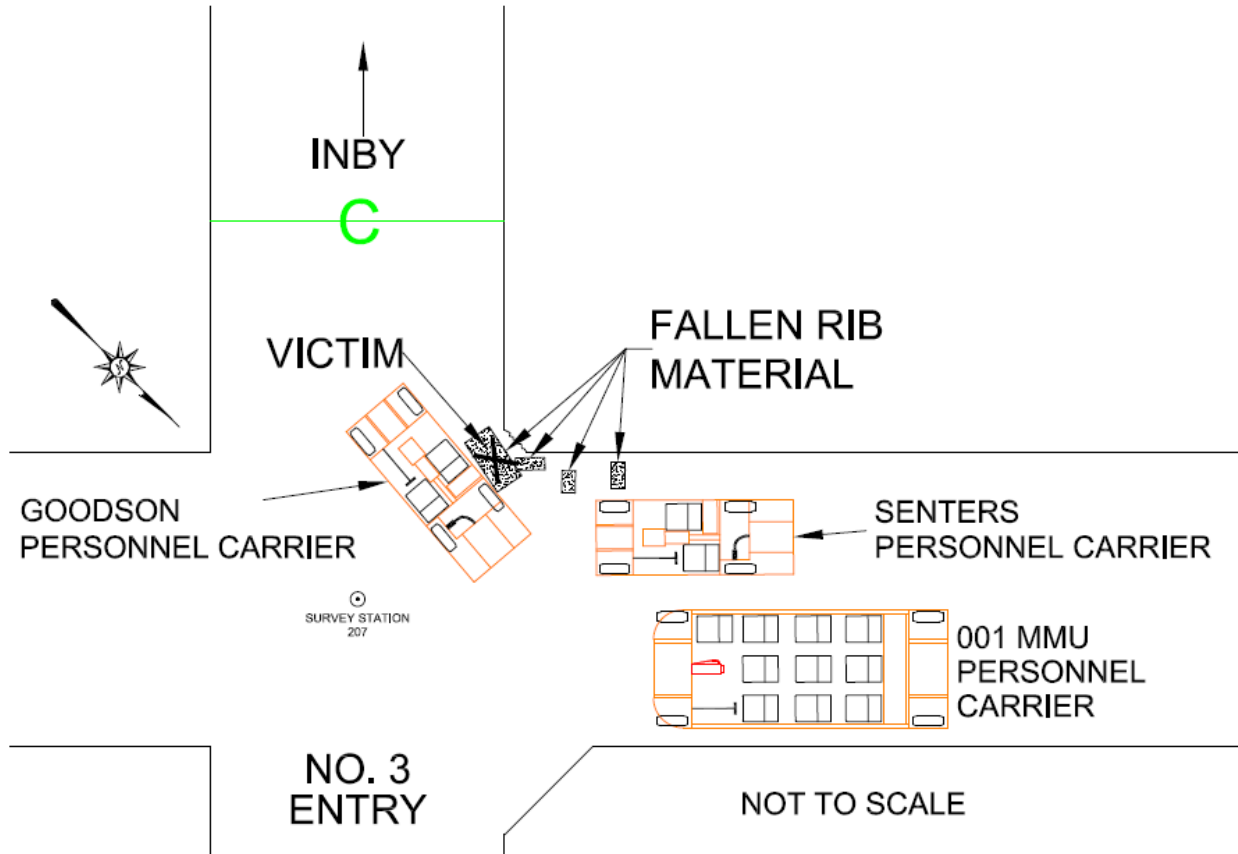
APPENDIX A  
Location of the Accident

Senters experienced mechanical problems with his personnel carrier en route to the 001 MMU. Senters parked the carrier in the right crosscut of the No. 3 entry at Survey Station 207, one crosscut outby the 001 MMU feeder (see Appendix A). He removed the lid from the carrier's control panel and examined the panel for defects. Uncertain of the circuit breaker configuration, he asked Corey Goodson, Section Foreman, about his personnel carrier, which was similar. After the discussion, Goodson said he would not need his carrier and Senters could examine it for the proper circuit breaker configuration. Senters agreed and began removing the lid from the control panel of Goodson's carrier. Goodson returned to the face area of the 001 MMU where the crew was producing coal.

The accident occurred in the intersection of the No. 3 heading, at survey station 207, three crosscuts outby the working face (see Appendix A). Prior to the accident, the mining heights rarely, if ever, exceeded 6 feet. During the accident investigation, investigators found that the mine operator increased the mining height in order to mine the overlying coal rider. The coal rider had moved downward in elevation closer to the Elkhorn No. 3 coal seam. Typically, coal rider seams are mined because, when they are in close proximity to the mined coal seam, they are a weak plane of the mine roof which can detach from the main mine roof resulting in roof falls. The mining height had to be increased to about 10 feet to mine the coal rider. The additional height and presence of the rock partings led to instability of the unsupported ribs. Investigators observed some rib sloughage at pillar corners. Most of the sloughage appeared to be where the mining height was over 6.5 feet.

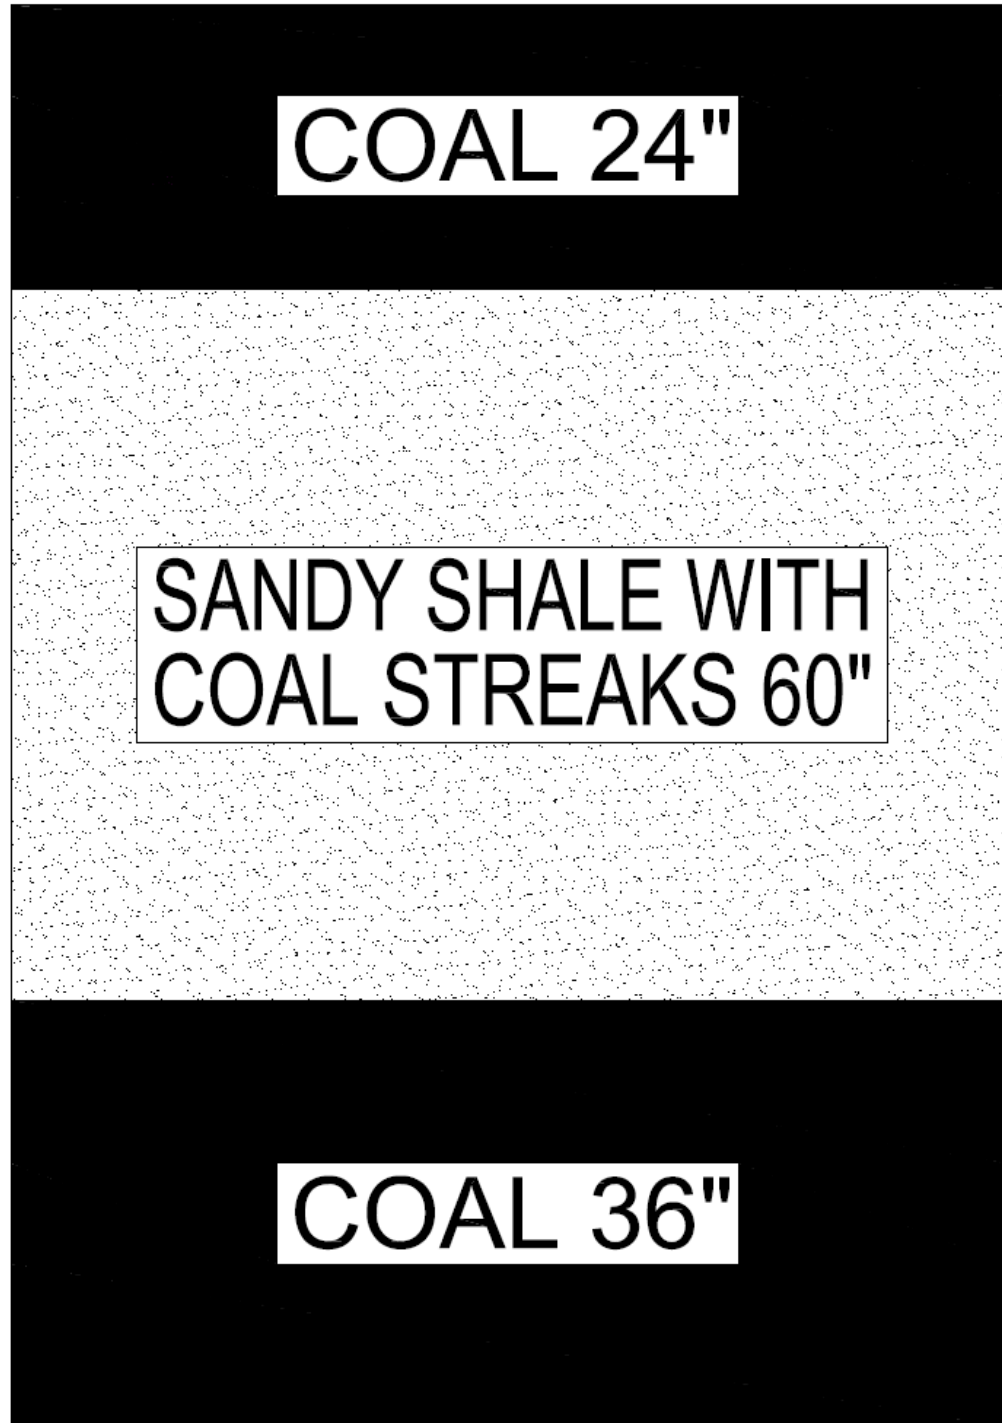
APPENDIX C  
Rock Strata at the Accident Site

Pillar stability evaluations of the underlying Elkhorn No. 1 workings indicate that the pillars were likely stable, and multiple seam interactions were not a factor in the rib sloughage at the accident site. The coal/rock rib which injured the miner consisted of sandy shale with coal streaks (see Appendix C).

10 FEET OVERALL HEIGHT
