UNITED STATES
DEPARTMENT OF LABOR
MINE SAFETY AND HEALTH ADMINISTRATION

REPORT OF INVESTIGATION

Electrocution
September 17, 2019

Panther Creek Mining, LLC
American Eagle Mine
Dawes, Kanawha County, West Virginia
I.D. No. 46-05437

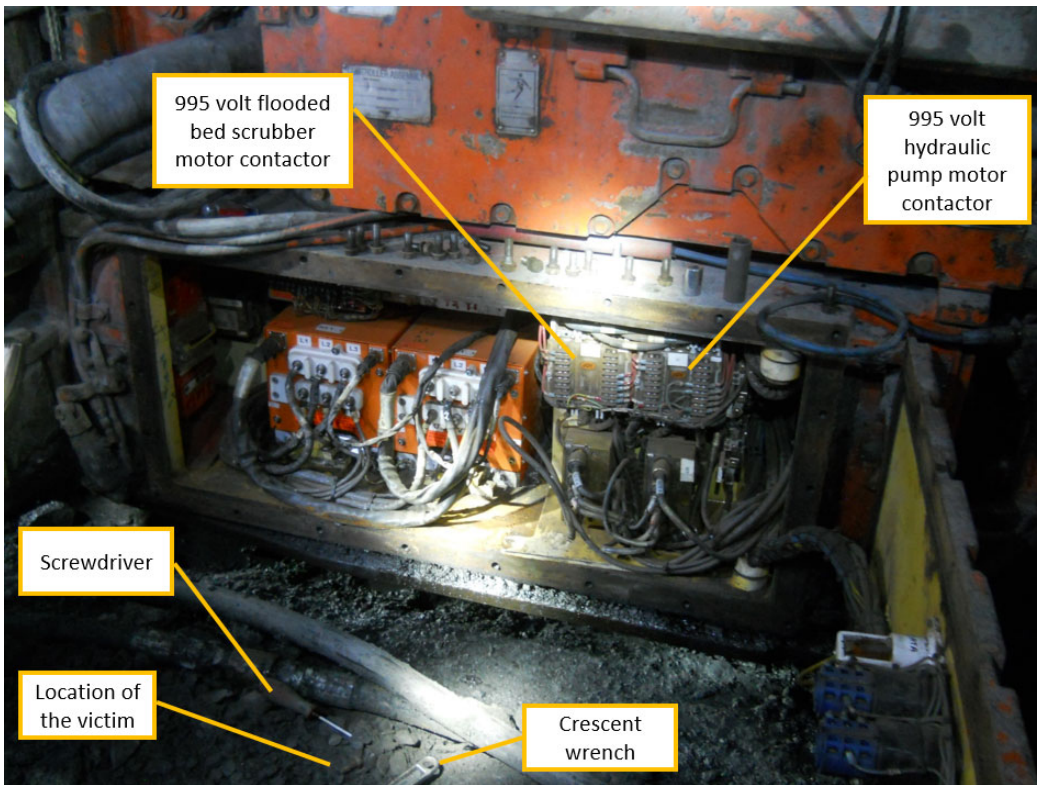
Inspection of the components and circuitry inside the main controller revealed that the scrubber motor circuit vacuum contactor was mounted beside the pump motor vacuum contactor. The scrubber motor contactor receives its power from the pump motor contactor via jumper wires. There was a loose connection of the center phase on the pump contactor (see Appendix B). The screw holding this connection to the pump contactor was a Phillips hex head screw. The screwdriver that was lying on the mine floor was a Phillips Bit Socket style driver. As previously stated, investigators found physical evidence that the victim was using this screwdriver when he was electrocuted.
