REPORT OF INVESTIGATION

Underground Coal Mine

Electrocution  
September 17, 2019

Panther Creek Mining, LLC  
American Eagle Mine  
Dawes, Kanawha County, West Virginia  
I.D. No. 46-05437

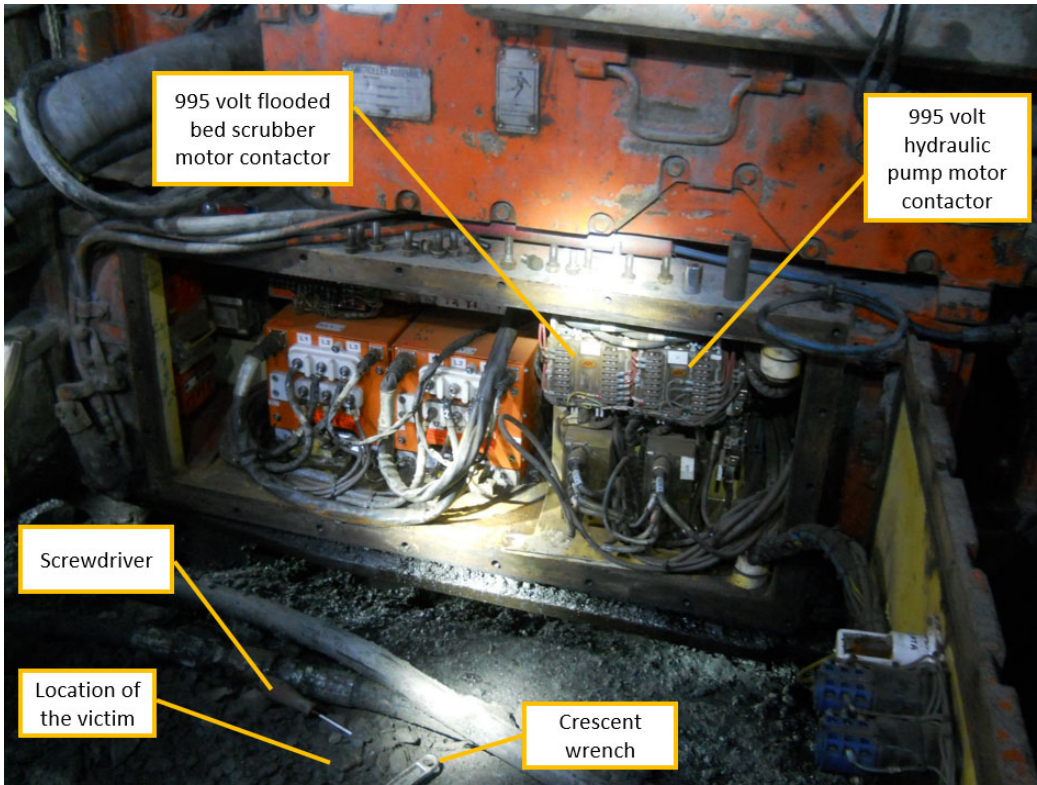
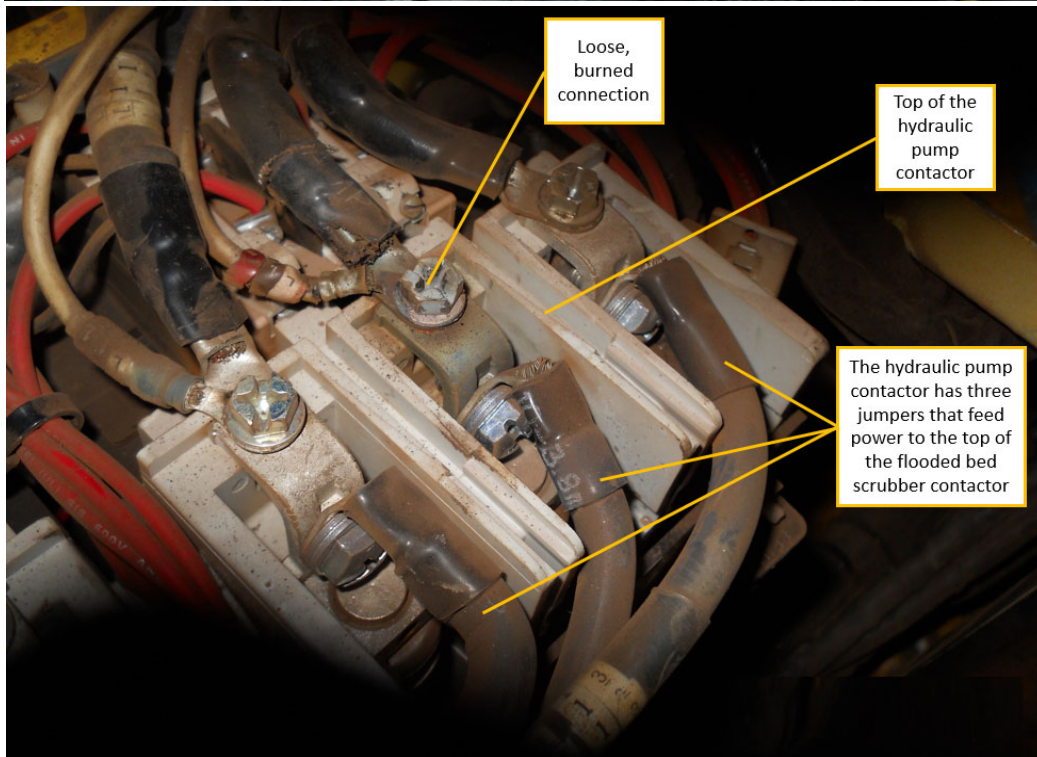
Appendix B  
Photographs

One screwdriver was lying in the mud. A second screwdriver was lying just below the main controller on the mine floor near the adjustable wrench. On the screwdriver below the main controller, investigators found physical evidence on the steel shaft near the handle that indicated it was being used by Keeney when he was electrocuted.

Inspection of the components and circuitry inside the main controller revealed that the scrubber motor circuit vacuum contactor was mounted beside the pump motor vacuum contactor. The scrubber motor contactor receives its power from the pump motor contactor via jumper wires. There was a loose connection of the center phase on the pump contactor (see Appendix B). The screw holding this connection to the pump contactor was a Phillips hex head screw. The screwdriver that was lying on the mine floor was a Phillips Bit Socket style driver. As previously stated, investigators found physical evidence that the victim was using this screwdriver when he was electrocuted.
