REPORT OF INVESTIGATION

Underground Coal Mine

Fatal Powered Haulage Accident
September 5, 2019

Cardinal Mine
Warrior Coal, LLC
Madisonville, Hopkins County, Kentucky
ID No. 15-17216

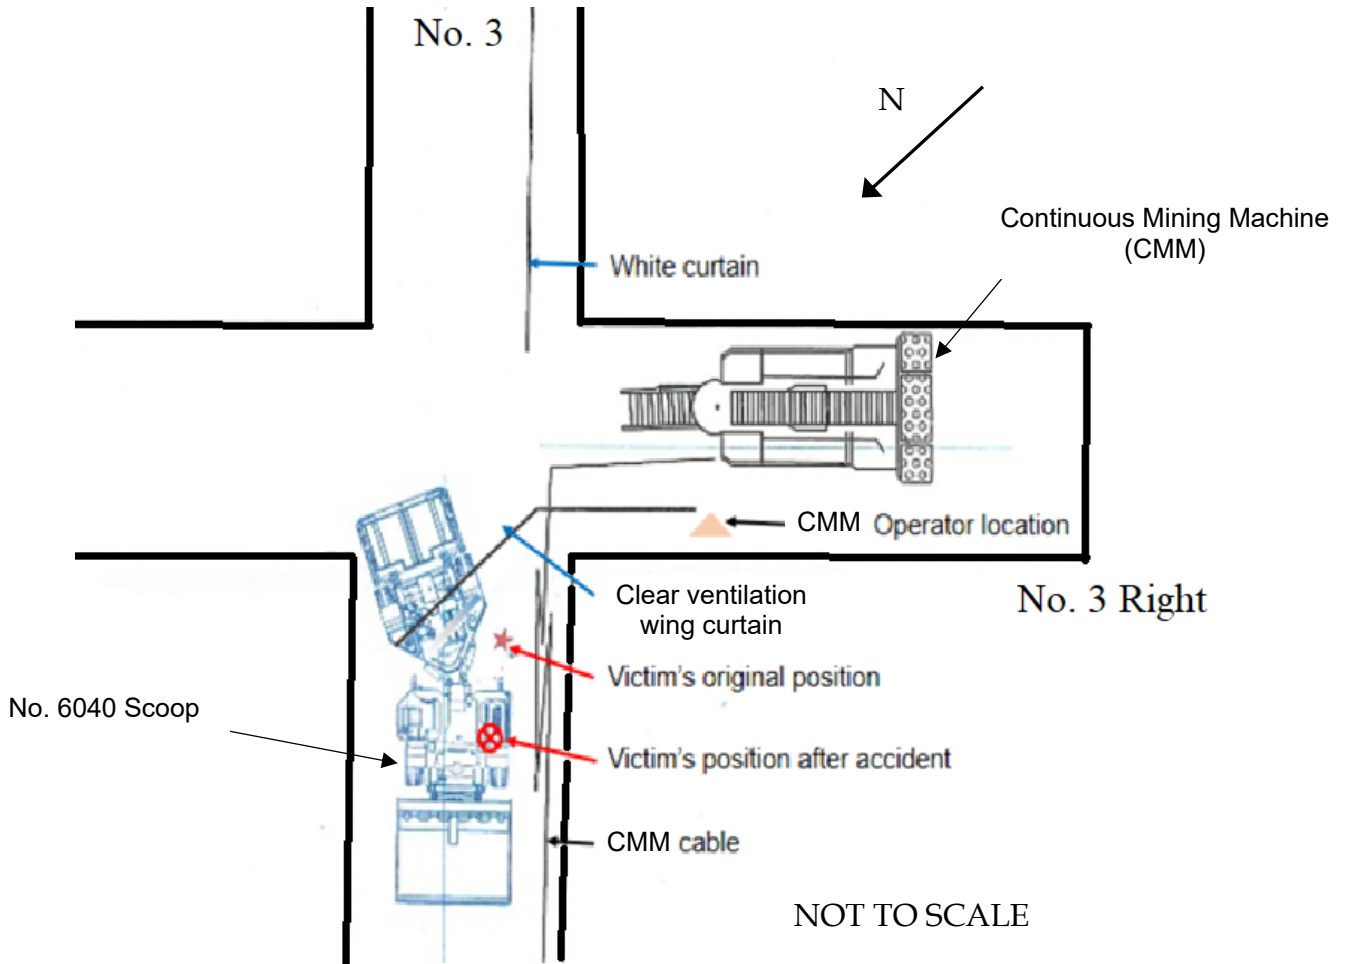
APPENDIX A
Accident Scene Drawing

At approximately 2:50 p.m., Elder stated that he had leg cramps. Vandiver last saw Elder sitting on the mine floor in the No. 3 entry, outby the No. 3 right crosscut and behind the ventilation curtain (see Appendix A). Vandiver saw Elder facing outby stretching his cramped muscles by extending his legs and pulling his toes toward him.

Investigators determined that the scoop traveled through the clear ventilation wing curtain and struck the victim who was last seen sitting on the mine floor approximately 10 feet outby the No. 3 right crosscut corner behind the ventilation curtain. The scoop operator did not sound an audible device or slow down prior to traveling through the ventilation curtain.

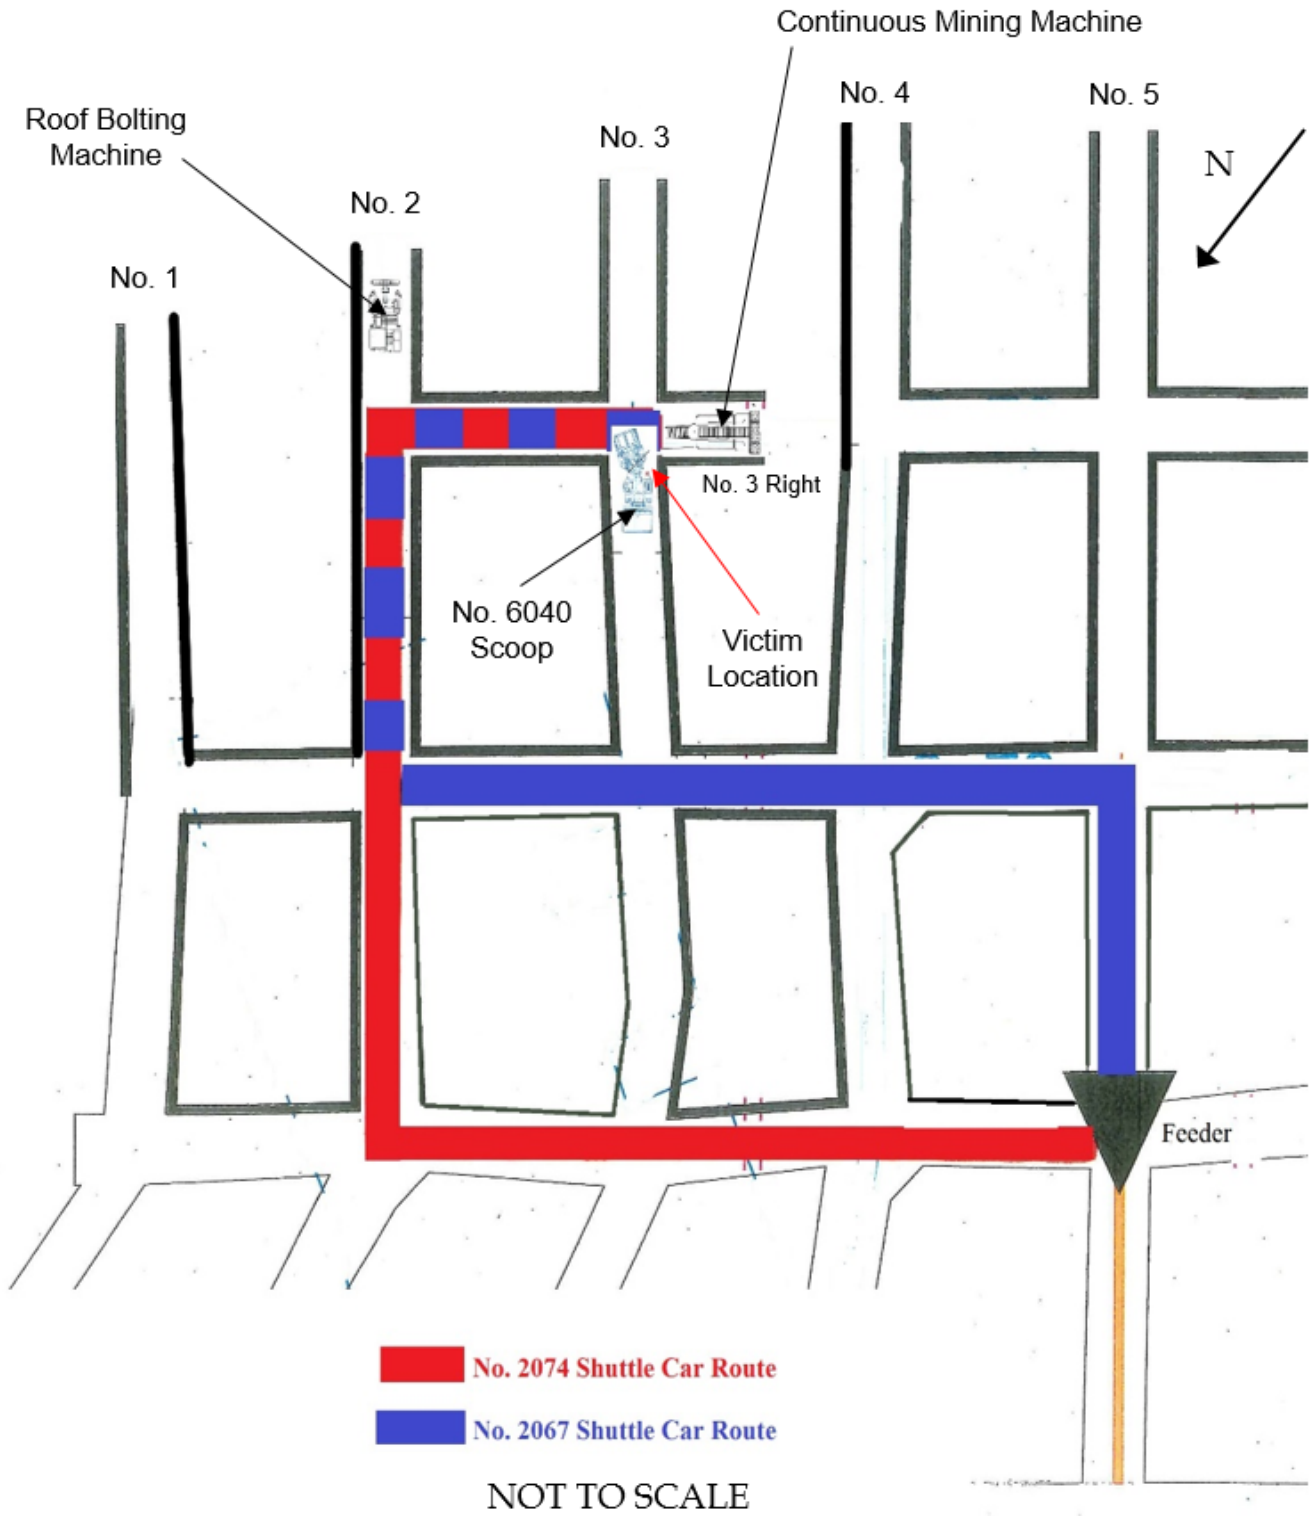
APPENDIX B
Shuttle Car Travel Route

Elder positioned himself away from the established shuttle car travel route which was from the No. 2 entry, through the No. 3 left crosscut, to the CMM that was mining the No. 3 right crosscut (see Appendix B). Corey Burge, Scoop Operator, used the No. 6040 scoop to take roof bolting supplies to the roof bolting machine near the face in the No. 2 entry (see Appendix C). After Burge unloaded the supplies at the roof bolting machine, he trammed the scoop outby in the No. 2 entry.

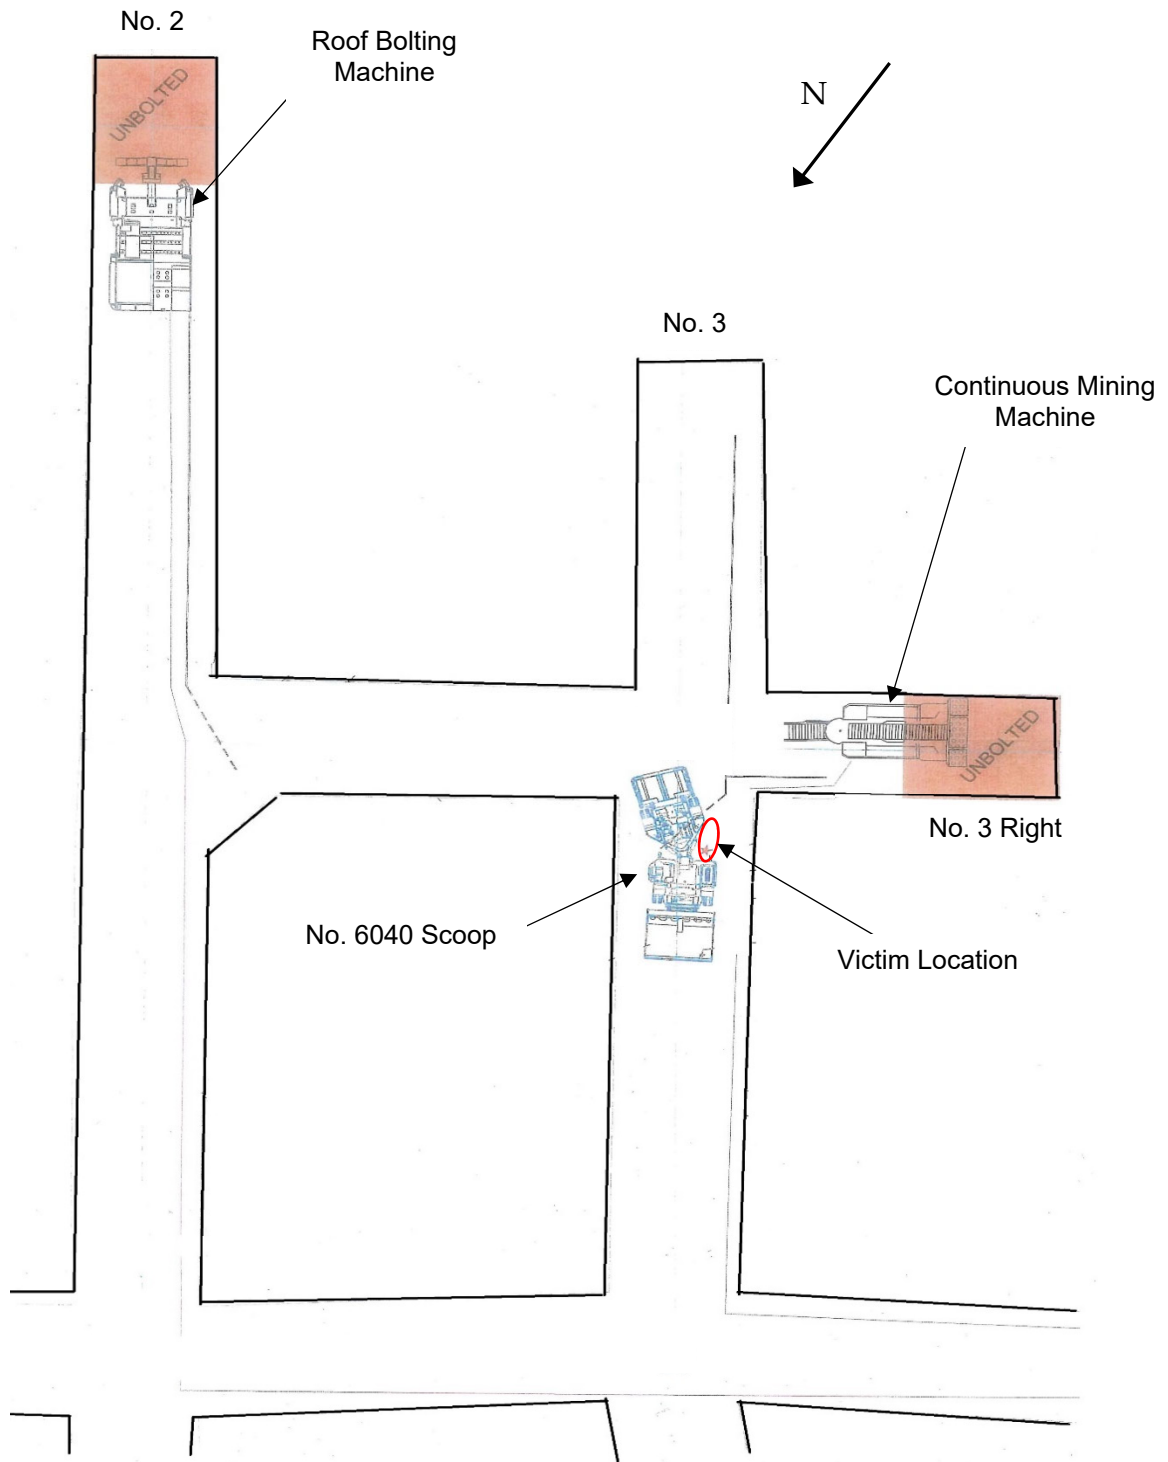
APPENDIX C
Accident Location

The accident occurred in the No. 3 entry just outby the No. 3 right crosscut intersection. The mining height in this area was 73 inches and the entry was 19 feet wide. The CMM was mining the No. 3 right crosscut and two shuttle cars trammed to the CMM using the No. 2 entry and the No. 3 left crosscut.
