REPORT OF INVESTIGATION

Fatal Powered Haulage Accident
February 27, 2020

Country Roads Transport LLC (C0627)
Morgantown, West Virginia

Federal No 2
Phoenix Federal No 2 Mining, LLC
Fairview, Monongalia County, West Virginia
I.D. No. 46-01456

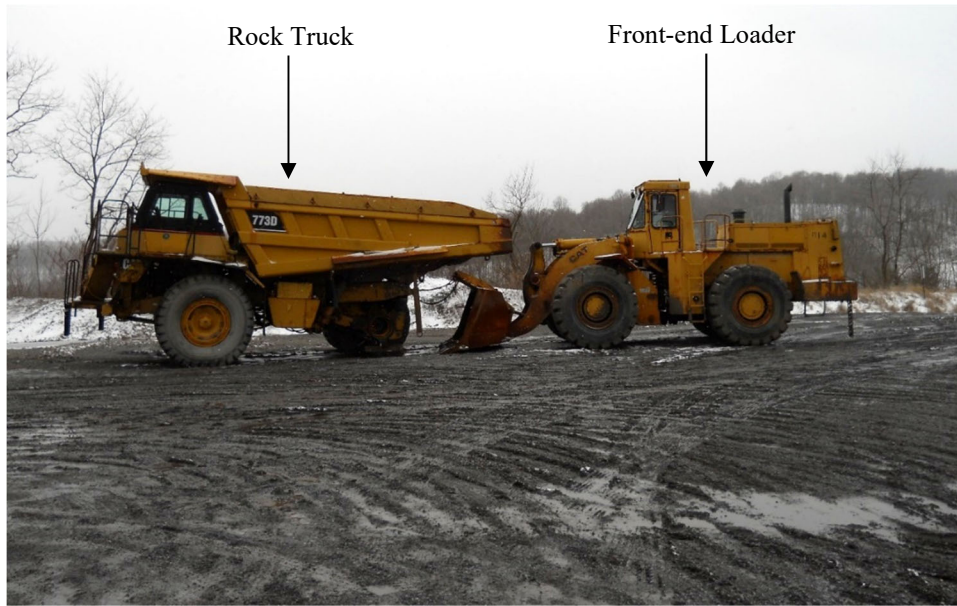
Cory King, the owner of Diesel Performance, the other contractor on-site, and Howard Shriver, a helper with Diesel Performance, guided Doss and Campbell from the mine entrance to the refuse load-out area where the rock truck was located. They briefly discussed how to load the rock truck since it was inoperative due to a missing rear tire and axle. They decided to push the rock truck onto the trailer with a front-end loader (see Figure 1 in Appendix A).
