REPORT OF INVESTIGATION

Surface Mine  
(Sand)

Fatal Machinery Accident  
February 29, 2020

Newmark Acquisition, LLC  
Newmark Acquisition, LLC  
Longville, Beauregard Parish, Louisiana  
ID No. 16-01557

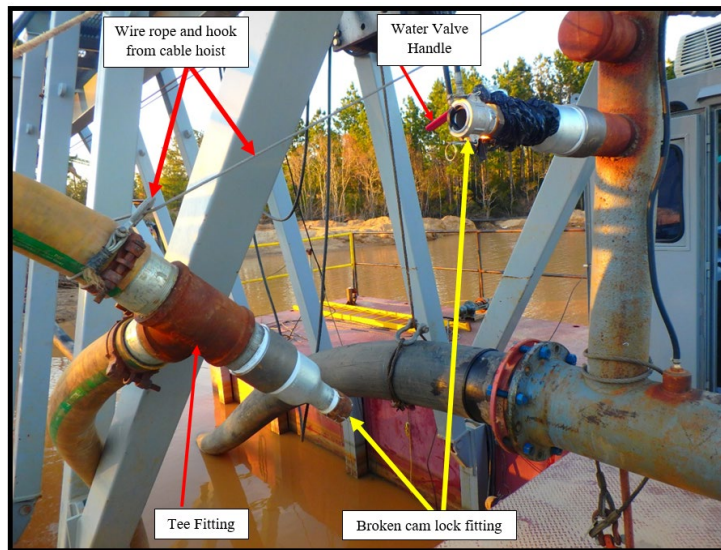
## Accident Scene OVERVIEW

Israel J. Spears, Jr., a 28-year-old plant foreman with over four years of total mining experience, died on February 29, 2020. Spears was closing a water valve used to prime the main suction line with the jet pump when a two-inch cam lock fitting (fitting) failed, causing pressurized water to strike him. The pressurized water knocked him into the operator's compartment and then swept him into the dredge pond where he drowned.

The accident occurred because the mine operator redesigned the dredge's water system beyond the manufacturer's design capacity. Mine management did not evaluate the capacity of the new parts used in relation to the stresses in which the parts would be subjected. Furthermore, the mine operator did not ensure that the victim wore a life jacket or belt where there was a danger of falling into the water.

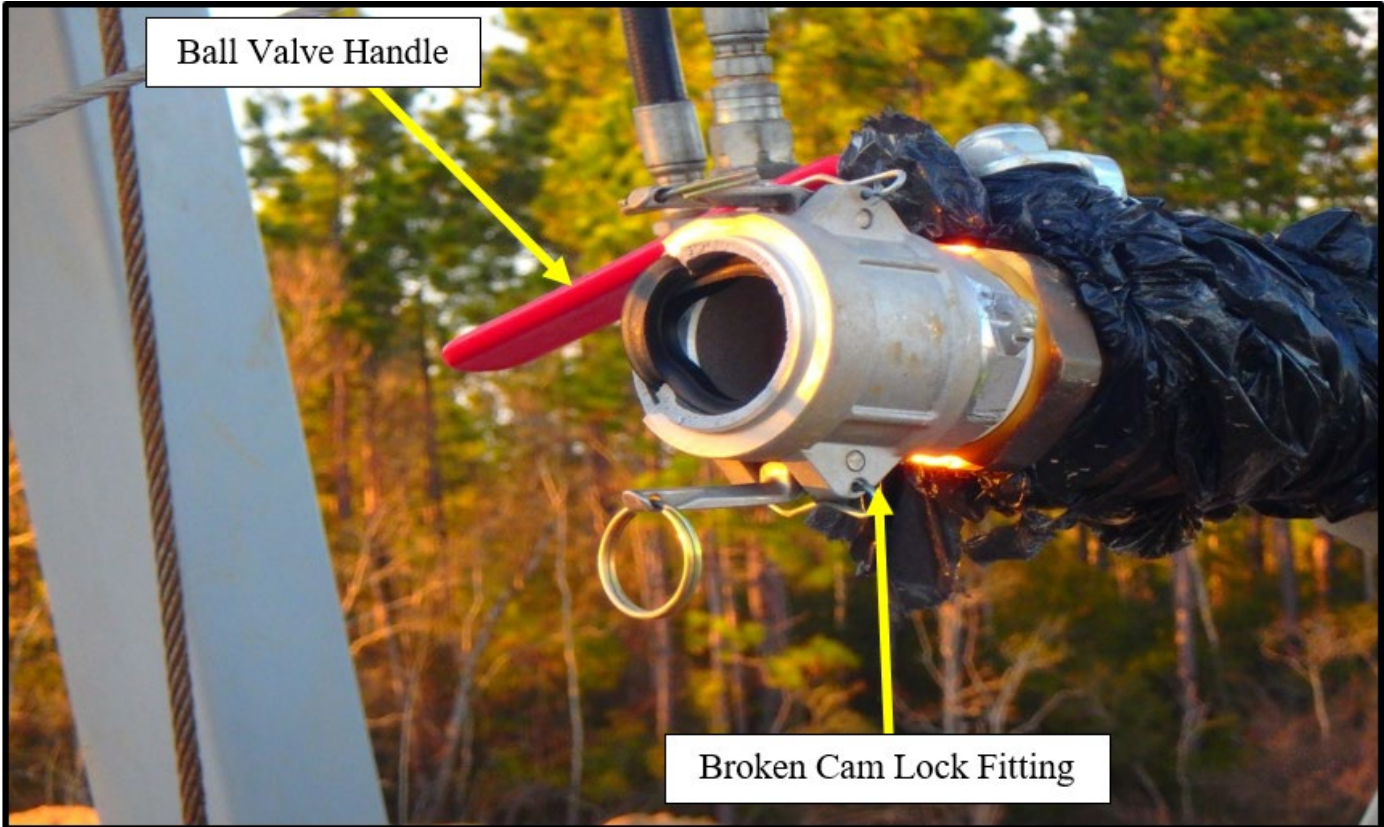
Appendix A  
Photograph of Broken Cam Lock Fitting

Based on video captured by a camera installed at the plant, at 9:33 a.m., Spears primed the main suction line on the front of the dredge by opening the ball valve (see Appendix A). Upon completion of priming, the valve was closed, at which time, the two-inch cam lock aluminum fitting snapped in half directly in front of the ball valve (see Appendix B). A blast of water from the broken pipe struck Spears knocking him backward into the operator's compartment of the dredge. The water swept Spears, who was not wearing a life jacket, into the dredge pond.

On February 25, 2020, the mine operator discovered that an existing four-inch ball valve that controlled flow in the suction line needed to be replaced. Beau M. Perero, Mine Supervisor, changed the design of the water system at this location by reducing the diameter from four inches to two inches, in order to increase the water pressure in the system. Perero also decided to replace the steel fittings with aluminum fittings. Perero purchased the four-inch to two-inch reducer, the aluminum fitting, and the associated valve and other materials. Perero did not consult an engineer, or the dredge or pump manufacturers to determine whether the modified design was appropriate. Spears installed the four-inch to two-inch reducer and the fitting, and connected the cam lock fitting to a new two-inch ball valve.

On February 26, 2020, the dredge began operating with the modifications in place. Tupper charged the water hose and, within 30 minutes, the two-inch cam lock fitting cracked. Tupper replaced the cam lock fitting. The replacement fitting was leaking, so Tupper added a second rubber gasket to stop the leak. Tupper then installed a rope and an electric-powered cable winch

1. The failed fitting was made of aluminum which has significantly less strength than the steel fittings and pipes in the assembly, resulting in a lower factor of safety.
2. The aluminum material in the failed fitting had extensive internal flaws which further decreased its strength.
3. The locking mechanism was compressing two sealing gaskets instead of one which applied additional stress to the body of the failed fitting.
4. The failed fitting was subjected to significant stress from the reaction forces created by water flow through the assembly.
5. The failed fitting was subjected to significant stress from the weight of the assembled fittings and hoses and the water they contained.
6. The supports installed for the assembly did not adequately relieve weight and reaction forces on the aluminum fitting.

X-ray fluorescence examination of both failed fittings showed they were an aluminum alloy casting of strength significantly less than the typical low carbon steel used in the other fittings and pipes used in this circuit. The maximum yield strength and ultimate strength of the aluminum casting alloy when properly manufactured is 24,000 psi and 48,000 psi, respectively. The yield strength and ultimate strength of the low carbon steel is 53,700 psi and 63,800 psi, respectively.

The flow of a fluid through a change in direction of a piping system creates a reaction force, or “thrust load”, on the pipe or fitting. At the time of the accident, water was flowing through a 90 degree bend at the tee fitting adjacent to the failed fitting. Opening and closing the valve to feed water to prime the suction line created a significant thrust load on the fitting.

The calculated bending stresses resulting from the lateral thrust load of the assembly is 53,676 psi on the threaded portion of the failed fitting. This load, being unsupported, results in stresses

exceeding the ultimate strength of the aluminum alloy. Microscopic examination of the fracture surface, of the failed fitting, showed the fitting had extensive internal flaws commonly associated with casting errors. These flaws were primarily in the form of gas porosity, distributed throughout the observed fracture. The casting flaws, would further reduce the effective material strength, making this thrust-induced bending stress markedly above the strength of the material. A rope and a cable winch were used in an attempt to support the weight acting on the assembly. These devices were inadequate, because they did not support the assembly sufficiently to mitigate the stresses on the failed fitting.

The failed fitting was designed to use one sealing gasket, but as previously described, had two gaskets. When miners actuated the locking arms on the fitting to make a seal, they compressed two gaskets instead of one, and applied stresses to the fitting greater than those intended by the manufacturer. These stresses were applied to the body of the fitting, the cutouts in the body for the locking arms, and the arm mounting lugs. Investigators observed cracks in the fitting at the corners of the cutouts.

1. Root Cause: The mine operator redesigned the water system beyond the manufacturer's design capacity without the required evaluations to ensure the modified system was safe to use. Mine management did not evaluate the capacity of the new parts used in light of the stresses to which the parts would be subjected.

Corrective Action: The mine operator developed and provided training to appropriate personnel on a new written policy that requires any proposed dredge design changes to be designed by a qualified engineer and in accordance with the manufacturer's design capacity. The engineering design and calculations will be provided to MSHA for review prior to the changes being made.

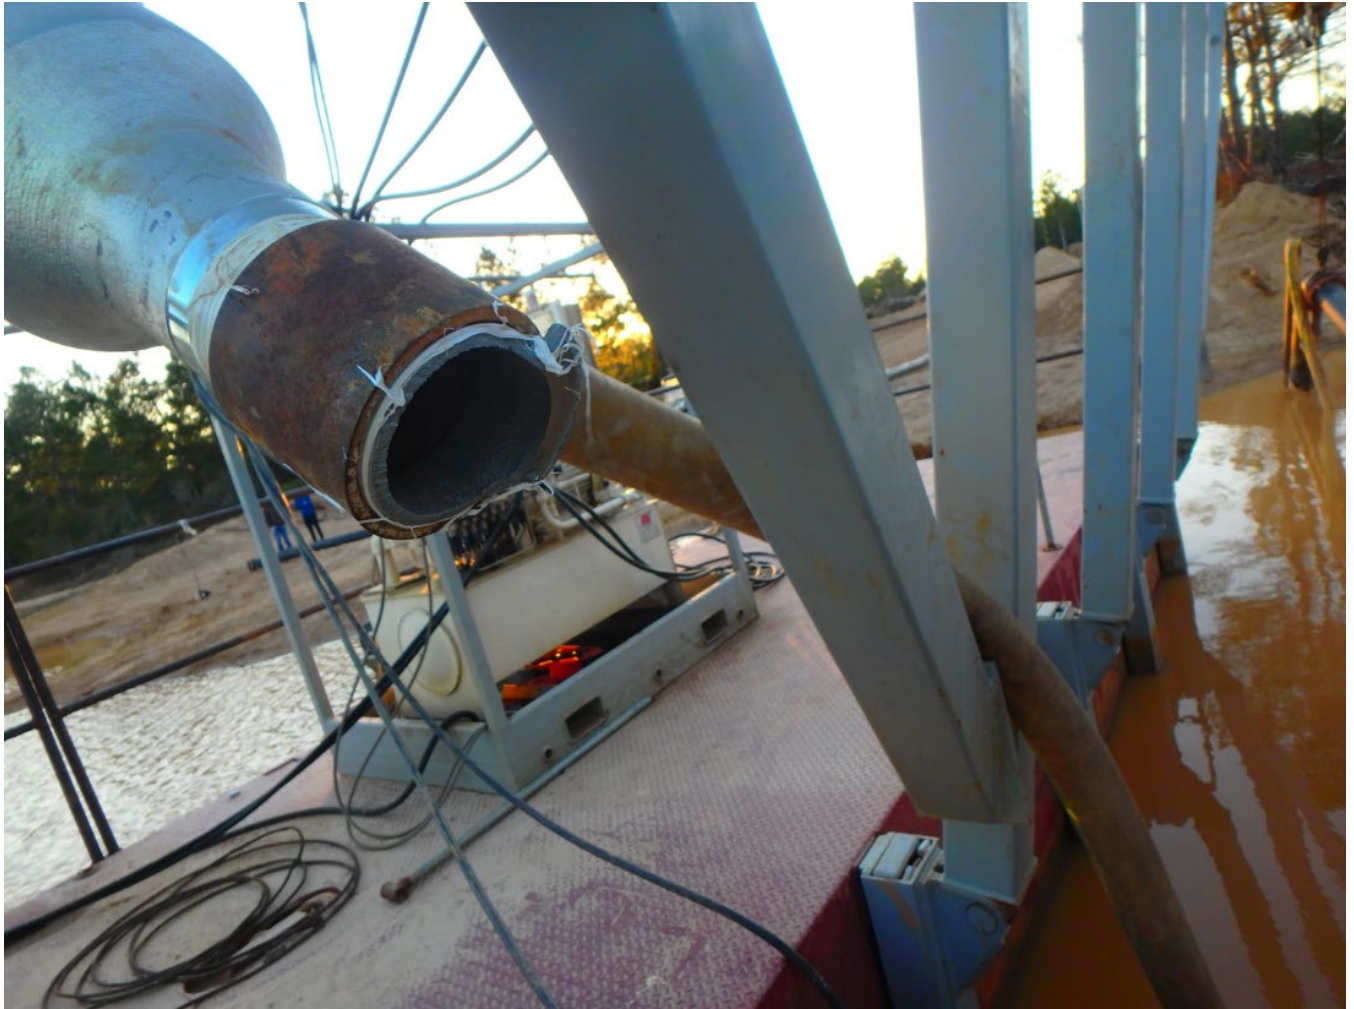
Appendix B  
Photograph of Broken Fitting

The accident investigation team sent the failed cam lock quick-connect fitting and the associated valve, reducers, and connected fittings for analysis by the MSHA Technical Support, Mechanical & Engineering Safety Division. They also sent the cam lock fitting that cracked four days before the accident and a sample of the rubber hose. The Mechanical & Engineering Safety Division identified the following six factors that contributed to the failure of the fitting involved in the fatal accident.
