REPORT OF INVESTIGATION

Surface Mine
(Sand)

Fatal Machinery Accident
February 29, 2020

Newmark Acquisition, LLC
Newmark Acquisition, LLC
Longville, Beauregard Parish, Louisiana
ID No. 16-01557

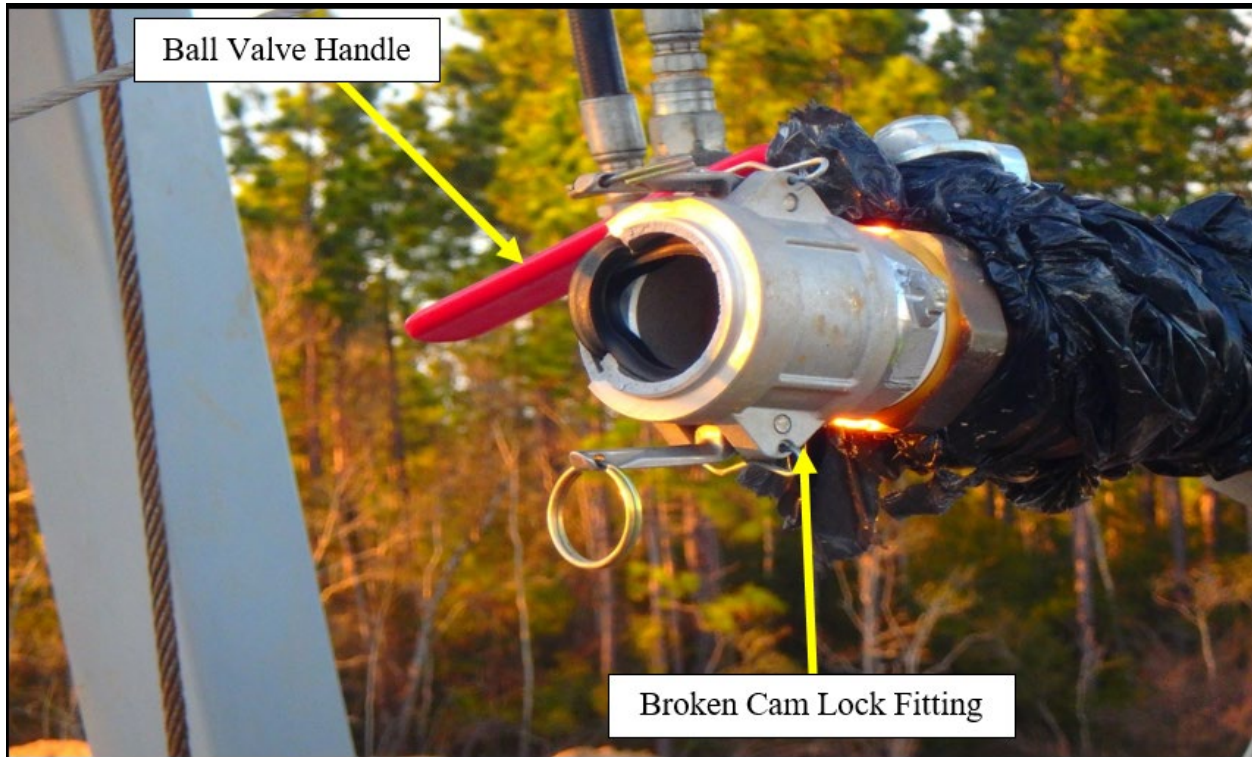
Appendix A
Photograph of Broken Cam Lock Fitting

Based on video captured by a camera installed at the plant, at 9:33 a.m., Spears primed the main suction line on the front of the dredge by opening the ball valve (see Appendix A). Upon completion of priming, the valve was closed, at which time, the two-inch cam lock aluminum fitting snapped in half directly in front of the ball valve (see Appendix B). A blast of water from the broken pipe struck Spears knocking him backward into the operator’s compartment of the dredge. The water swept Spears, who was not wearing a life jacket, into the dredge pond.

1. The failed fitting was made of aluminum which has significantly less strength than the steel fittings and pipes in the assembly, resulting in a lower factor of safety.
2. The aluminum material in the failed fitting had extensive internal flaws which further decreased its strength.
3. The locking mechanism was compressing two sealing gaskets instead of one which applied additional stress to the body of the failed fitting.
4. The failed fitting was subjected to significant stress from the reaction forces created by water flow through the assembly.
5. The failed fitting was subjected to significant stress from the weight of the assembled fittings and hoses and the water they contained.
6. The supports installed for the assembly did not adequately relieve weight and reaction forces on the aluminum fitting.

X-ray fluorescence examination of both failed fittings showed they were an aluminum alloy casting of strength significantly less than the typical low carbon steel used in the other fittings and pipes used in this circuit. The maximum yield strength and ultimate strength of the aluminum casting alloy when properly manufactured is 24,000 psi and 48,000 psi, respectively. The yield strength and ultimate strength of the low carbon steel is 53,700 psi and 63,800 psi, respectively.

The calculated bending stresses resulting from the lateral thrust load of the assembly is 53,676 psi on the threaded portion of the failed fitting. This load, being unsupported, results in stresses exceeding the ultimate strength of the aluminum alloy. Microscopic examination of the fracture surface, of the failed fitting, showed the fitting had extensive internal flaws commonly associated with casting errors. These flaws were primarily in the form of gas porosity, distributed throughout the observed fracture. The casting flaws, would further reduce the effective material strength, making this thrust-induced bending stress markedly above the strength of the material. A rope and a cable winch were used in an attempt to support the weight acting on the assembly.

The failed fitting was designed to use one sealing gasket, but as previously described, had two gaskets. When miners actuated the locking arms on the fitting to make a seal, they compressed two gaskets instead of one, and applied stresses to the fitting greater than those intended by the manufacturer. These stresses were applied to the body of the fitting, the cutouts in the body for the locking arms, and the arm mounting lugs. Investigators observed cracks in the fitting at the corners of the cutouts.

Failed cam lock and quick connect fitting.

Corrective Action: The mine operator developed and provided training to appropriate personnel on a new written policy that requires any proposed dredge design changes to be designed by a qualified engineer and in accordance with the manufacturer's design capacity. The engineering design and calculations will be provided to MSHA for review prior to the changes being made.

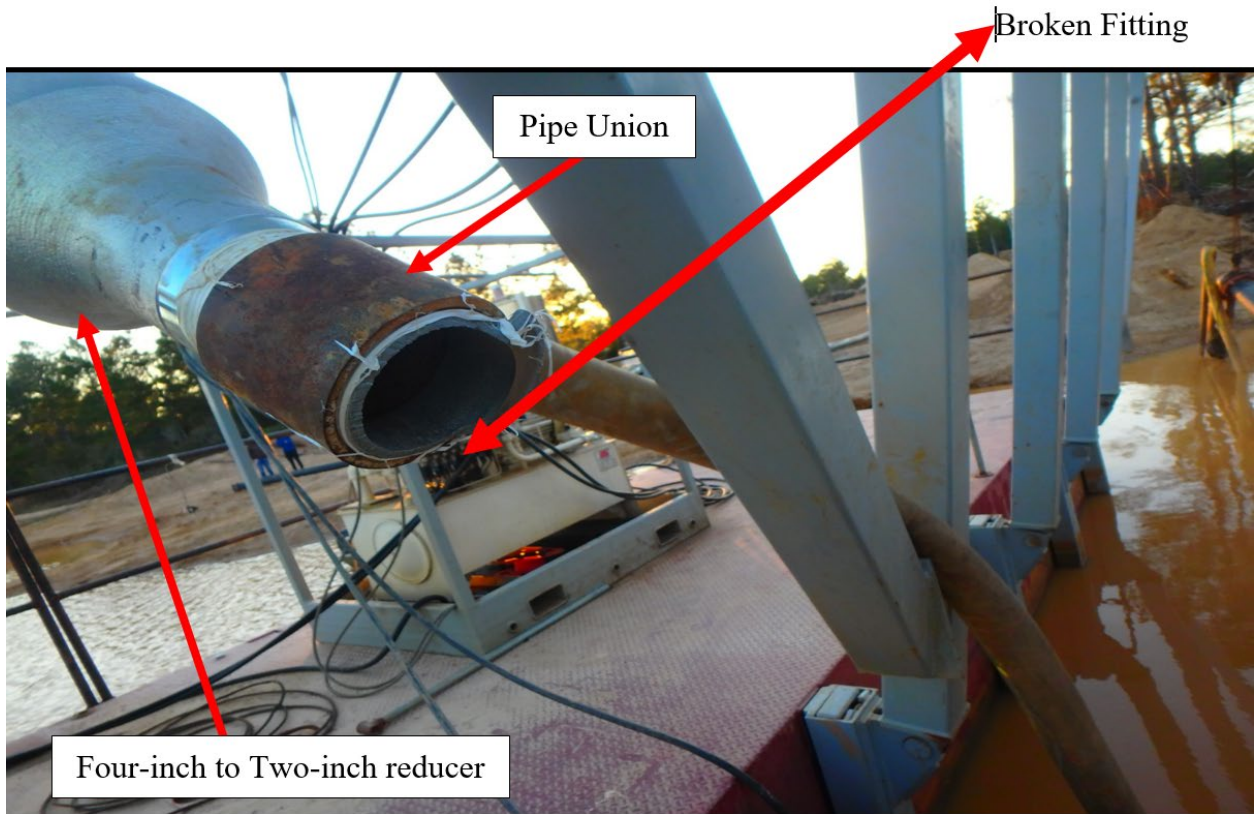
Appendix B
Photograph of Broken Fitting

View of portion of fractured quick connect fitting protruding from pipe union and reducer.

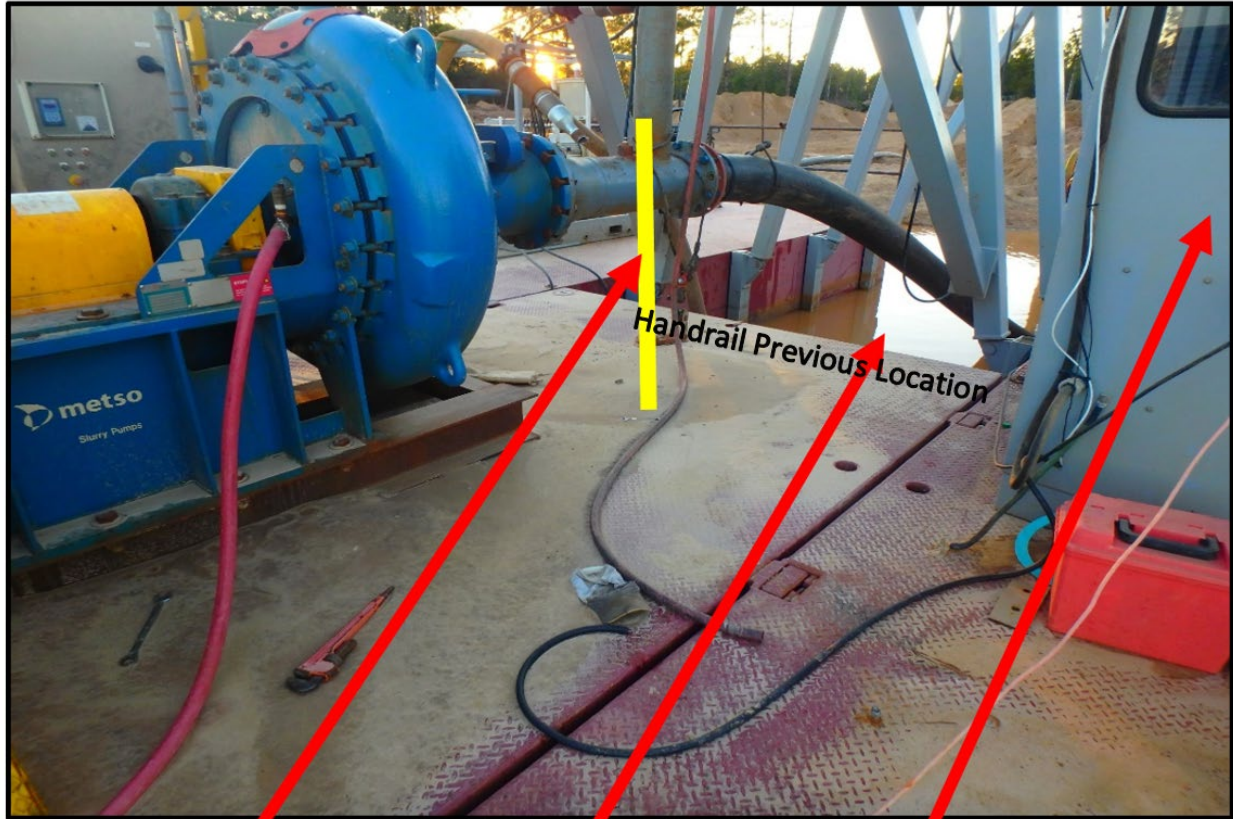
Appendix E
Photograph of Accident Scene

On February 27, 2020, Tupper disconnected the ten-inch suction line to clear the blockage. When he did so, the hose fell and knocked down the cable handrail around the key of the dredge and broke the stanchions (see Appendix E). The mine operator did not replace the handrails prior to the accident.

Location of victim prior to accident.

Key in the dredge where
victim entered water.

Operator's station.

Corrective Action: The mine operator developed a new written policy that requires miners to wear life jackets at all times where a danger of falling into water exists. All miners will be trained on this new written policy prior to the dredge being placed back into service.
