REPORT OF INVESTIGATION

Surface Nonmetal Mine
(Construction Sand and Gravel)

Fatal Slip or Fall of Person Accident
June 1, 2020

Plant #1
Desert Aggregates
Buckeye, Maricopa County, Arizona
ID No. 02-03413

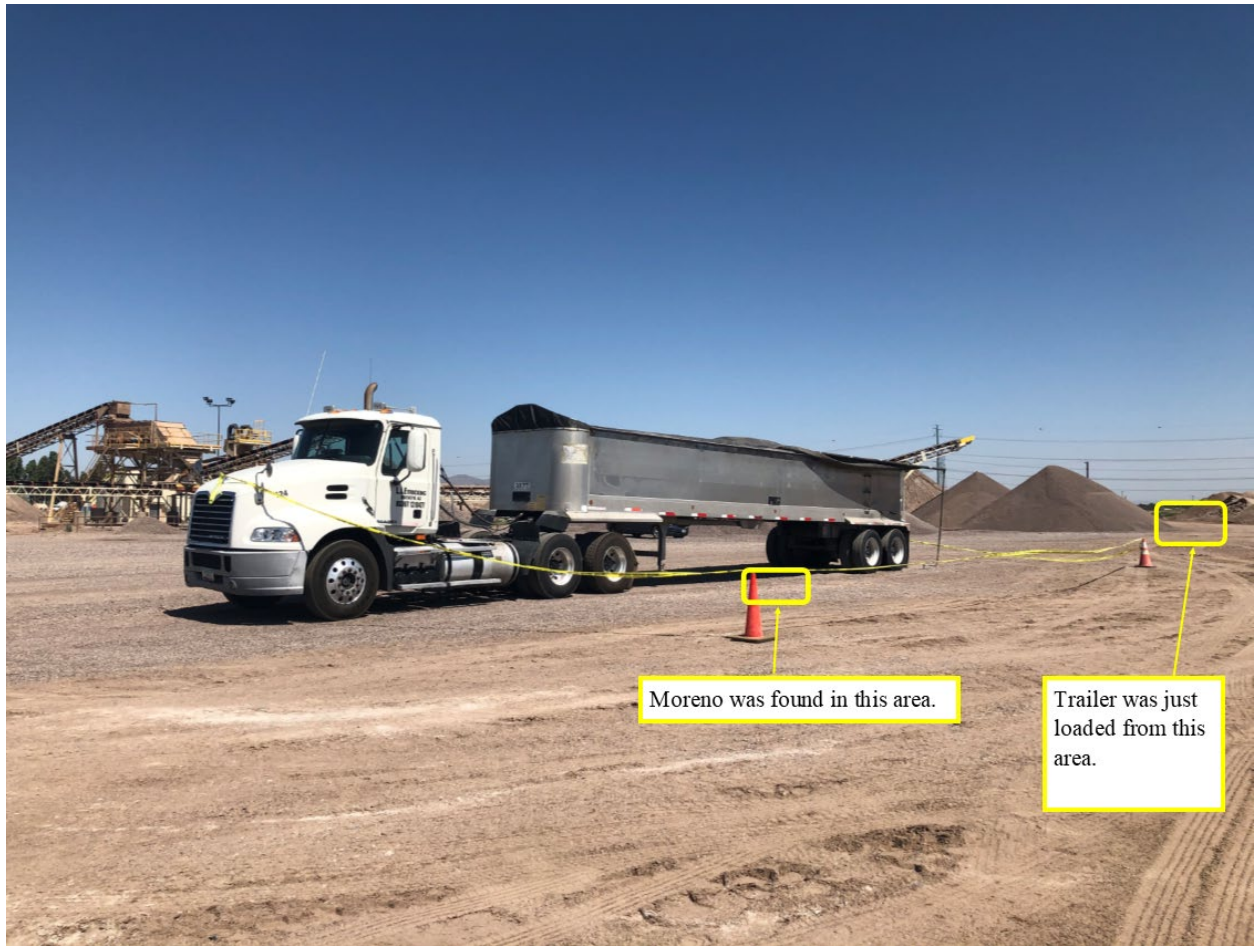
Appendix B
Photograph of Accident Site

The accident occurred 140 yards from the sand stockpile, referred to as 57 rock pile, on the east side of the mine. The area is flat, with no noticeable grade (see Appendix B).

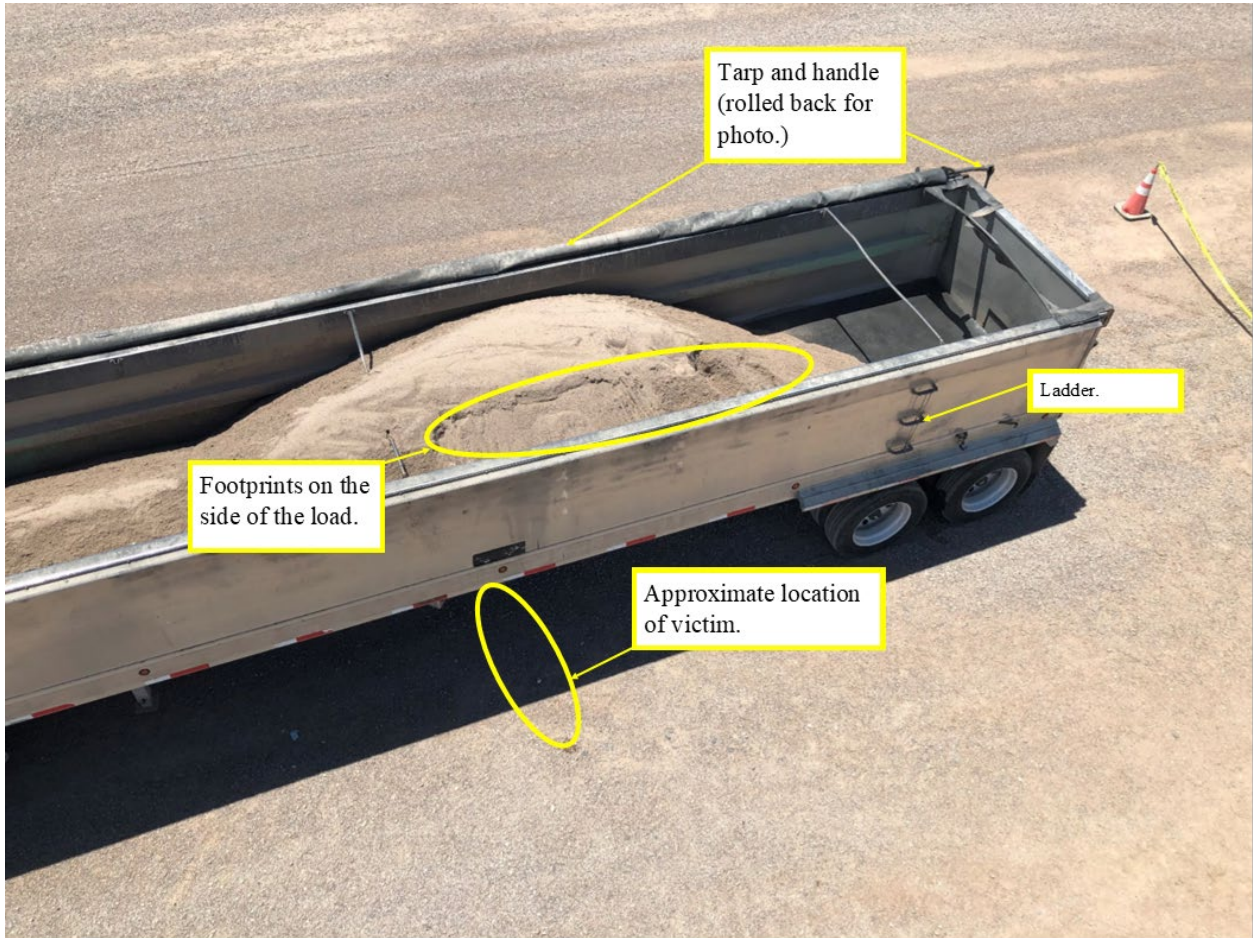
Appendix C
Photo showing footprints in the load of sand

Investigators found footprints in the sand on top of the load where Moreno had been working prior to falling (see Appendix C). Based on witness testimony, investigators concluded that Moreno used the service ladder on the side of the end-dump trailer to access the top and climb onto the load. The footprints in the sand lead away from the location above the ladder, supporting the conclusion that he did not fall from the ladder, but rather, fell from atop the truck. The tarp was found partially deployed. Investigators found evidence of contact along the side of the truck (see Appendix D) from Moreno's boots above the location where he came to rest. The victim fell 9' 6" and was not wearing fall protection. Neither the mine operator nor L.J.E. Trucking provided fall protection to Moreno or other truck drivers.

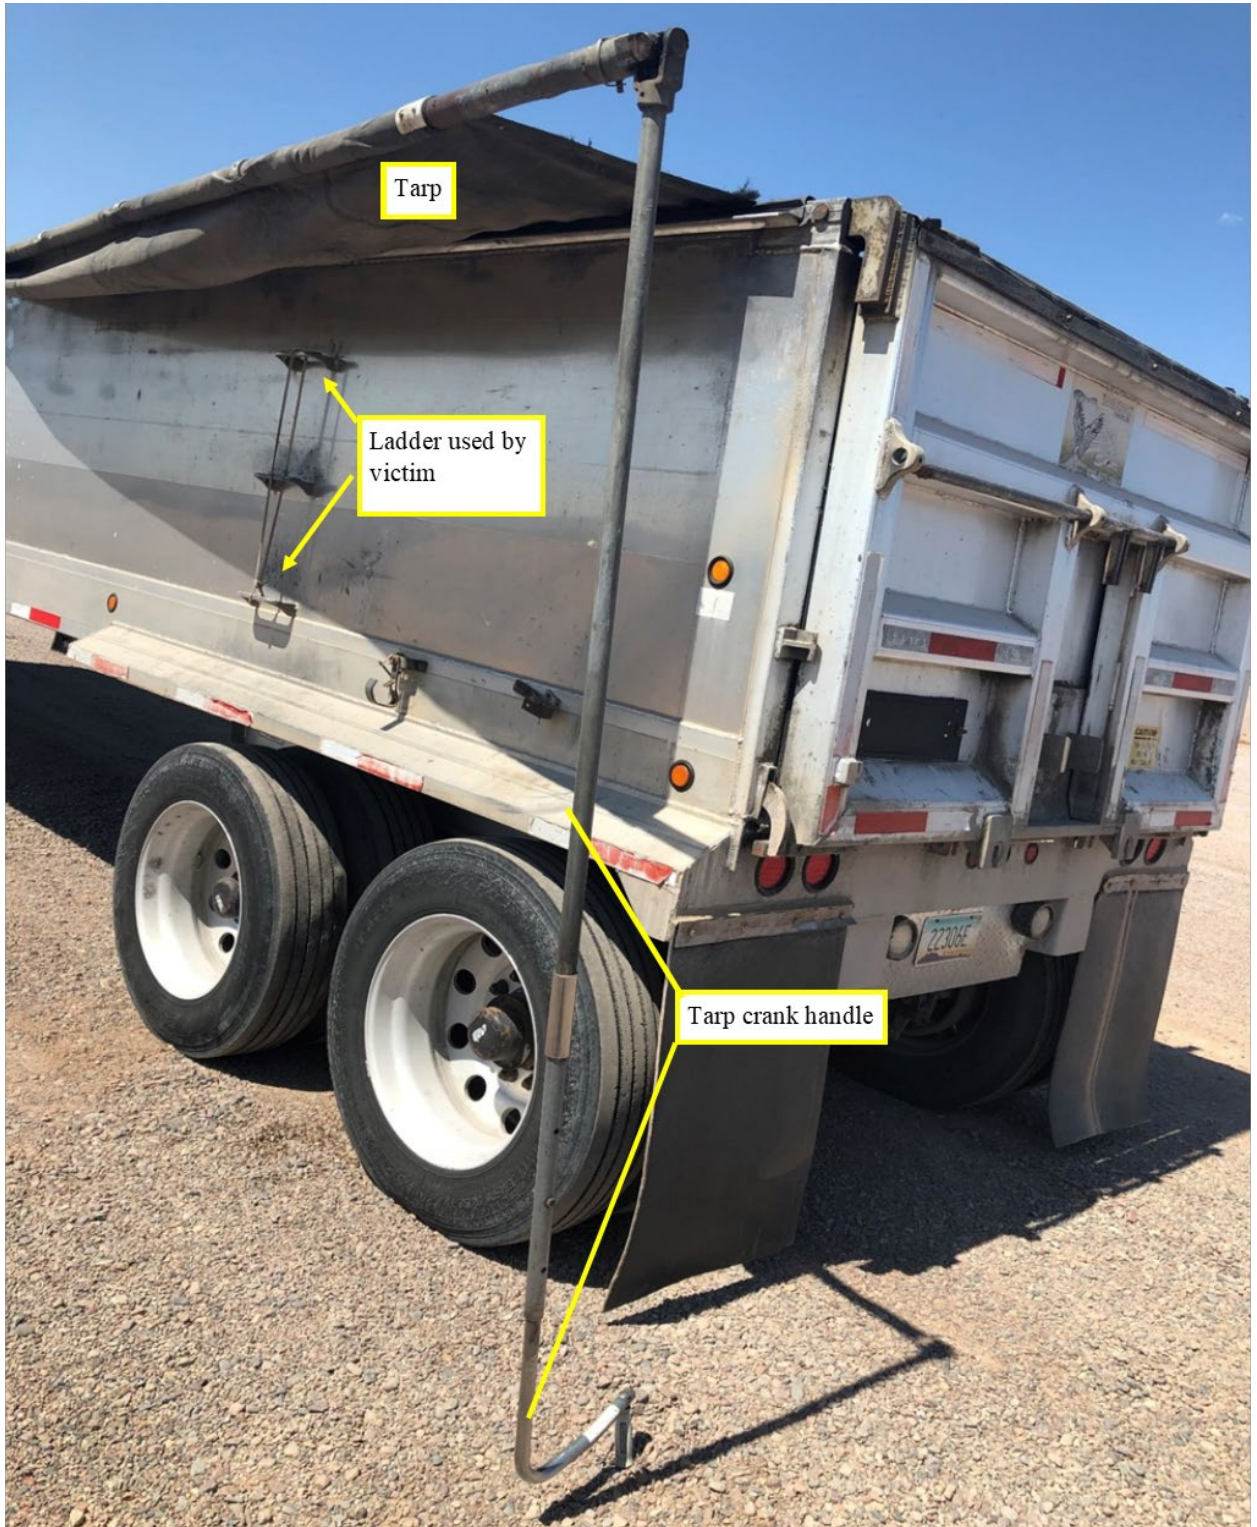
Appendix D
Photo showing the end-dump trailer ladder, the tarp and tarp crank handle

The tractor-trailer was a 2009 Mack truck with a 2005 Eaglerock end-dump trailer. The tractor-trailer was equipped with a SHUR-CO, SHUR-LOK manual tarp (see Appendix E).

Citation No. 9474178 – Issued to Desert Aggregates Plant #1 (02-03413), under the provision of section 104(a) of the Mine Act for a violation of 30 CFR § 56.11001. A fatal accident occurred at Desert Aggregates Plant #1 on June 1, 2020, when a safe means of access was not provided to a customer truck driver who used the service ladder on the side of the truck bed to gain access the top of the load. The driver died after he fell approximately 9' 6" over the edge of the trailer.

Corrective Action: Management designated areas for parking so truck drivers can be observed from the crusher tower while tarps are being deployed. Mine management is now training truck drivers on the portion of the site-specific hazard awareness training plan that addresses working from elevated areas and using fall protection. This training includes procedures to request a man lift or dumping the load. Management also revised the site-specific hazard awareness training plan to provide that truck drivers exit their trucks only in designated areas.
