REPORT OF INVESTIGATION

Surface Mine  
(Construction Sand and Gravel)

Fatal Machinery Accident  
June 13, 2020

Carl's Dragline Service (K439)

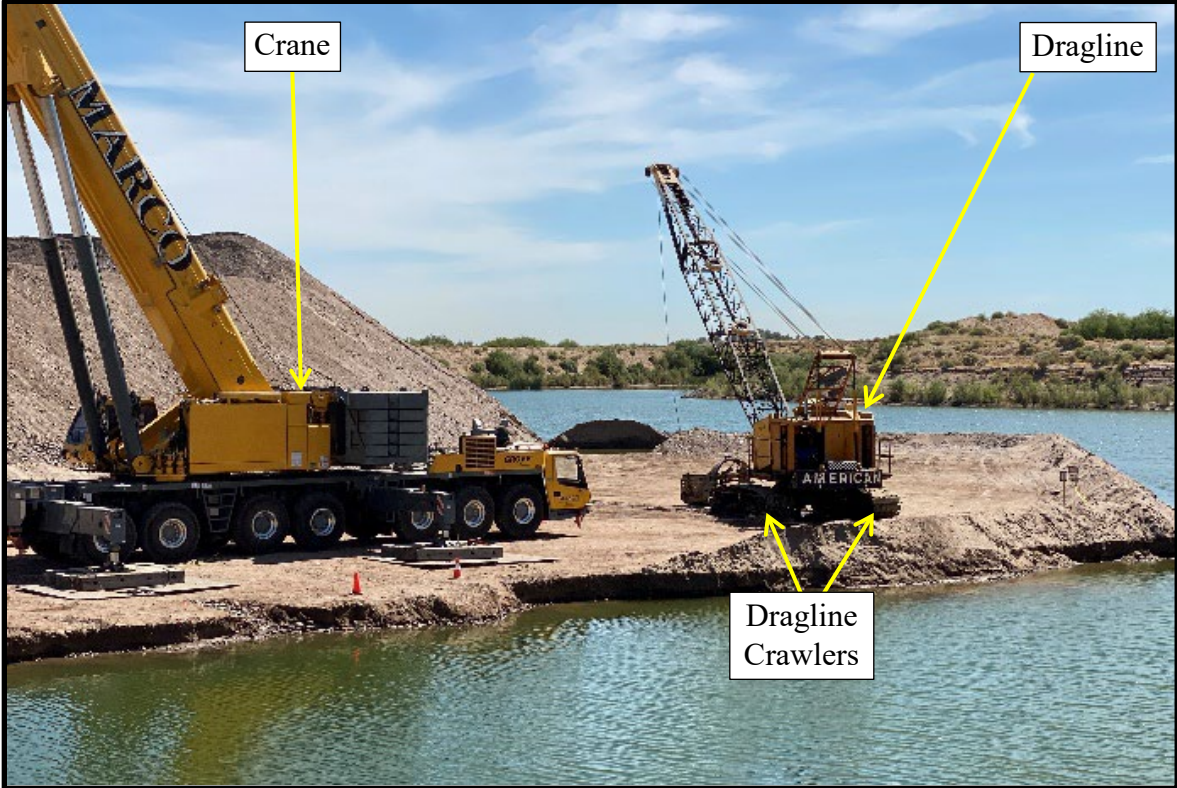
Accident Scene after Recovery of the Dragline

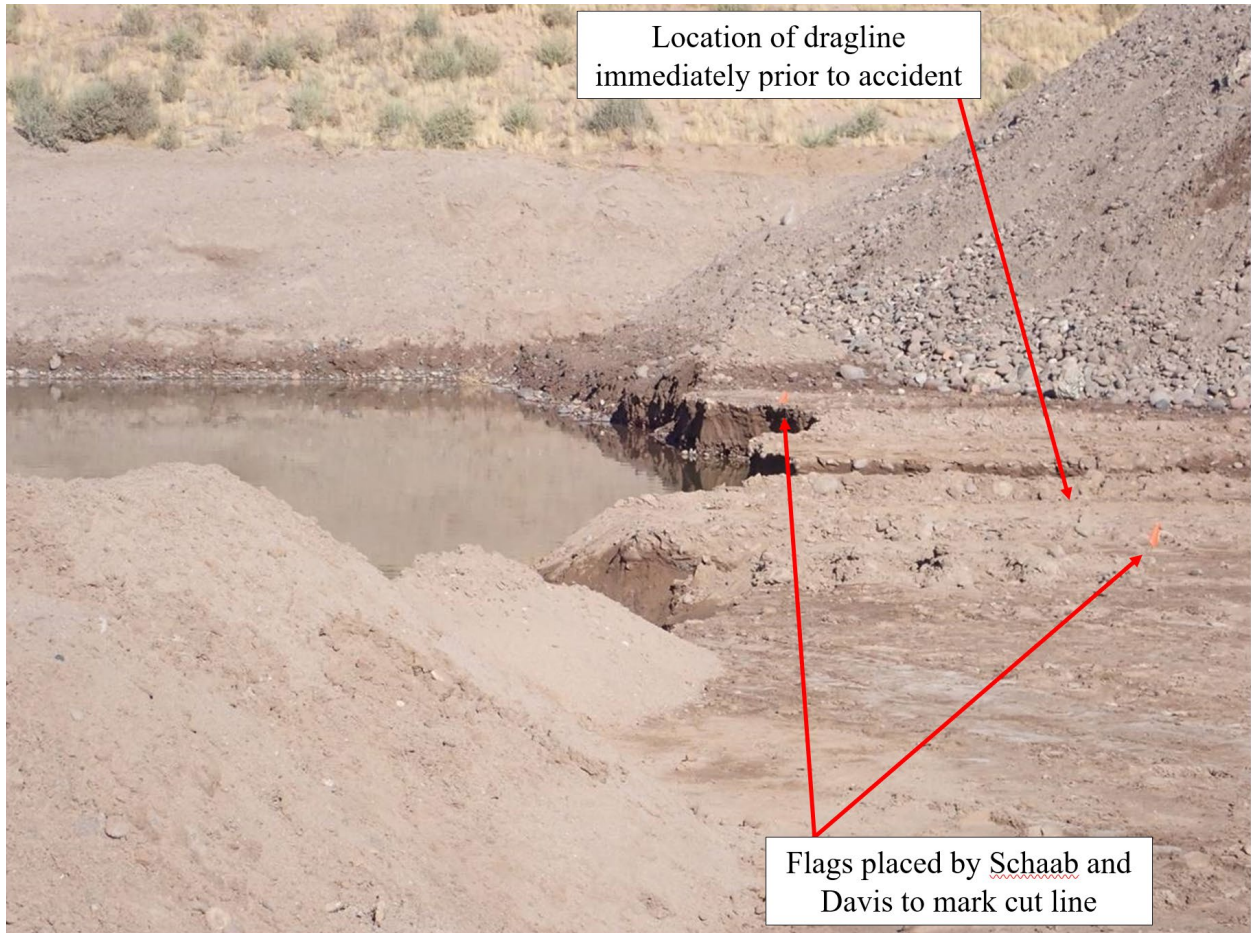
Appendix A  
Photograph of Dragline Location Before Accident

On June 13, 2020, at 5:00 a.m., Davis started work performing a pre-operational examination of the American Hoist and Derrick Company 599C Dragline. After he completed his examination, he began to extract material from the submerged deposit. At approximately 8:00 a.m., Carl Schaab, Carl's Dragline Service's Owner, arrived on the scene to check on Davis. Davis and Schaab discussed the "cut line", the line where the dragline would excavate the shoreline, to even the bank of the pit (see Appendix A). Schaab told Davis to work until 2:00 p.m. and then meet him at Schaab's house at 3:00 p.m.

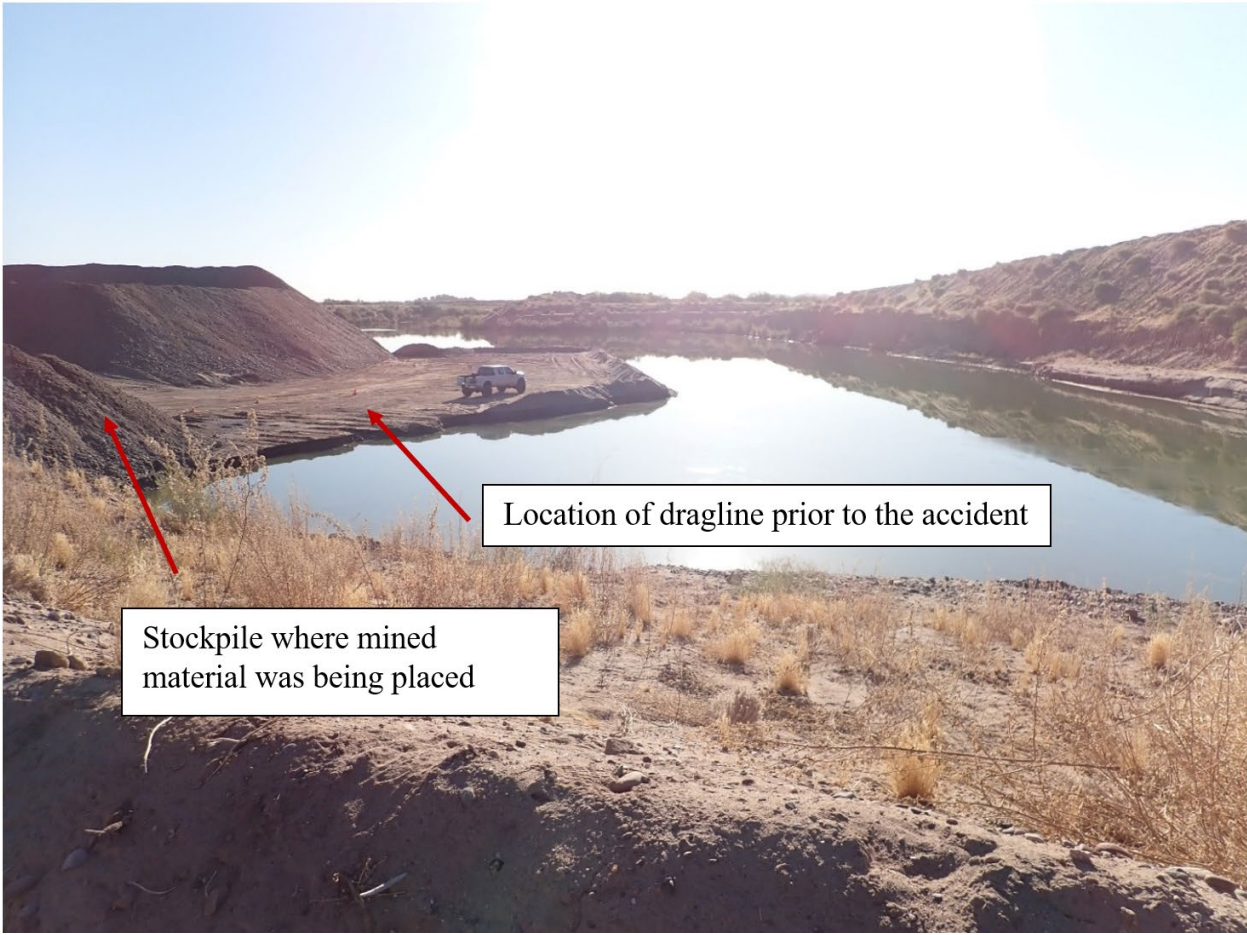
Appendix C  
Photograph of Accident Area

The accident occurred in the pit adjacent to the stockpile (see Appendix C). The dragline was positioned in order to avoid a nearby bank erosion. The water in the pit was approximately 25 feet deep.

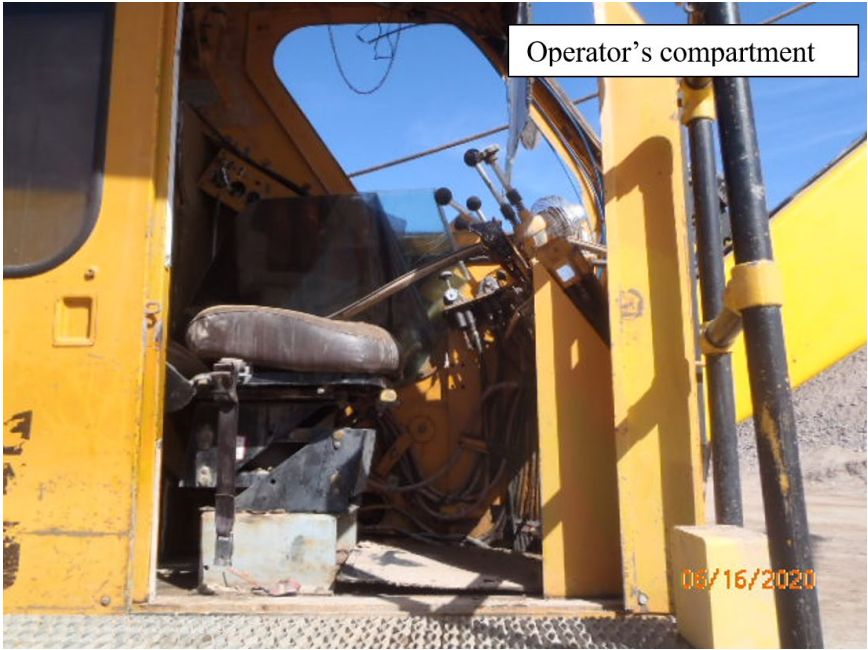
Appendix D  
Photograph of Dragline Compartments

Davis was operating an American Hoist and Derrick Company 599C dragline. The dragline has two crawlers which allow the dragline to move from place to place. Investigators reviewed the position of the air-actuated controls and the hoist and drag drum positions (see Appendix D).

The dragline operator can lock the crawlers and prevent any crawler movement by engaging the crawler travel locks. Investigators observed that the crawler travel locks were in the "no restraint" position, which allows crawler movement, and the drag drum was in the "engaged" position.

Based on the positions of the controls in the dragline, the victim lowered the bucket into the water and engaged the drag drum to draw or pull the dragline bucket toward the dragline. This is how the dragline excavates material from the bottom or submerged deposit. With the crawler travel locks in the “no restraint” position and the drag drum in the “engaged” position, when the victim attempted to draw in the dragline bucket, it caused the dragline to be pulled into the water. A review of the dragline revealed that the resulting force from the water pushed him through a 17-inch doorway and into the engine housing. The dragline’s operating manual states “[t]he travel locks should be set with the machine stopped.”

Root Cause: Carl’s Dragline Service did not ensure that equipment operators maintained control while operating equipment.

Corrective Action: Carl’s Dragline Service has designed and successfully tested a system that prevents the drag drum from engaging when the crawler travel locks are not engaged. This system will be installed on the dragline prior to putting it back into service. The system will also be installed on all draglines operated by the company. Additionally, this system provides a visual indication when the crawler travel locks are not engaged. All miners will be trained on the new safety systems once the dragline is operational.
