EXAMINATION OF COMPONENTS OF JOY MINING MACHINERY JNA CONTROL SYSTEM

INVESTIGATIVE REPORT

Examination of Components of Joy Mining Machinery JNA Control System
Recovered from a Mine Explosion at
Performance Coal Company
Upper Big Branch Mine-South (MSHA ID 46-08436)
Montcoal (Raleigh County), WV

Prepared By:
Robert Holubeck, Electrical Engineer
Matthew Heightland, Electrical Engineer

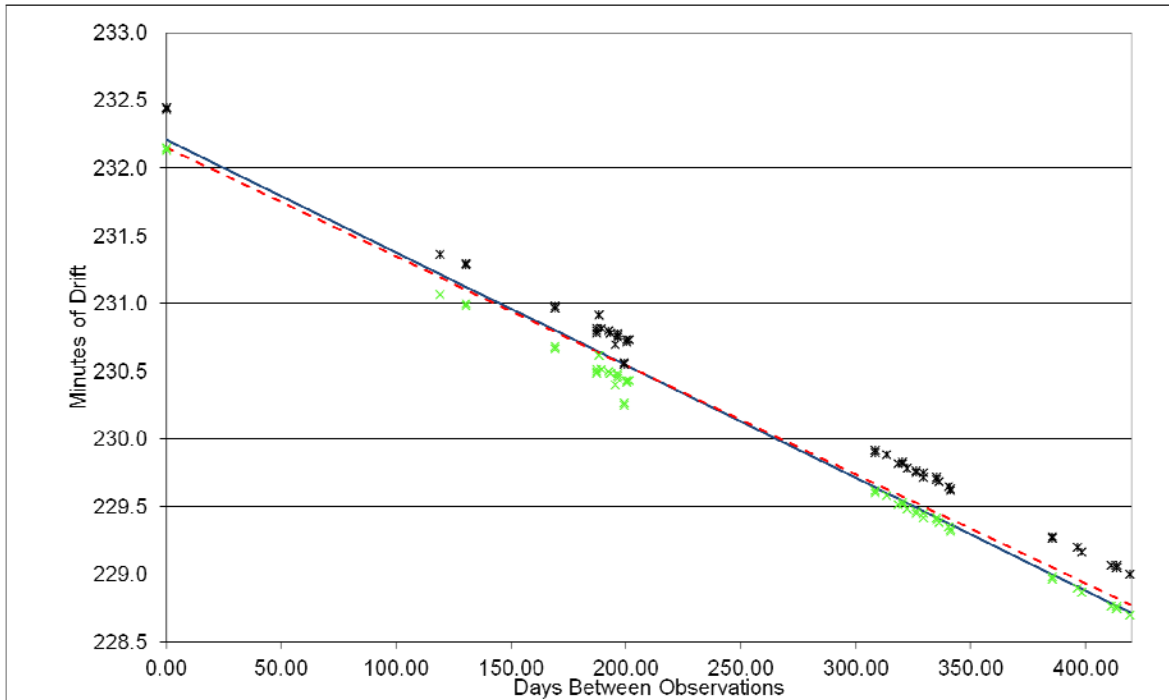
Figure 1. Calculated Minimum and Maximum Clock Drift Rates, Exhibit No. PE-0164

The smallest tolerance on the time observed on the MSHA network and www.time.gov that would allow a straight line to fit all points, as shown on Figure 1 below, was the minimum allowable tolerance of ± 9 seconds. This tolerance was then applied to the reference time, resulting in the points on Figure 1; the points represented by asterisks were the largest possible deviation, and those represented by X were the smallest possible deviation.

Once again, by systematic trial and error, straight lines were fit between the two sets of data (largest and smallest deviation) by adjusting the y-intercept and slope of the lines until the minimum and maximum possible slopes were obtained. These slopes were the minimum and maximum rates of drift of the JNA0 system clock.

The maximum and minimum slopes were 0.49971 and 0.4824 seconds per day. This means, if the drift was constant from April 5, 2010 until measurements started on July 23, 2010, the actual expected time and date for the last “STS Right Handheld ESTOP” event which was recorded at 6:52:39 PM on April 5, 2010 was between 2:59:32 PM and 2:59:38 PM on April 5, 2010.
