EXAMINATION OF COMPONENTS OF JOY MINING MACHINERY JNA CONTROL SYSTEM

INVESTIGATIVE REPORT

Examination of Components of Joy Mining Machinery JNA Control System
Recovered from a Mine Explosion at
Performance Coal Company
Upper Big Branch Mine-South (MSHA ID 46-08436)
Montcoal (Raleigh County), WV

Prepared By:
Robert Holubeck, Electrical Engineer
Matthew Heightland, Electrical Engineer

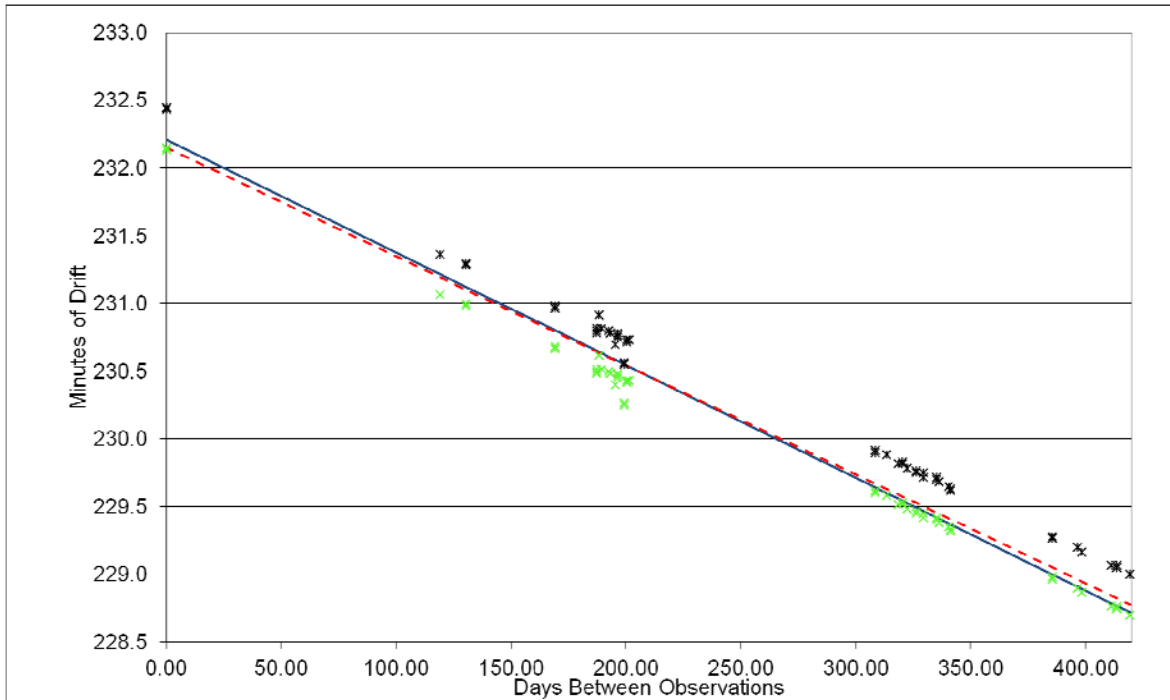
Figure 1. Calculated Minimum and Maximum Clock Drift Rates, Exhibit No. PE-0164

The smallest tolerance on the time observed on the MSHA network and www.time.gov that would allow a straight line to fit all points, as shown on Figure 1 below, was the minimum allowable tolerance of ± 9 seconds. This tolerance was then applied to the reference time, resulting in the points on Figure 1; the points represented by asterisks were the largest possible deviation, and those represented by X were the smallest possible deviation.

The maximum and minimum slopes were 0.49971 and 0.4824 seconds per day. This means, if the drift was constant from April 5, 2010 until measurements started on July 23, 2010, the actual expected time and date for the last "STS Right Handheld ESTOP" event which was recorded at 6:52:39 PM on April 5, 2010 was between 2:59:32 PM and 2:59:38 PM on April 5, 2010.
