REPORT OF INVESTIGATION

**Fatal Underground Mine Explosion
April 5, 2010**

**Upper Big Branch Mine-South, Performance Coal Company
Montcoal, Raleigh County, West Virginia, ID No. 46-08436**

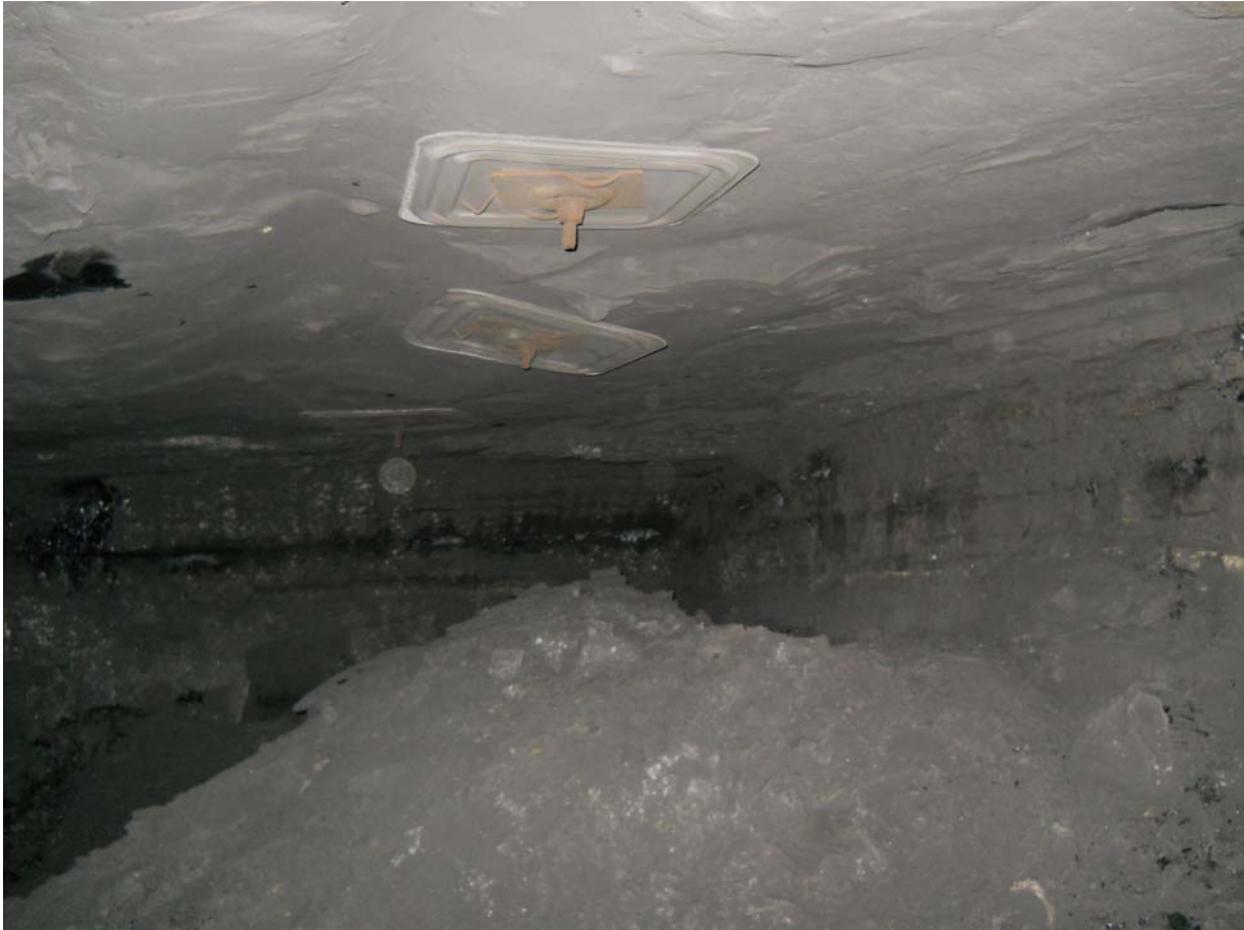
the explosion. Miners working in these areas testified these accumulations existed prior to the explosion.

Figure 3. Accumulations of loose coal, coal dust, and float coal dust were measured up to 7 feet wide by 12 feet long by up to 4 feet in depth. These were found consistently along every single air course.

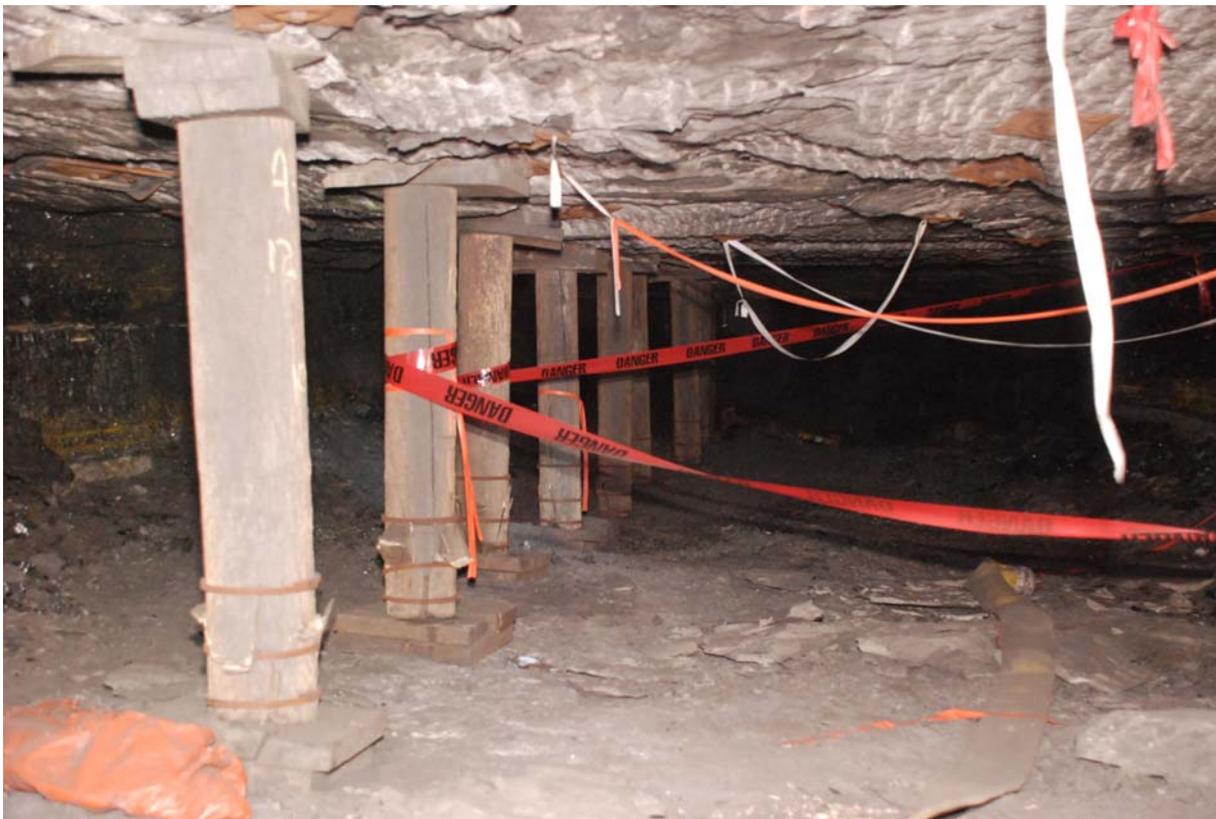
PCC's roof control plan required two rows of posts or two 8' cable bolts in the No. 7 entry in the longwall tailgate as supplemental support. This requirement was intended to maintain adequate roof support in that entry. PCC only installed one row of posts in the entry as shown in Figure 4. Both the single row of posts and the resulting roof control issues were obvious; examiners testified that they did not like to travel in that entry due to the bad top. PCC never recorded the hazard in any of its examination books. Poor roof conditions led to a roof fall in the No. 7 entry, which likely restricted air flow coming off the longwall face, and allowed methane to accumulate prior to the explosion. The investigation indicated that this fall was present prior to the explosion; blackened dust from the explosion was present on the fall and could only have occurred after the explosion.

Figure 4. Photograph of Tailgate 1 North No. 7 entry showing only one row of posts installed. The approved roof control plan required two rows of 8' cable bolts or posts.

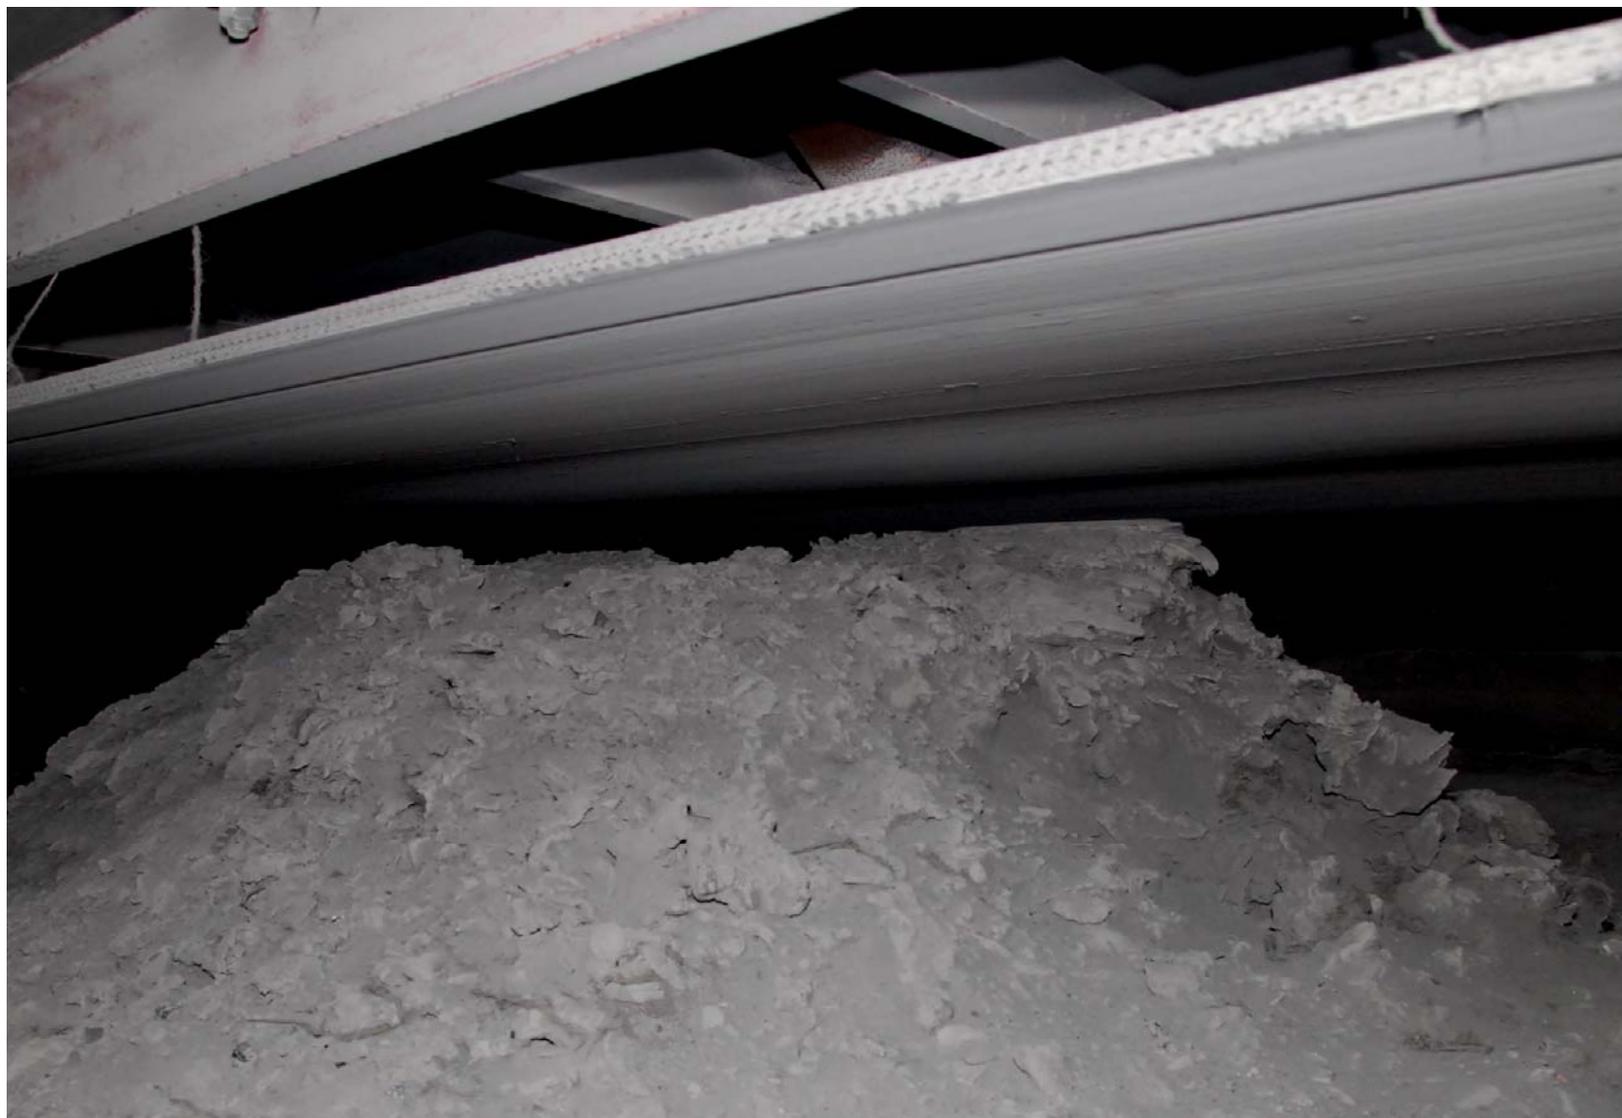
During the underground investigation, MSHA identified accumulations in over 50 locations along the conveyor belts. These accumulations were allowed to pile up below and around the belt and belt structure, and along portions of ribs that were not cleaned up during initial development. Examples of this are shown in Figures 8 and 9. The size and number of these accumulations demonstrate that the hazards existed for a long period of time.

Figure 8. Accumulations of loose coal with the top of the pile flattened due to rubbing the moving belt.

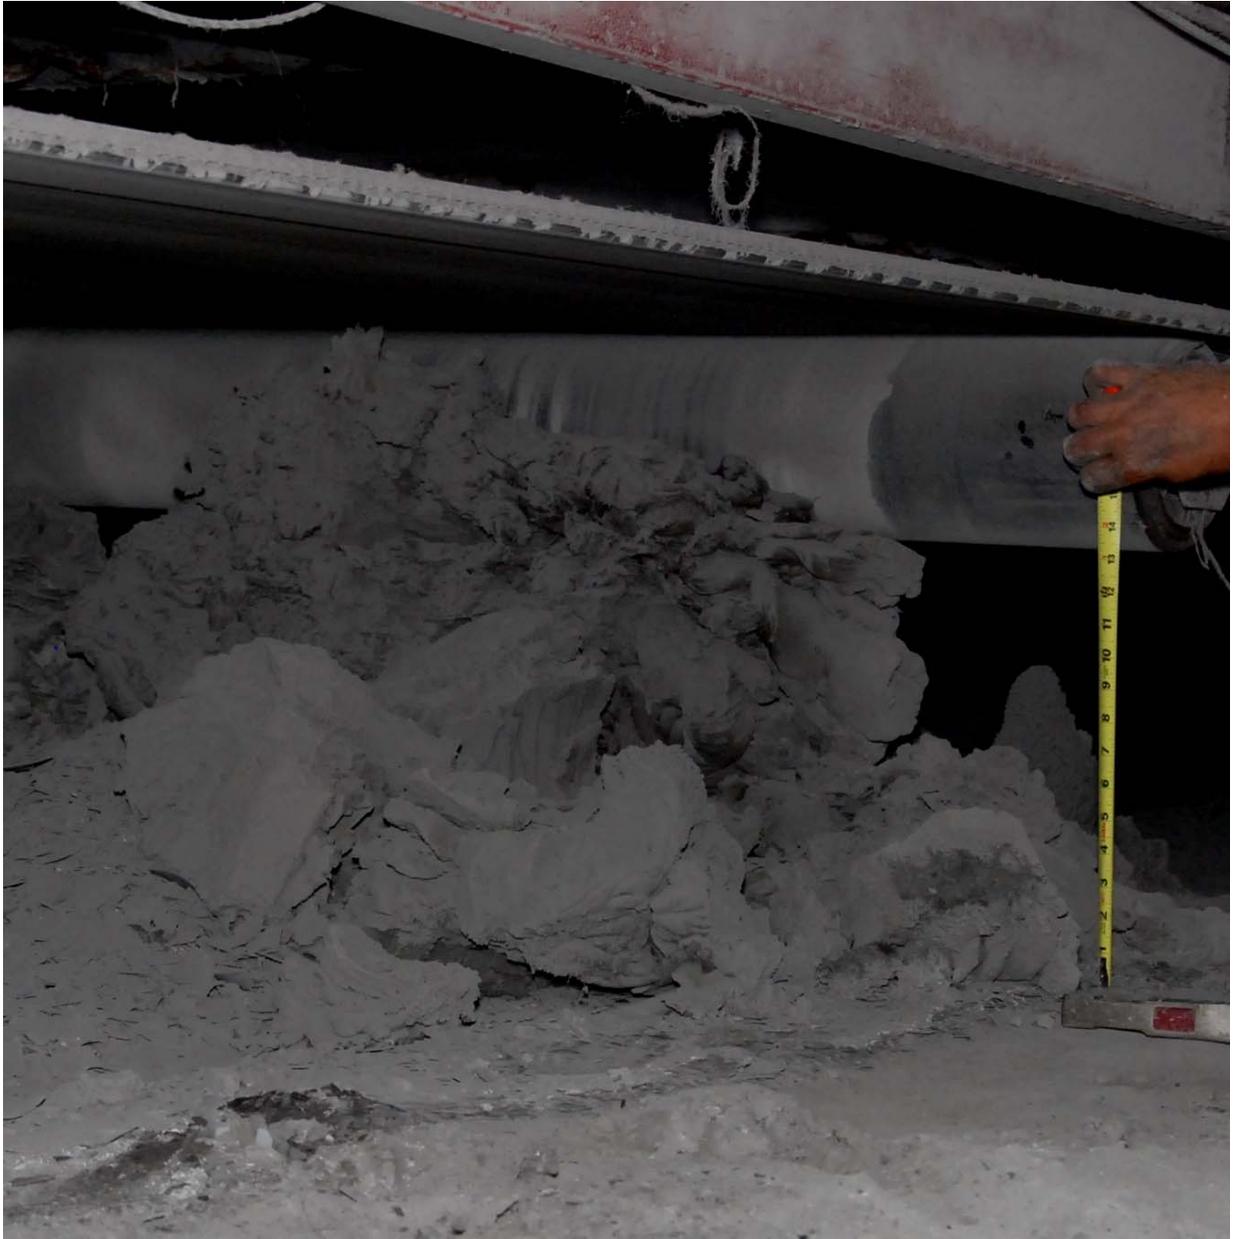
Figure 9. Accumulations of loose coal built up to the point that the belt roller is turning in the accumulations.

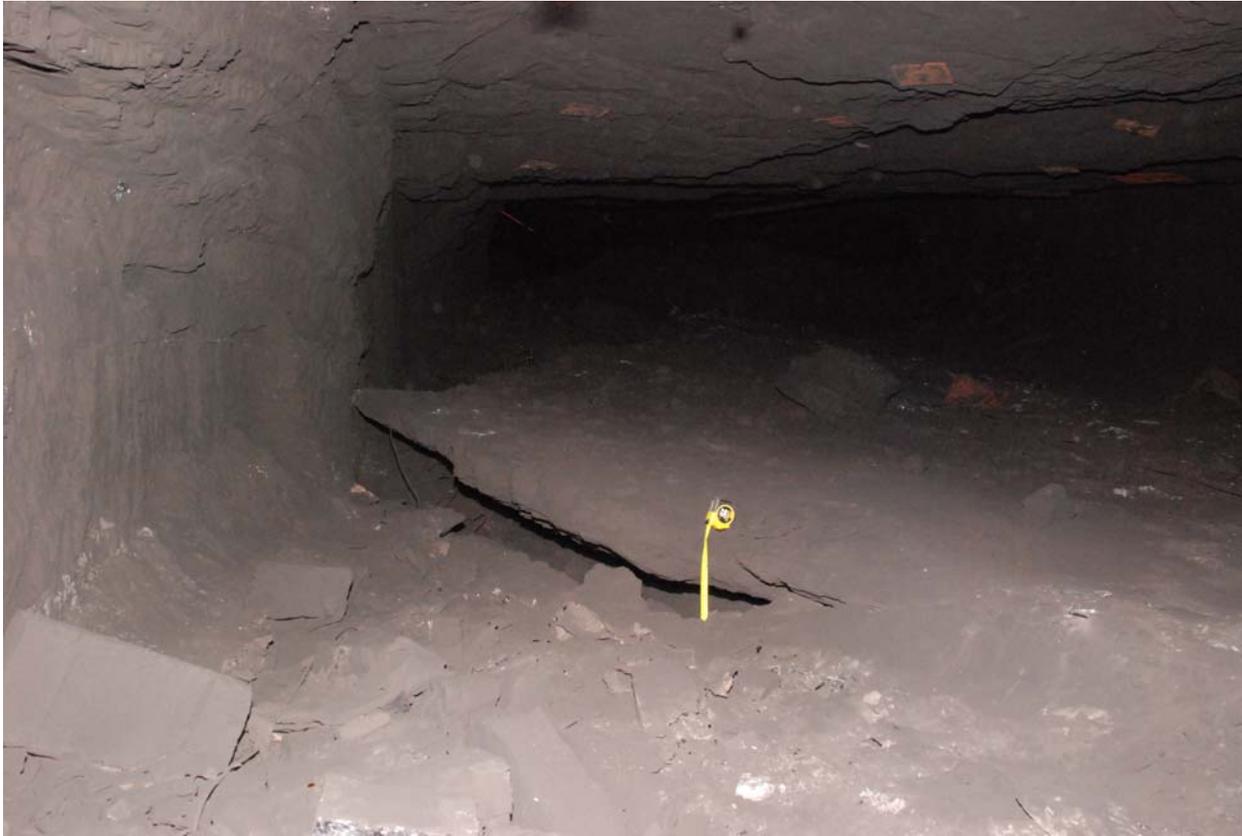
Figure 13. Cantilevered slab of floor sandstone forms broken brow with rootless, open aperture fracture. This style of floor heave is typical throughout Tailgate 1 North, the Panel 1 crossover and adjacent rooms, TG 22, and HG 22.

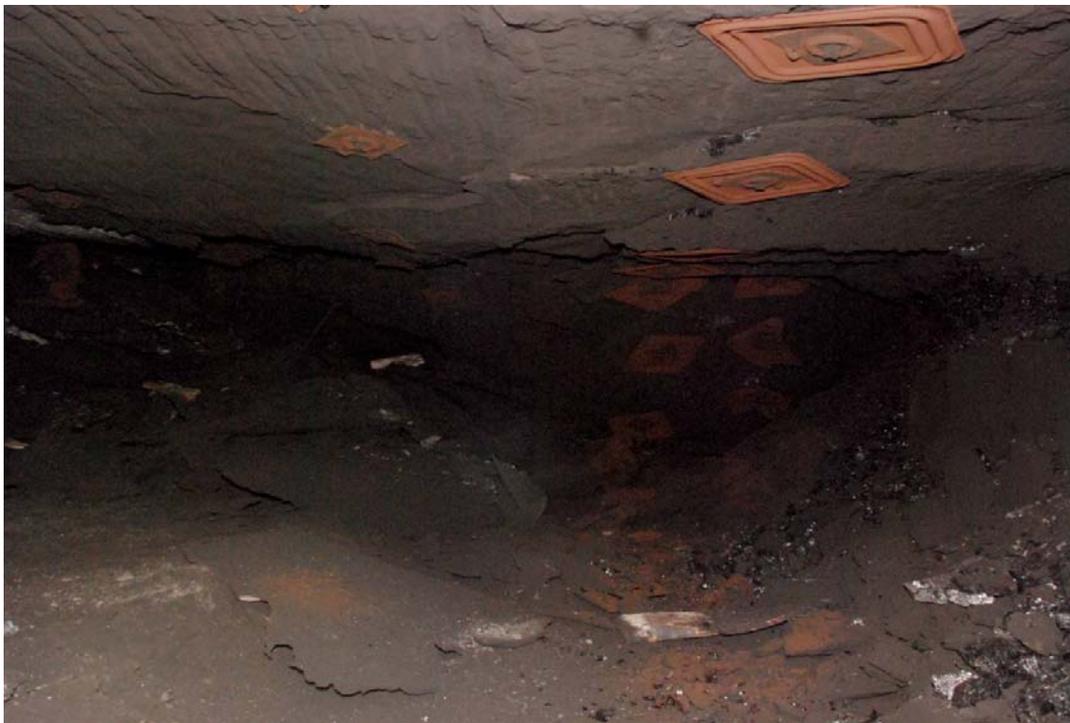
Figure 23. Caved roof in tailgate entry, as viewed in crosscut 49, which represents the next crosscut inby the face. Coatings of soot on the fallen rubble, juxtaposed against small pieces of freshly fallen, white sandstone, indicate that the intersection had caved prior to the explosion.

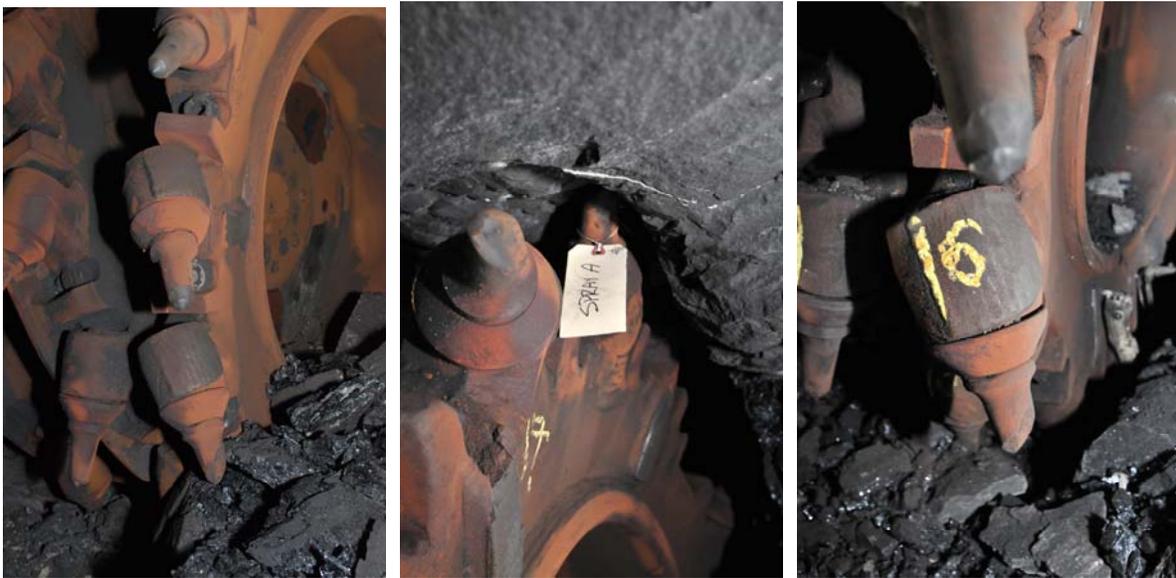
Figure 30. 1 North Panel tailgate drum, showing configuration of water sprays used in the pick-point flushing system. Note that sprays are directed toward the front of the bits, one missing water spray, and two bits exhibiting extreme wear.

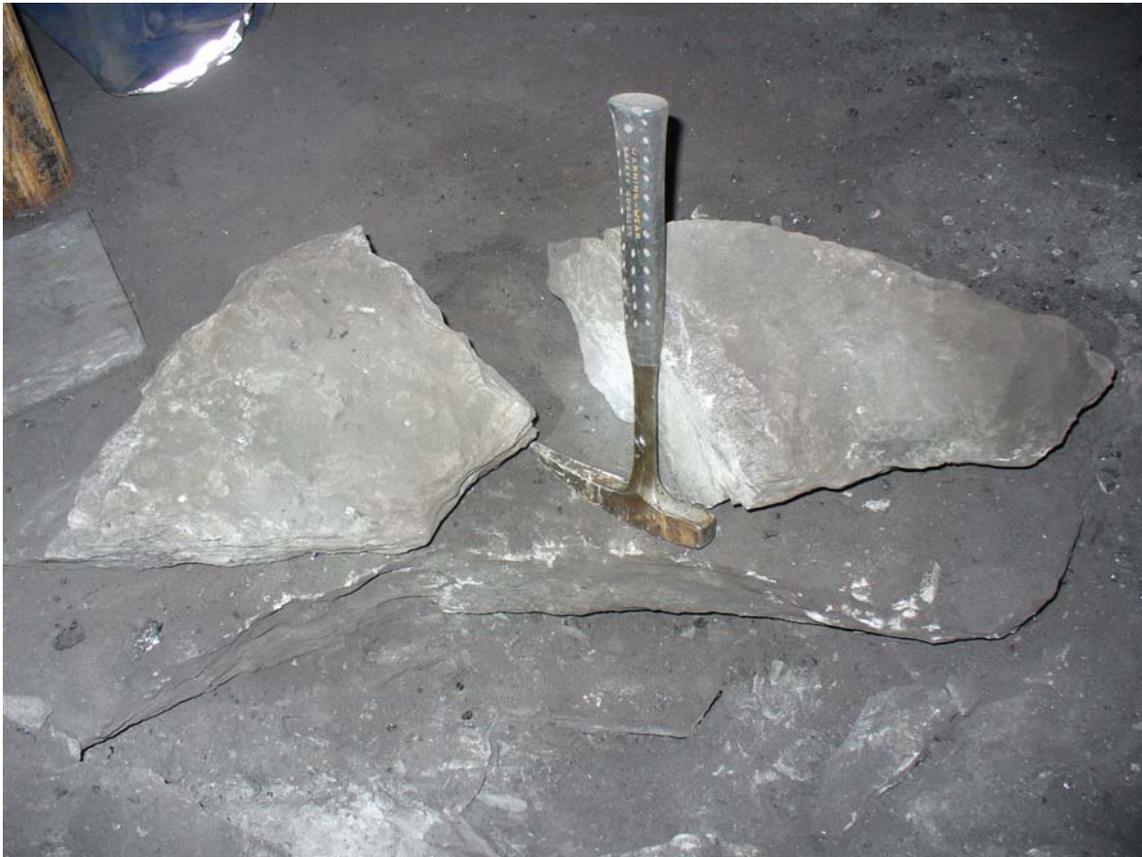
Figure Q-5. Sample of sandstone was collected from floor heave brow beneath survey station 22582 in 1 North Panel longwall tailgate, 36 feet outby the face. Brow of heaved sandstone slab reveals rootless crack.

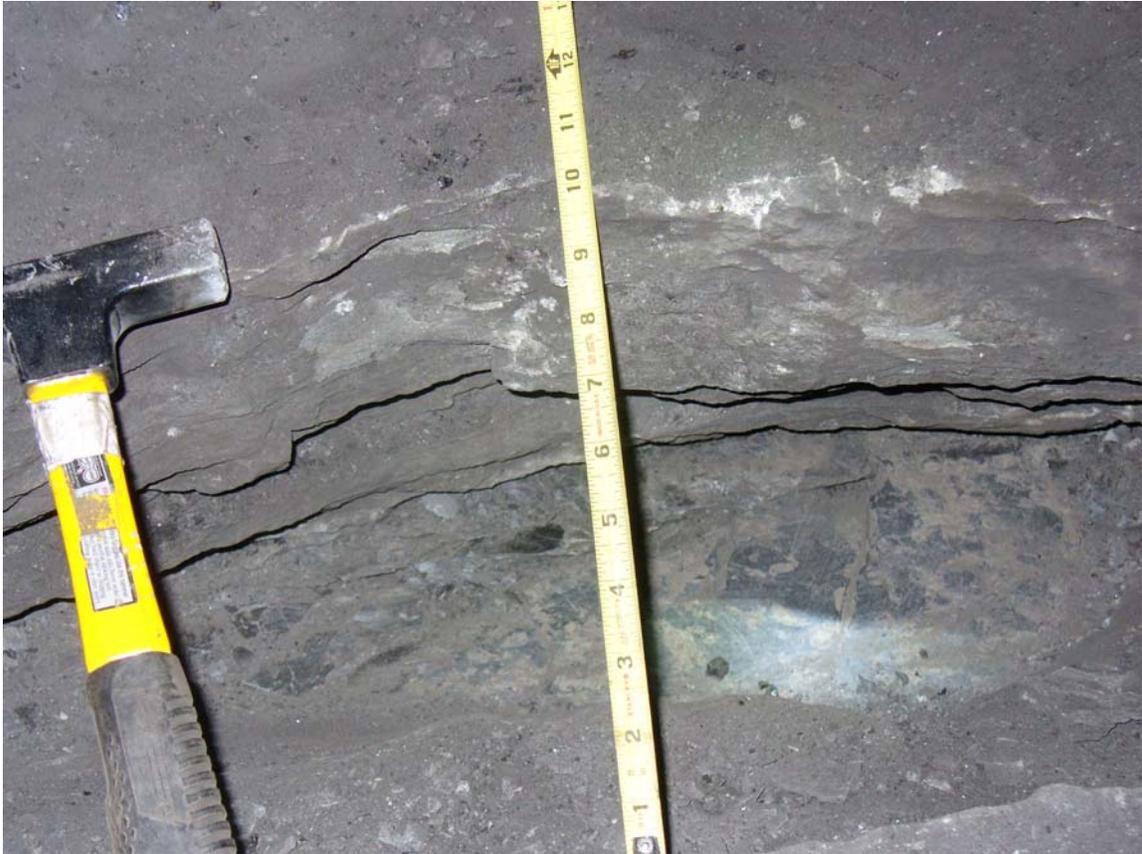
Figure Q-6. View of exposed floor heave crack looking straight down, with hammer and tape measure for scale. The crack is rootless and dies out approximately 12 inches into the floor at a layer of shale.

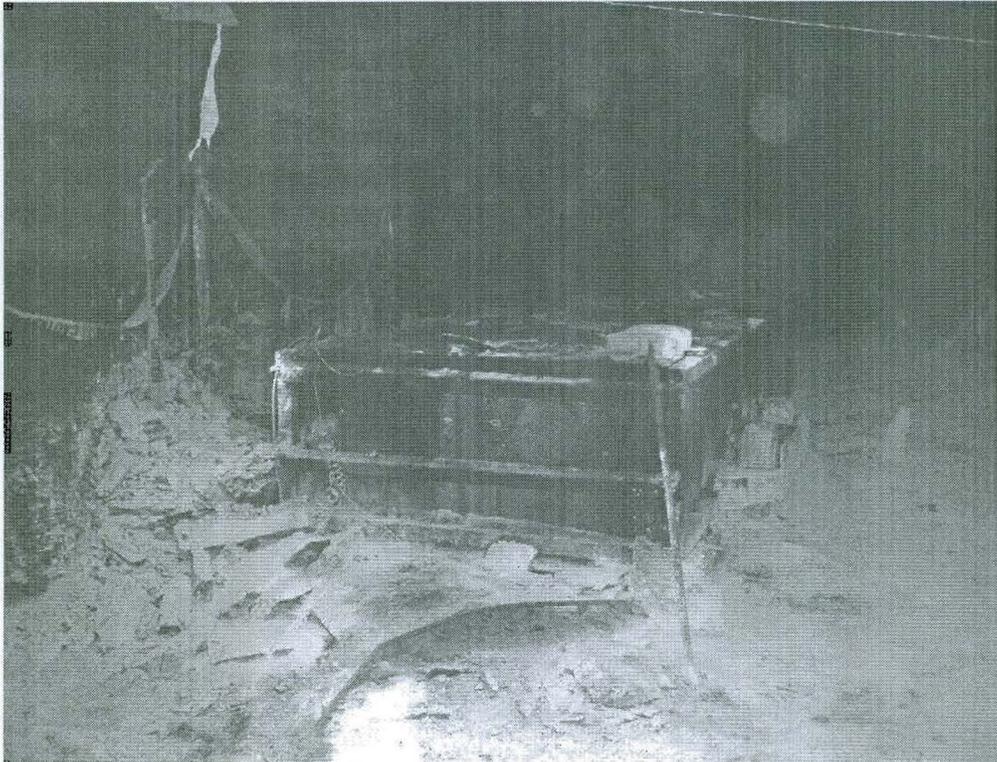
- The unit appeared to have been under up to 20 inches of water. The water reportedly built up following the explosion and while the mine's pumps were not operated. The water was eventually pumped and the area was dry during the inspection.
- Side access door showed no visible damage and there was no evidence of moisture.
- There was evidence of heating on a plastic bag containing the hand-held gas detector stored in this compartment.
- Solaris™ gas detector was located in this compartment. It could not be determined if the detector would operate from the affects of the flash fire and heating due to the battery status. The detector had remained in place and had not been charged since the explosion. There was no visible evidence of damage or heat effects to the detector.

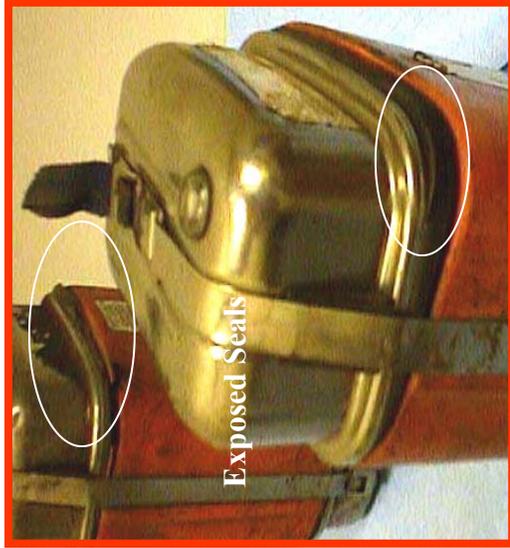
Seals are protruding and security band out of alignment. Such conditions result from forceful impacts.

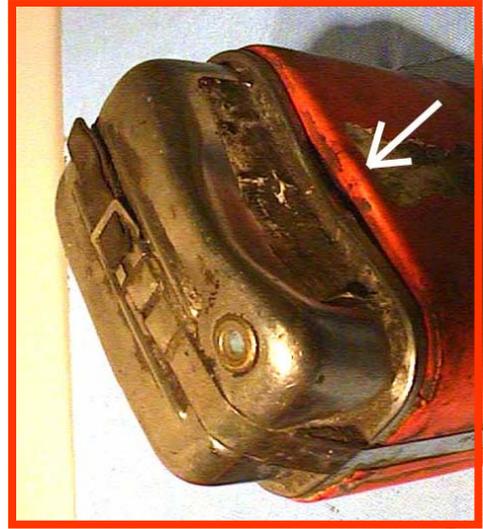
This unit has received a severe impact to its top cover. As a result, the top cover has a significant dent and the seal ring has been displaced.
