**UNITED STATES DEPARTMENT OF LABOR
MINE SAFETY AND HEALTH ADMINISTRATION
COAL MINE SAFETY AND HEALTH**

REPORT OF INVESTIGATION

**Fatal Underground Mine Explosion
April 5, 2010**

**Upper Big Branch Mine-South, Performance Coal Company
Montcoal, Raleigh County, West Virginia, ID No. 46-08436**

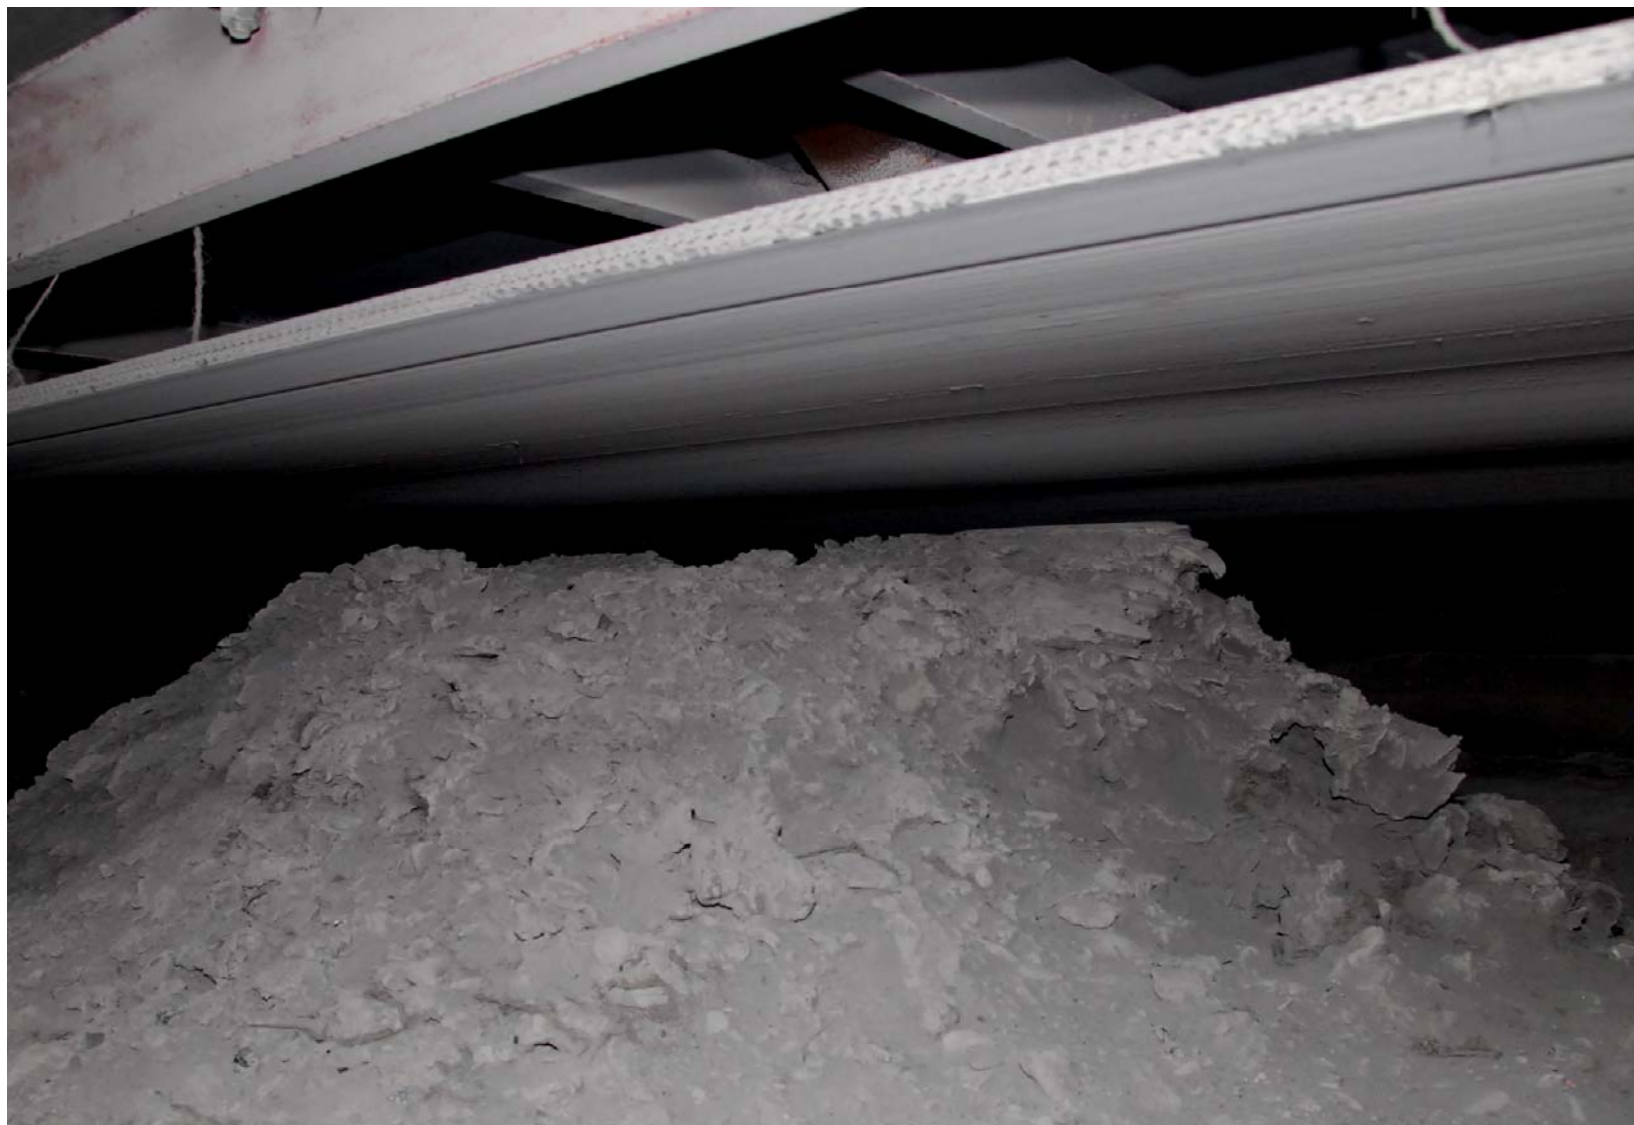
During the underground investigation, MSHA identified accumulations in over 50 locations along the conveyor belts. These accumulations were allowed to pile up below and around the belt and belt structure, and along portions of ribs that were not cleaned up during initial development. Examples of this are shown in Figures 8 and 9. The size and number of these accumulations demonstrate that the hazards existed for a long period of time.

Figure 8. Accumulations of loose coal with the top of the pile flattened due to rubbing the moving belt.

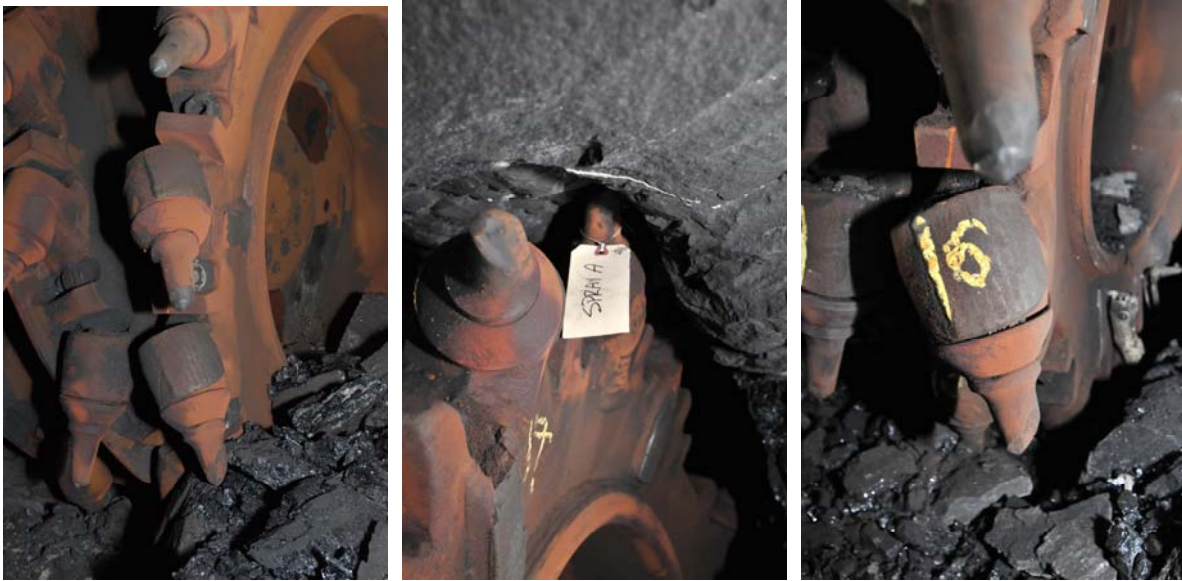
During the underground investigation, MSHA found that at least two cutting bits on the tail drum showed signs of excessive wear, including total erosion of the carbide tip and a large wear flat developed in the steel shank. One such bit is shown in Figure 30. Bits with large wear flats worn down to the steel shank striking quartz-rich sandstone, which is characterized by a high incensive potential, represents the most likely source of the initial methane ignition. While only a few bits were worn to the steel shank, one worn bit can provide an ignition source.

Figure 30. 1 North Panel tailgate drum, showing configuration of water sprays used in the pick-point flushing system. Note that sprays are directed toward the front of the bits, one missing water spray, and two bits exhibiting extreme wear.
