Upper Big Branch Mine–South Mine ID: 46-08436

April 5, 2010 Accident

Final Report

December 6, 2011

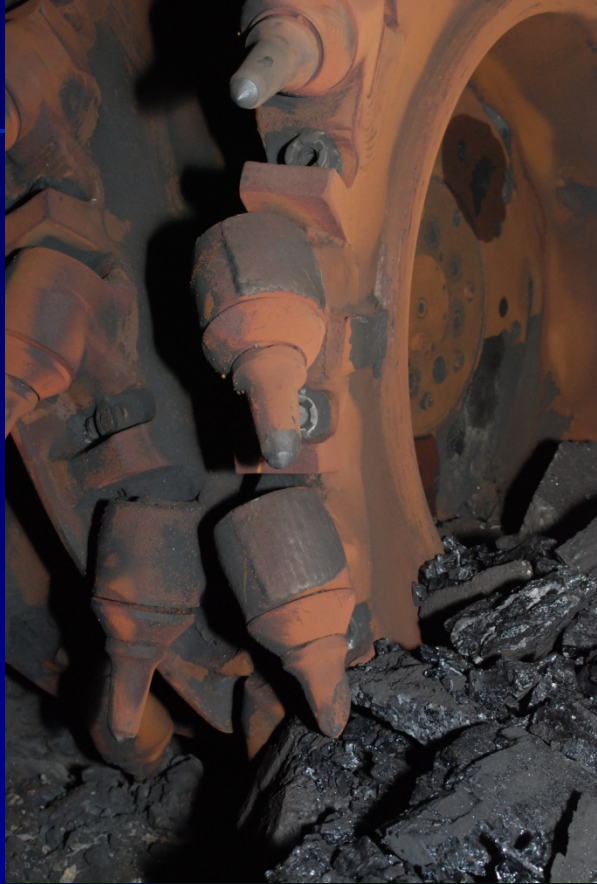
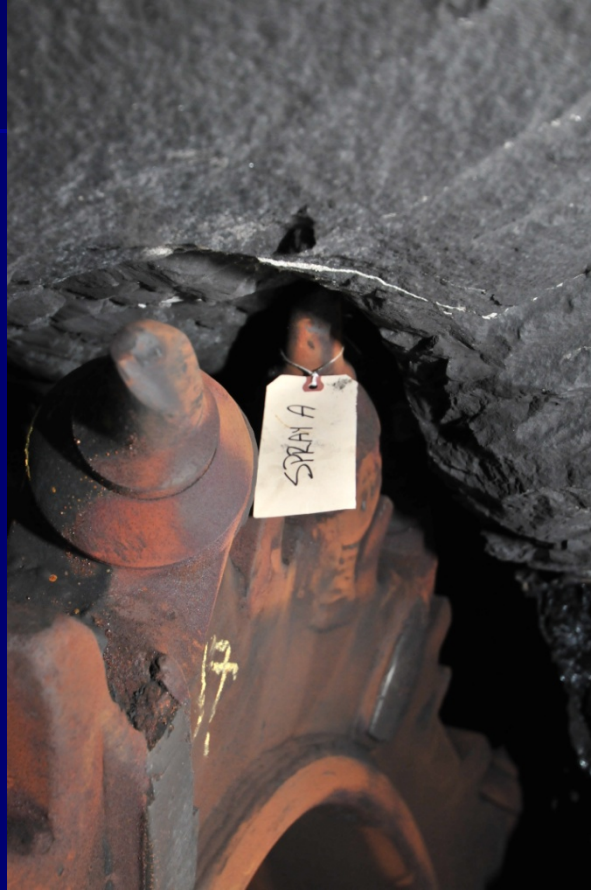
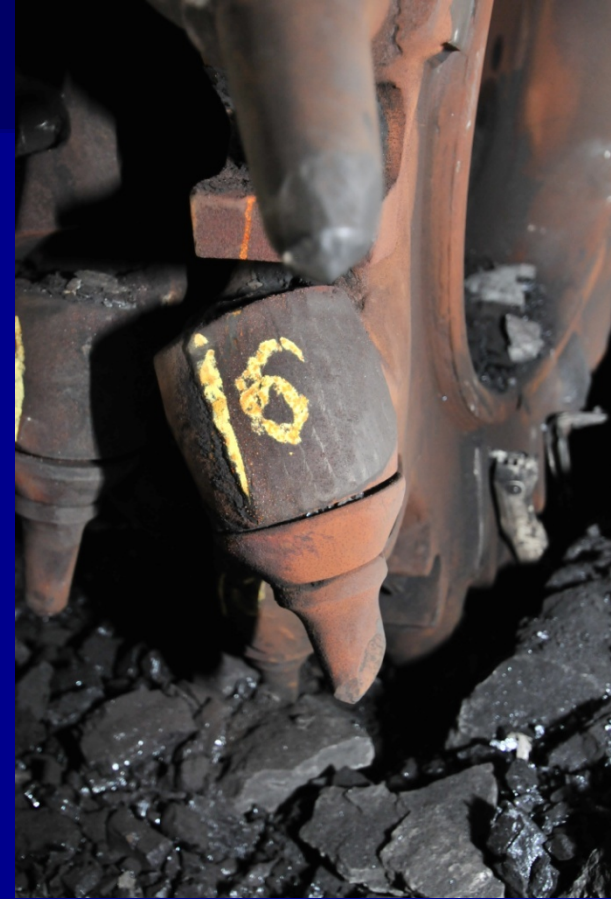
- PCC and Massey did not maintain the longwall shearer in a safe operating condition
 - 2 worn bits present on face ring of tail drum
 - Missing carbide tips on 2 bits

- 30 C.F.R. § 75.1725(a) (Operation and Maintenance of Equipment)
 - Failure to maintain longwall shearer in proper operating condition
 - Missing or worn bits

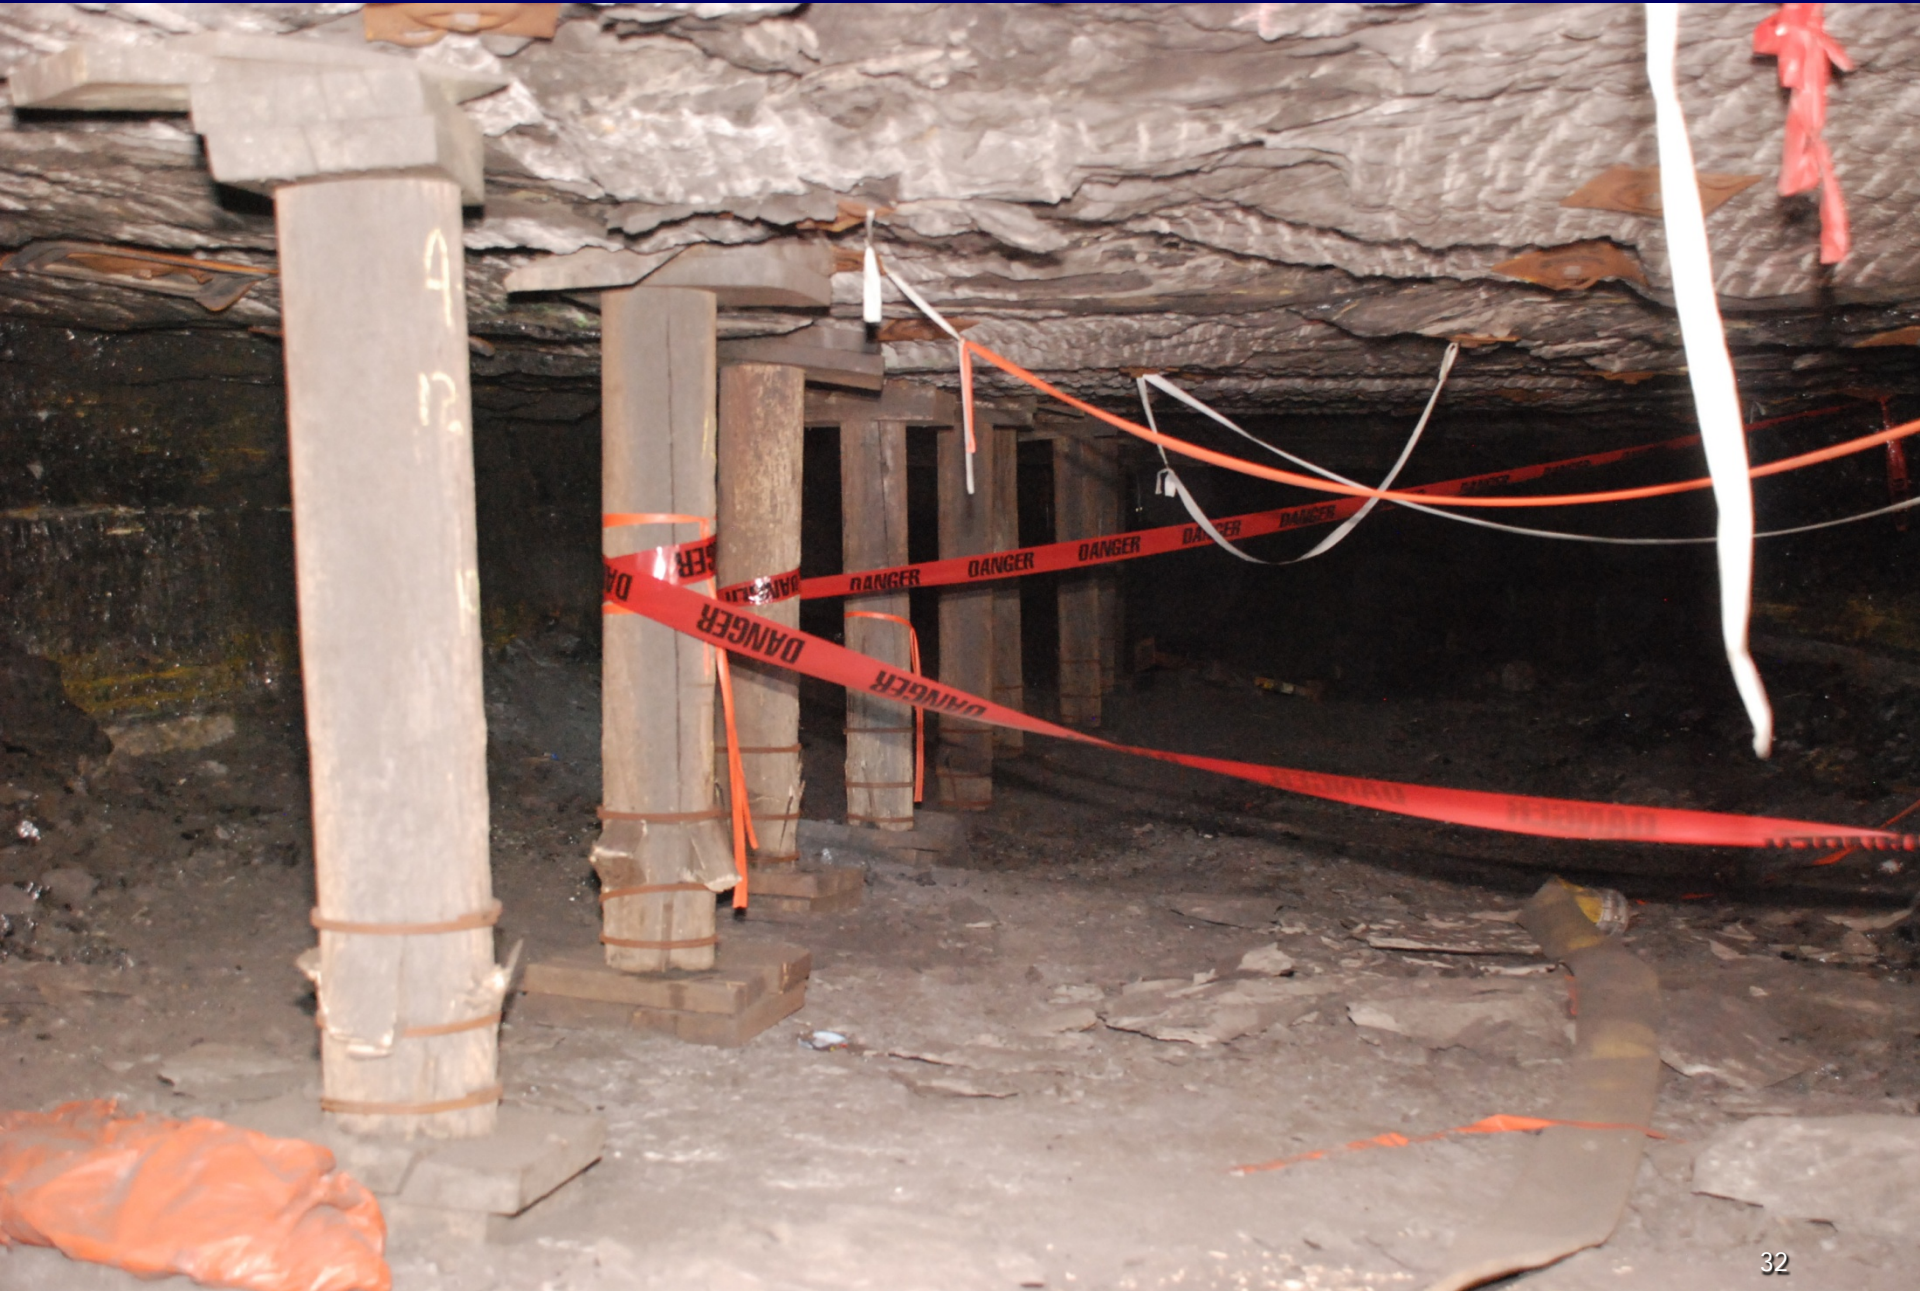
- PCC and Massey did not comply with the approved roof control plan
 - Required supplemental roof support in tailgate entry not installed according to plan requirements

- 30 C.F.R. § 75.220(a)(1) (Roof Control Plan)
 - Failure to provide 2 rows of supports in tailgate of longwall as required by the plan

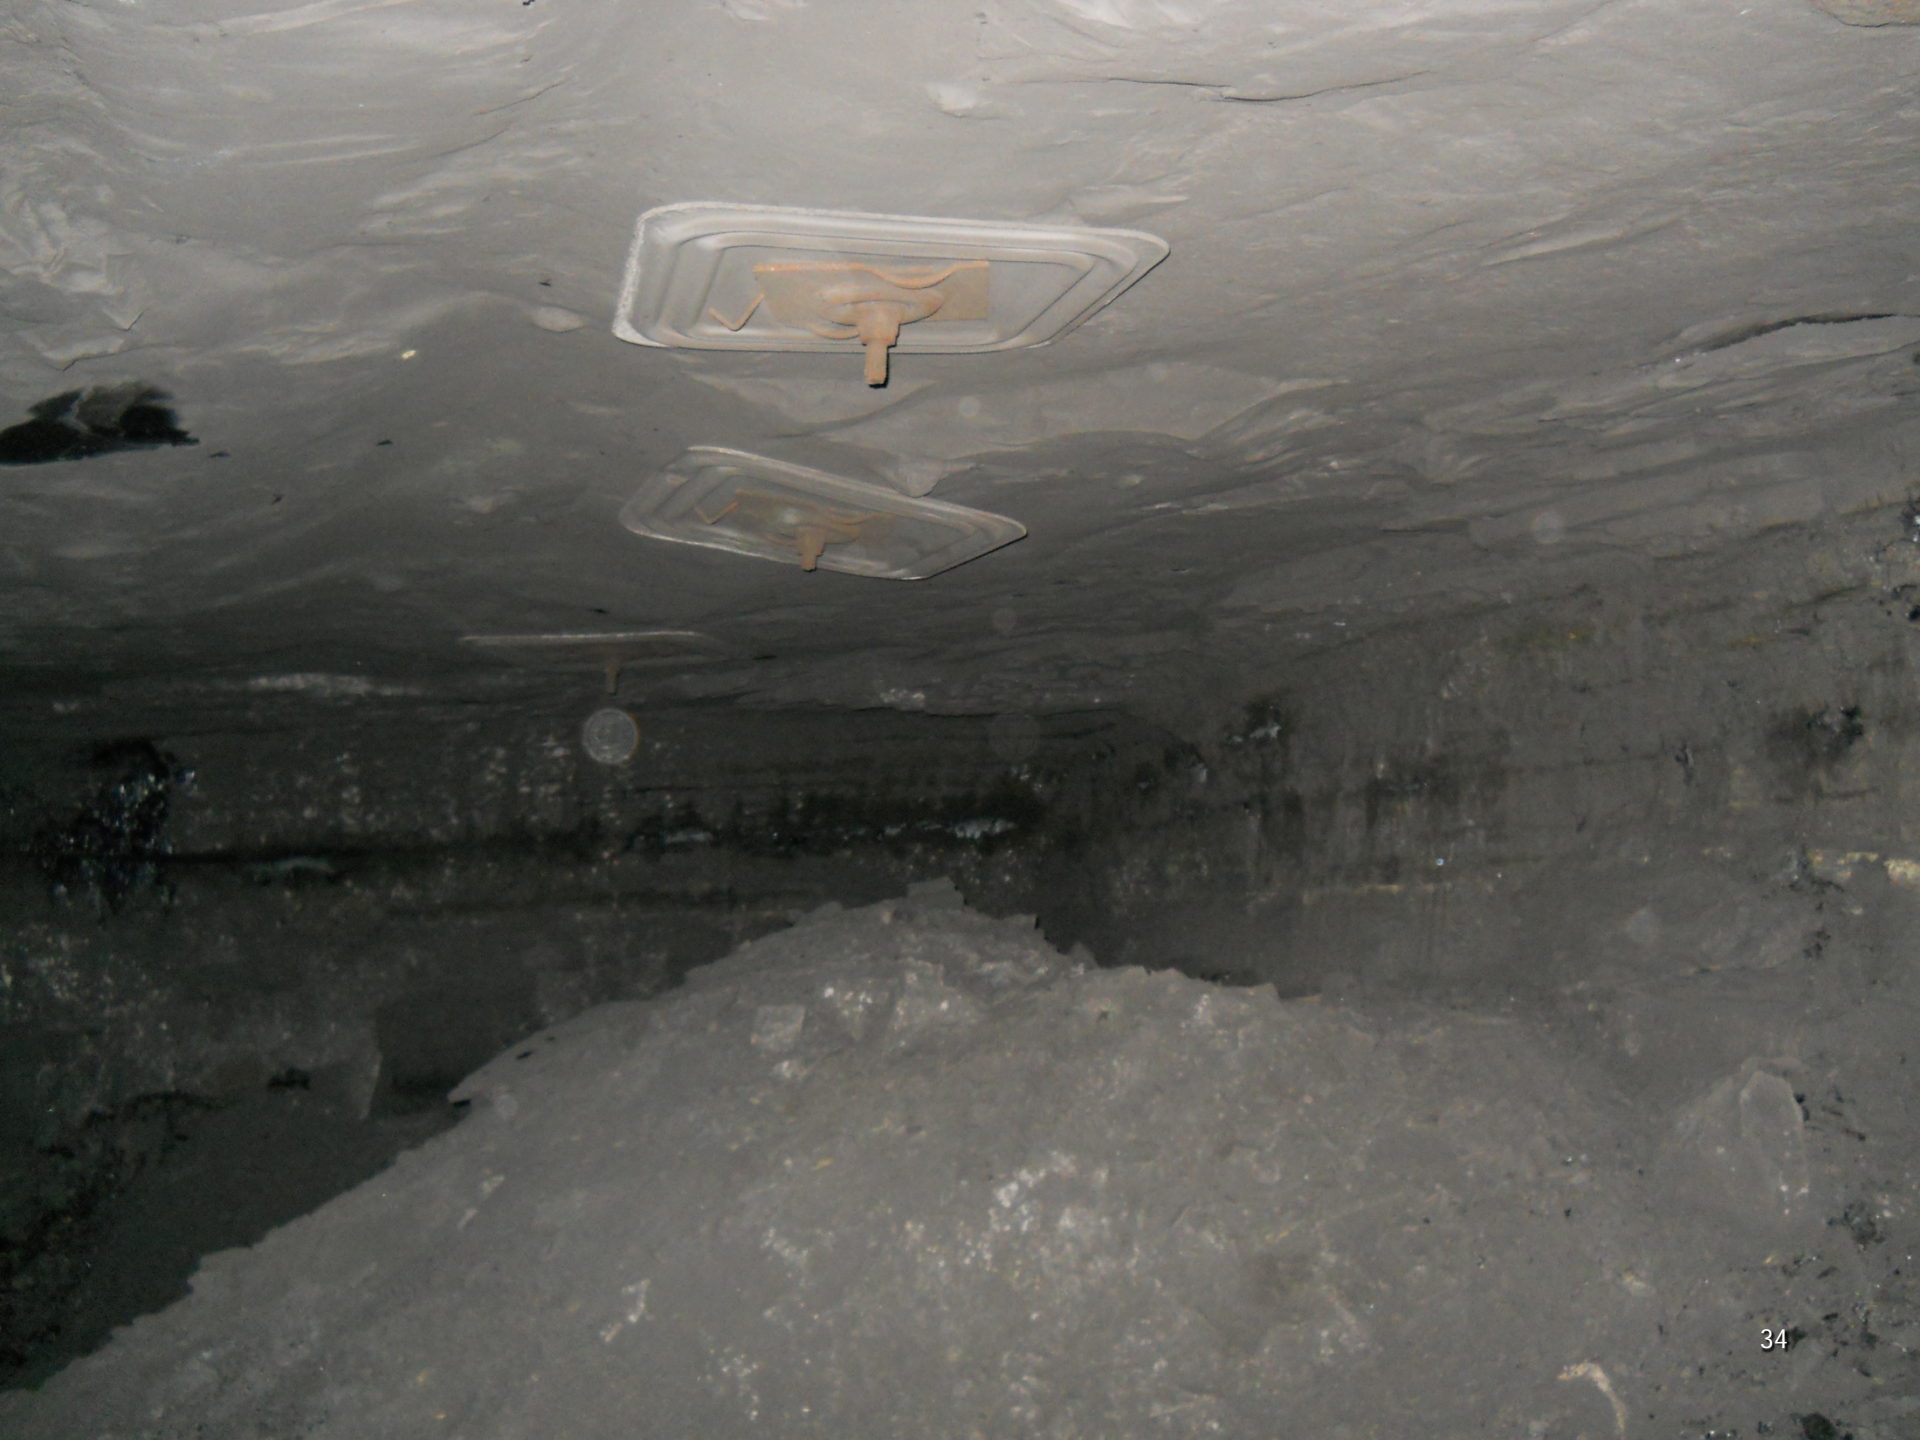
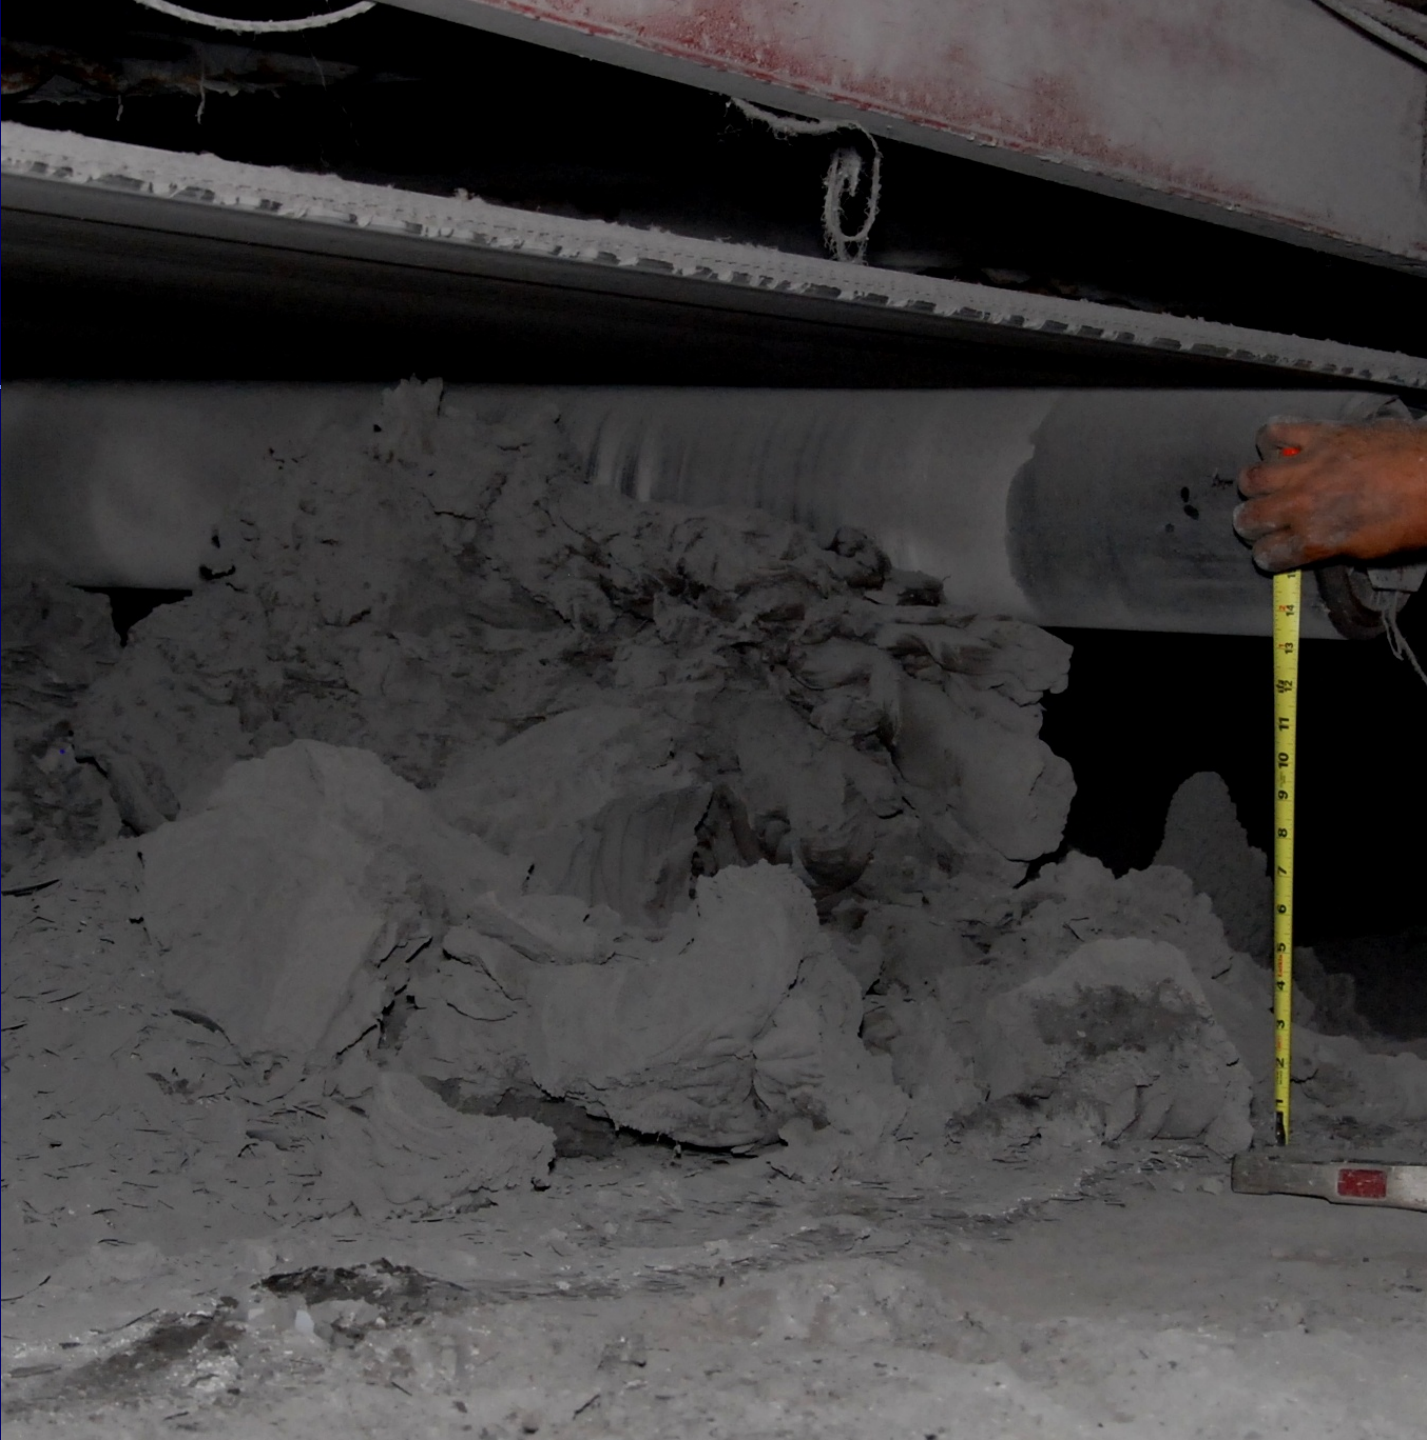
- PCC and Massey failed to ensure that accumulations of loose coal, coal dust and float coal dust were cleaned up and removed from mine

- 30 C.F.R. § 75.400 (Coal Accumulations)
 - Coal accumulations include float coal dust, coal dust, loose coal, and other combustible materials were not cleaned up and removed
