Upper Big Branch Mine—South

April 5, 2010 Accident

Final Report

December 6, 2011

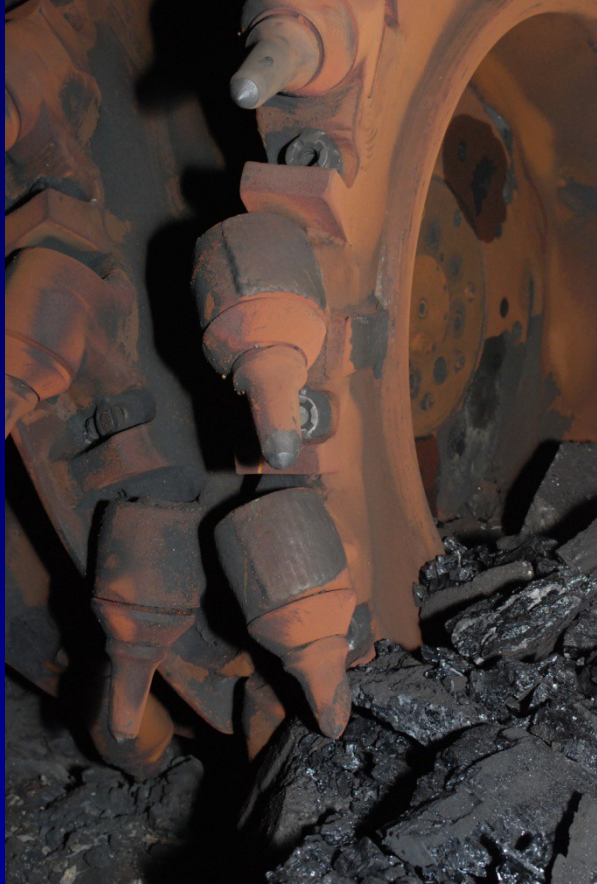
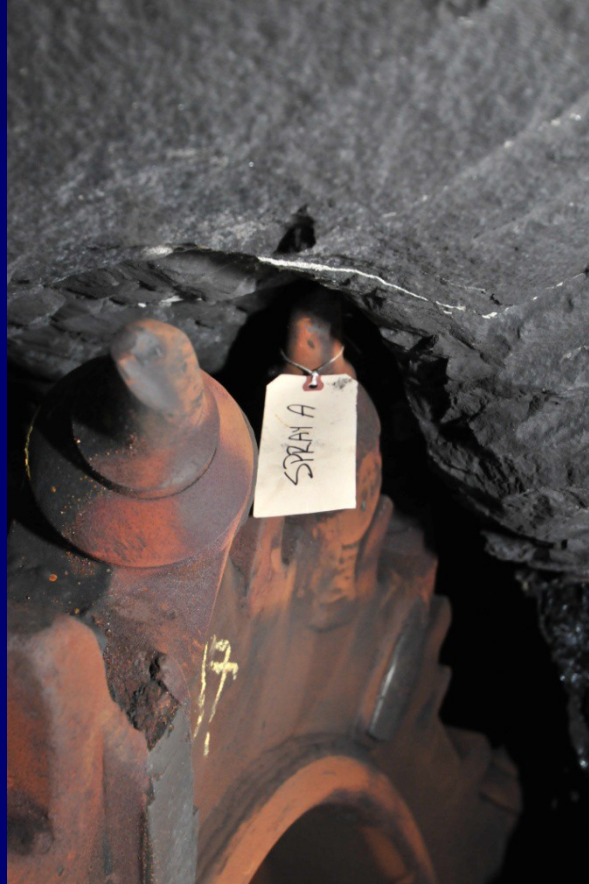
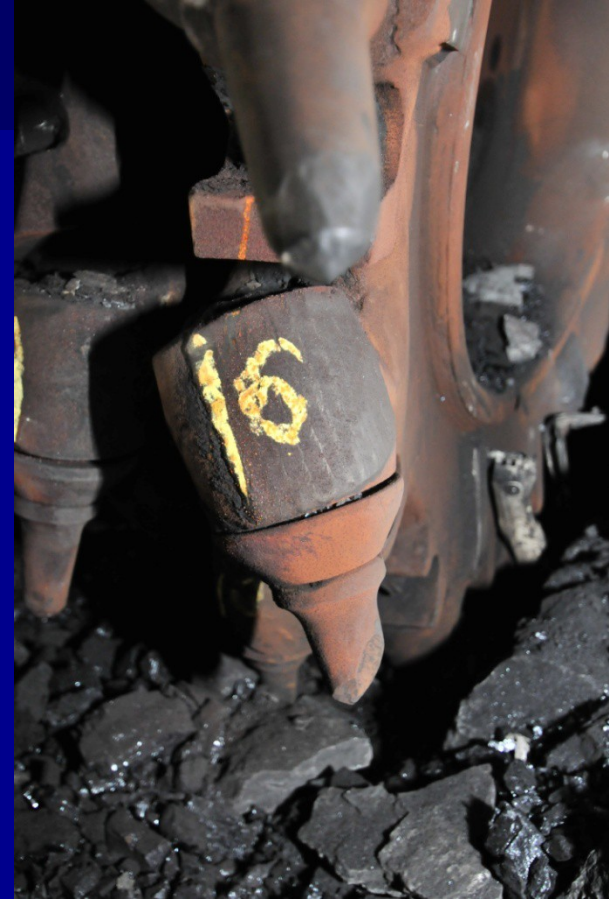
- PCC and Massey did not maintain the longwall shearer in a safe operating condition
 - 2 worn bits present on face ring of tail drum
 - Missing carbide tips on 2 bits

- 30 C.F.R. § 75.1725(a) (Operation and Maintenance of Equipment)
 - Failure to maintain longwall shearer in proper operating condition
 - Missing or worn bits

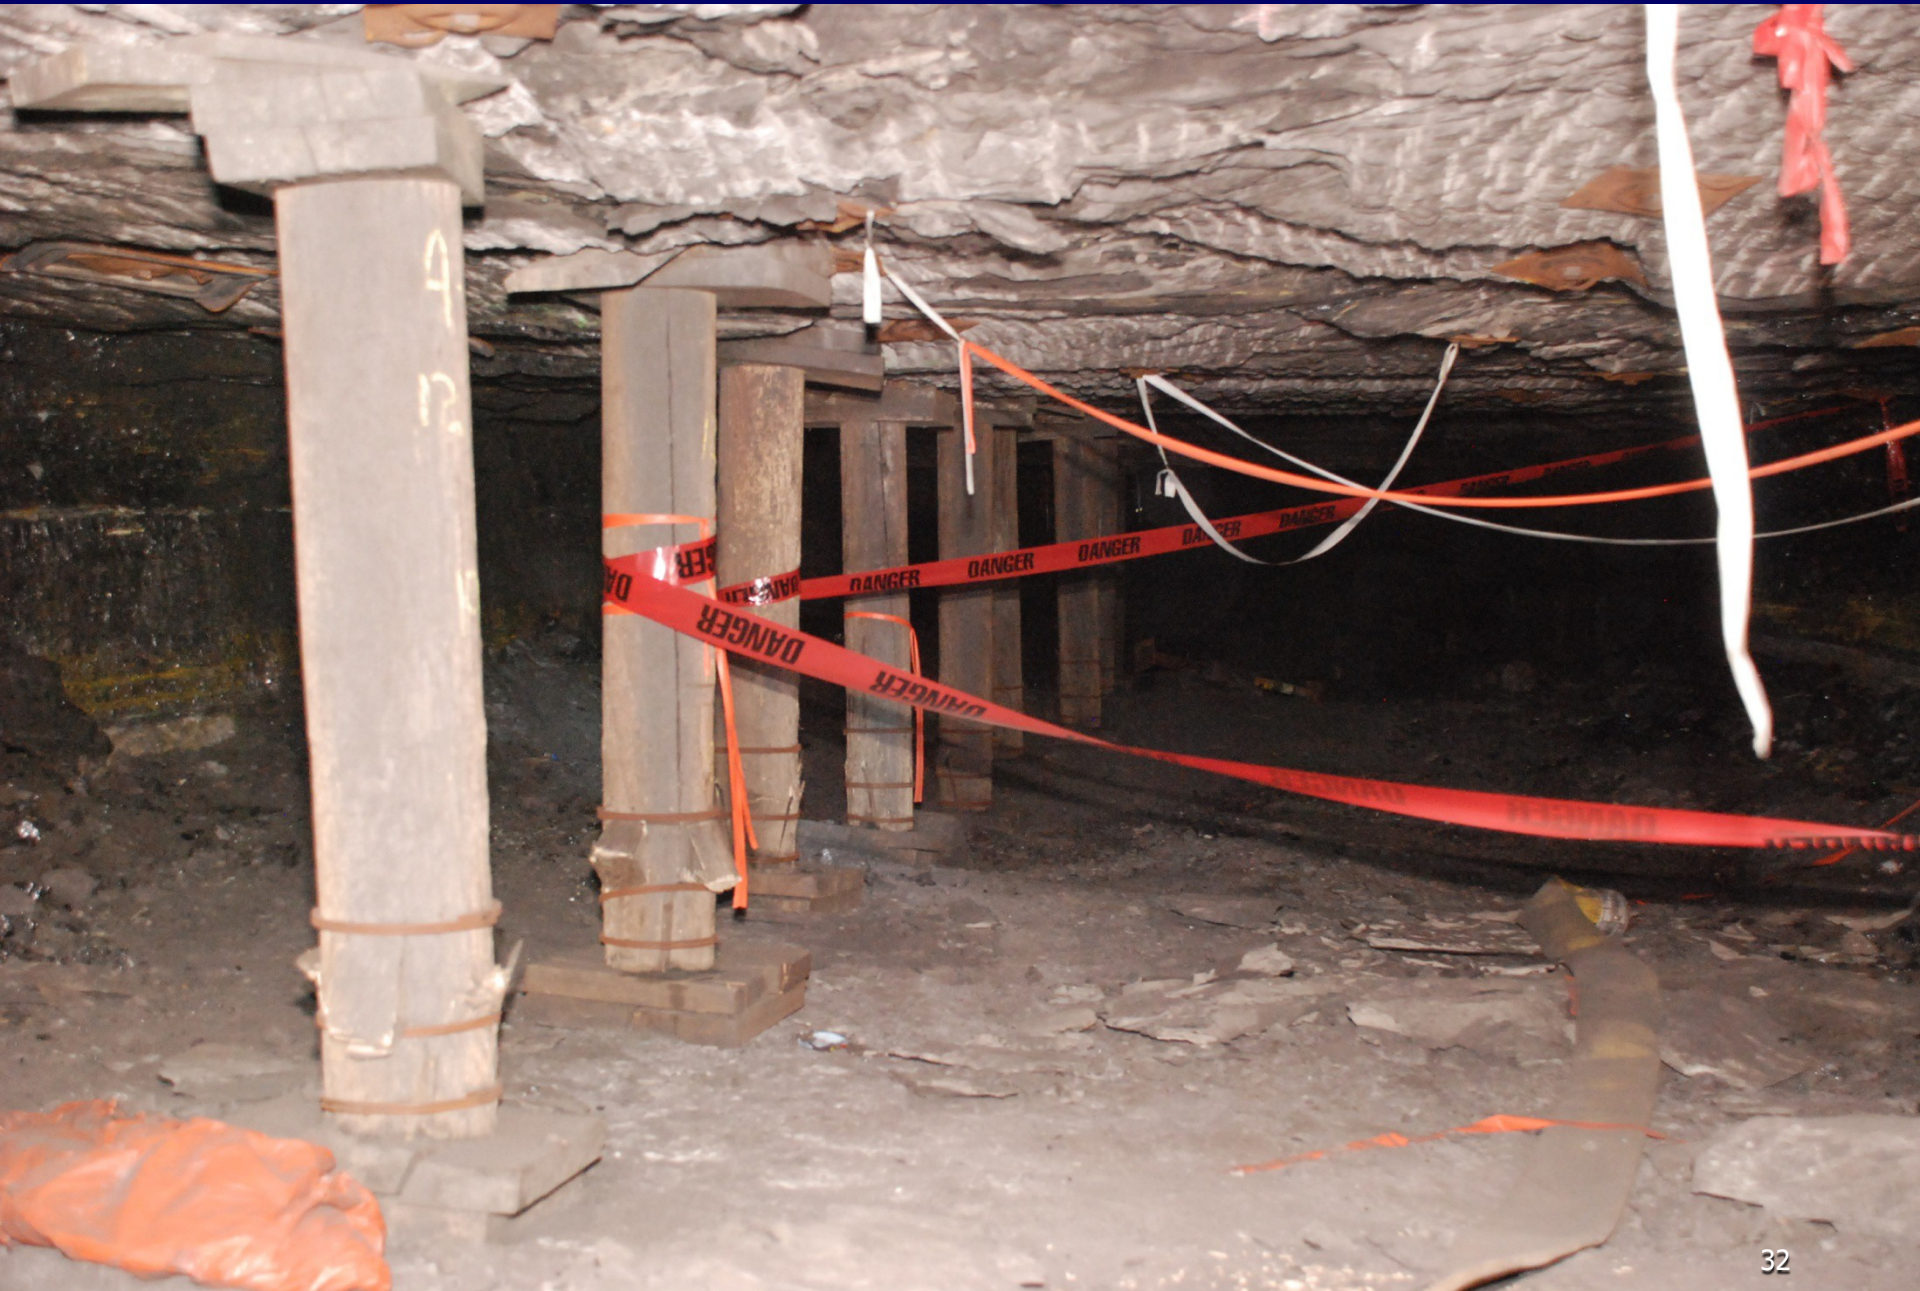
- PCC and Massey did not comply with the approved roof control plan
 - Required supplemental roof support in tailgate entry not installed according to plan requirements

- 30 C.F.R. § 75.220(a)(1) (Roof Control Plan)
 - Failure to provide 2 rows of supports in tailgate of longwall as required by the plan

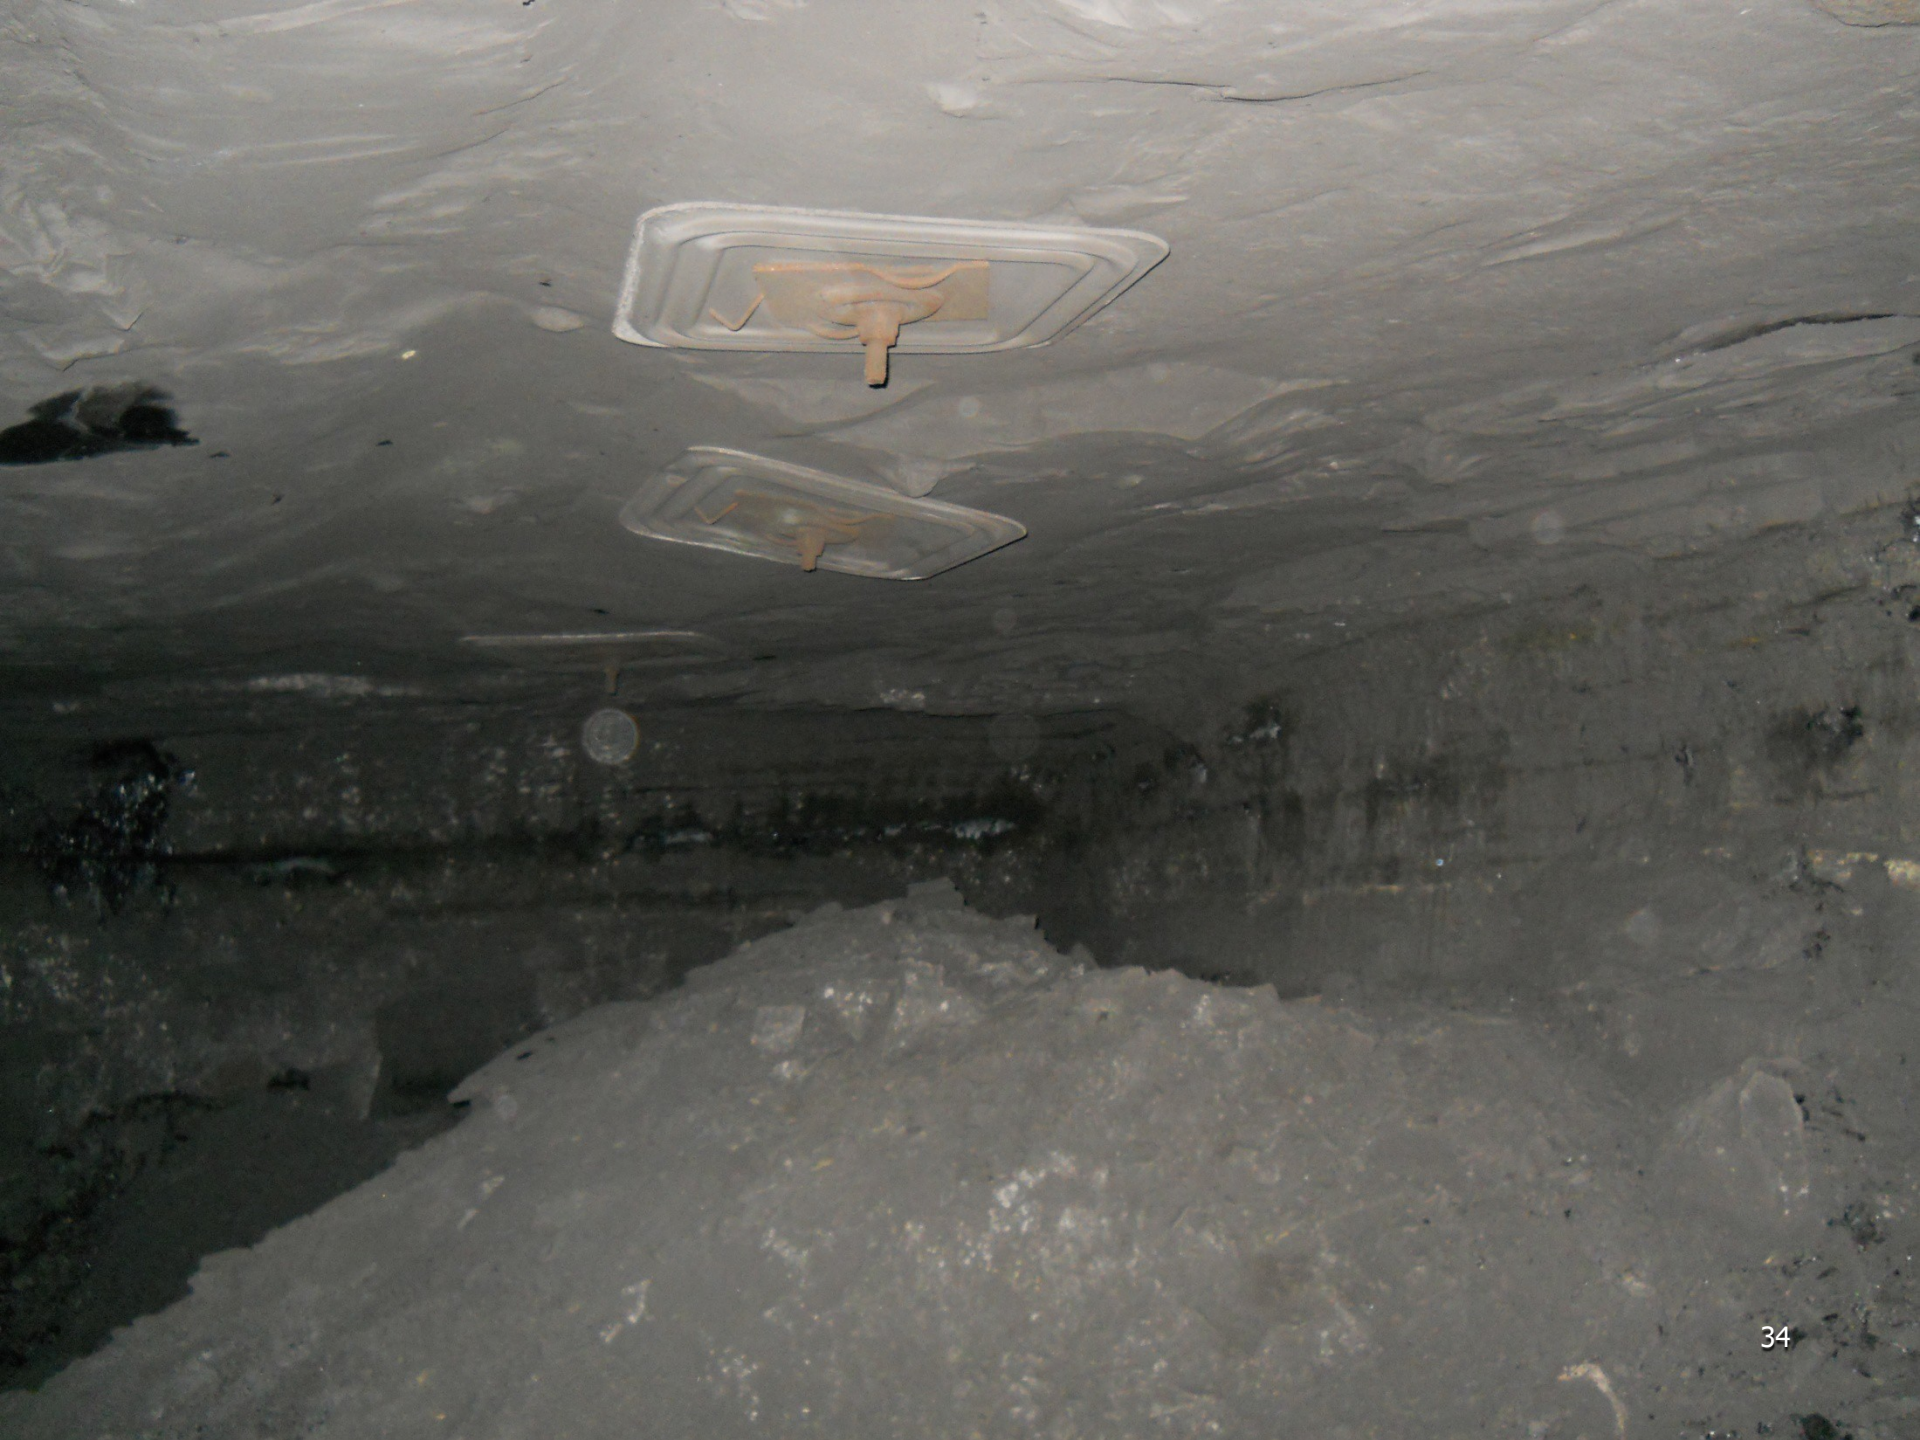
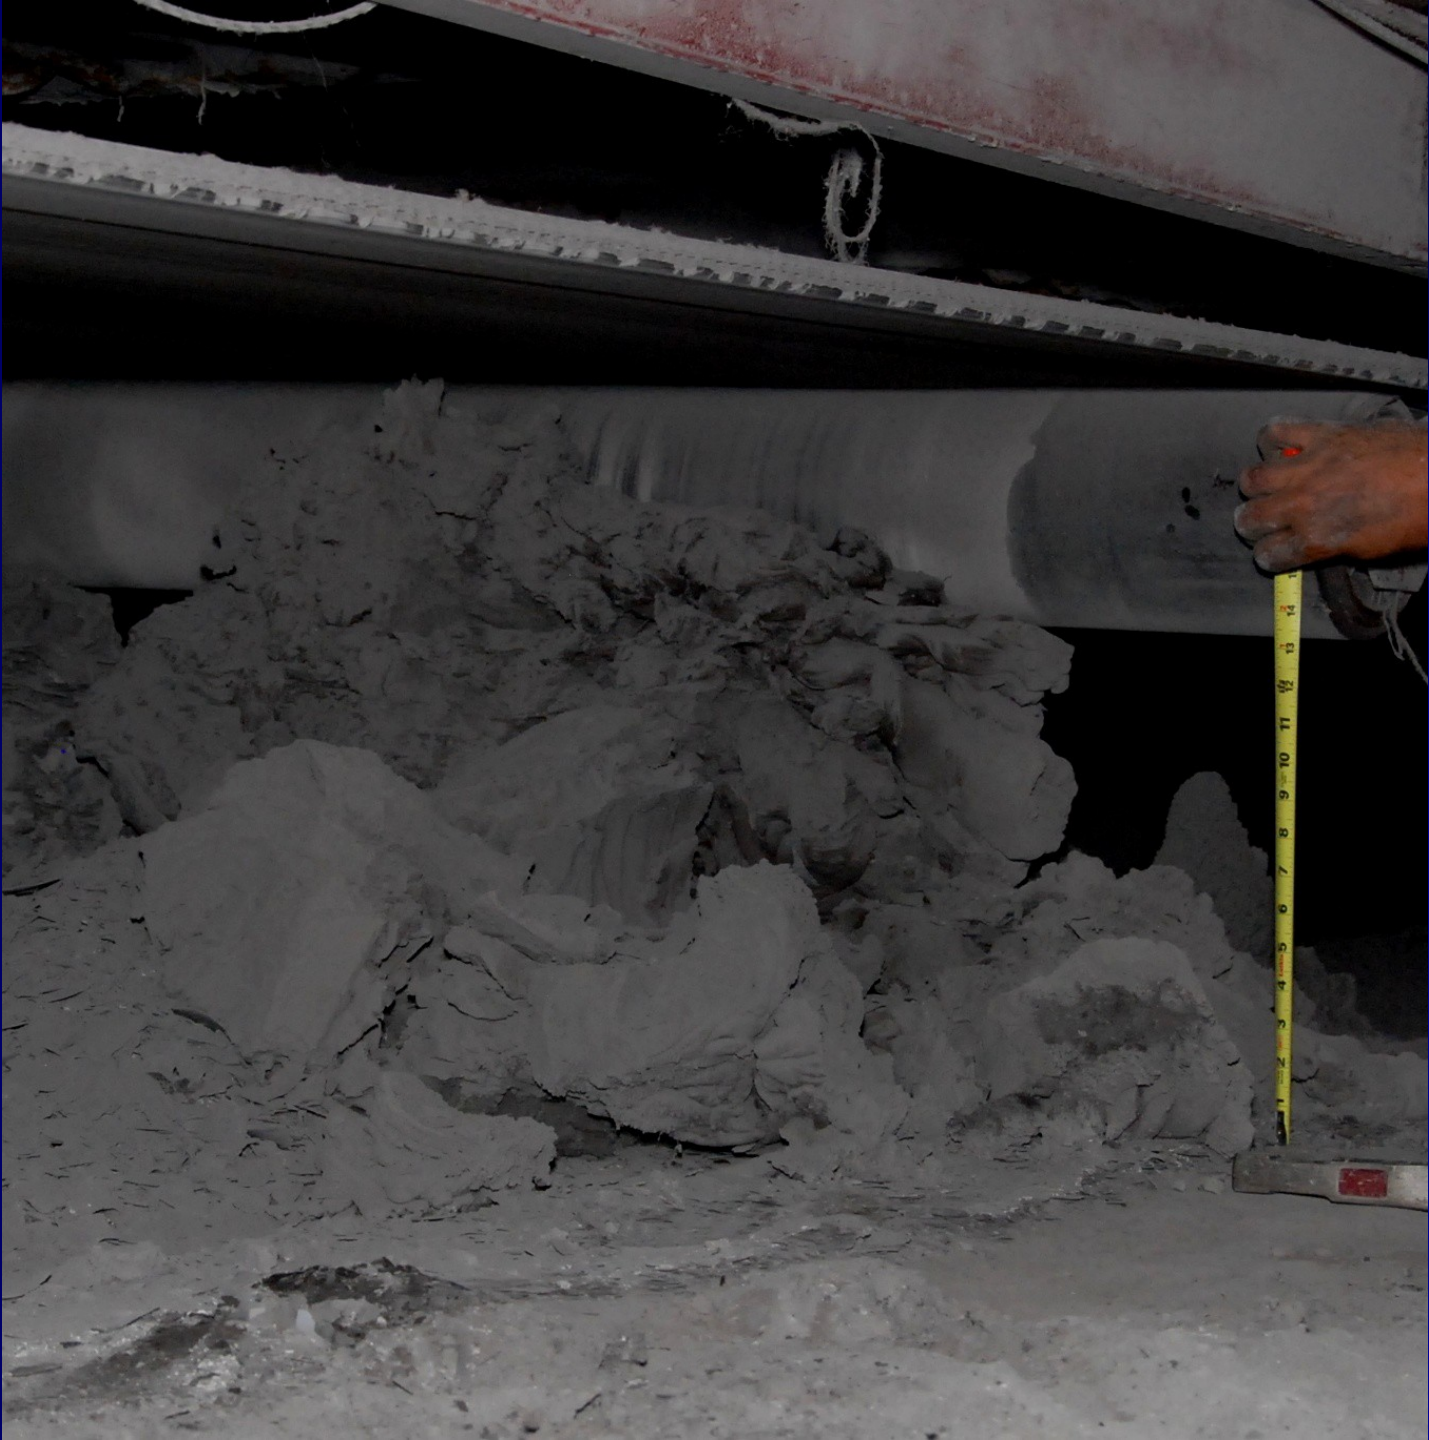
- PCC and Massey failed to ensure that accumulations of loose coal, coal dust and float coal dust were cleaned up and removed from mine

- 30 C.F.R. § 75.400 (Coal Accumulations)
 - Coal accumulations include float coal dust, coal dust, loose coal, and other combustible materials were not cleaned up and removed
