REPORT OF INVESTIGATION

Surface Mine
(Barite and Calcium Carbonate)

Fatal Electrical Accident
November 23, 2020

Houston Plant
Excalibar Minerals LLC
Houston, Harris County, Texas
ID No. 41-04449

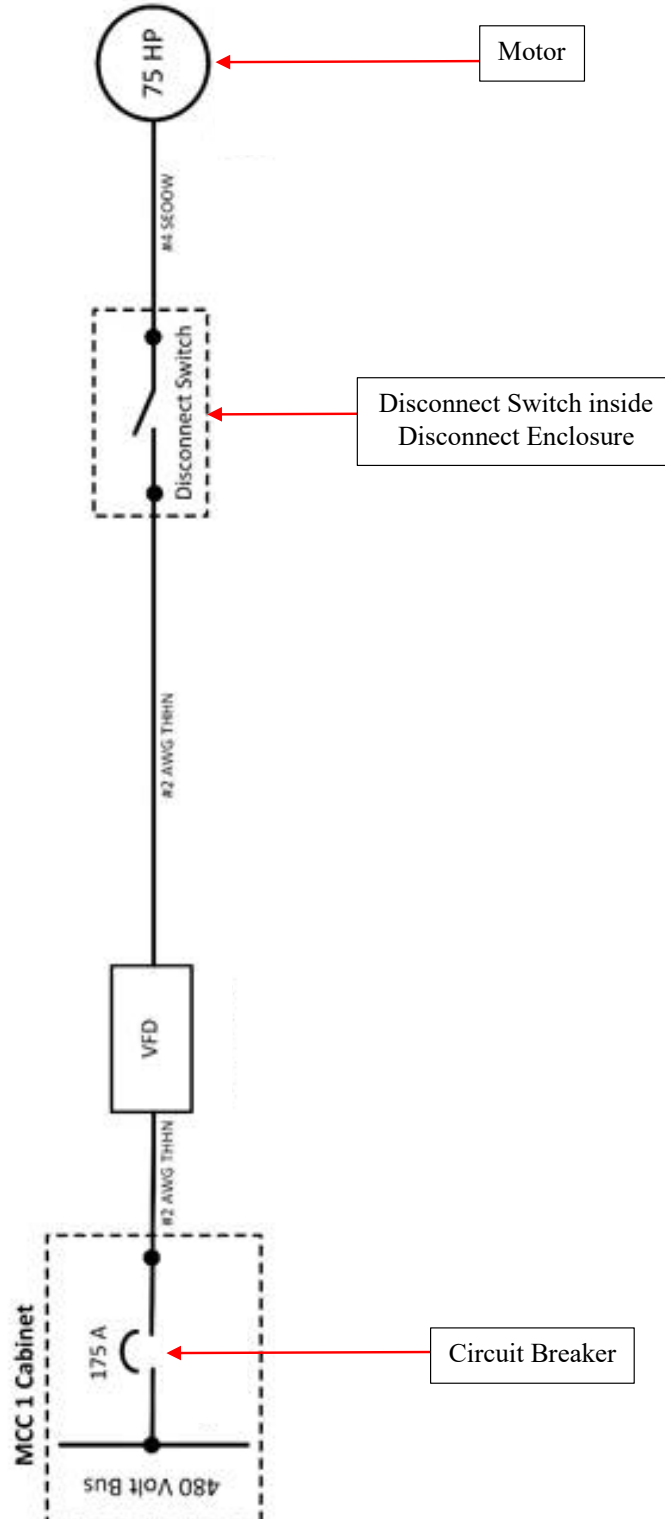
Appendix B

A transformer provides 480 VAC to a bus (common connection to which any number of loads are connected in parallel) in the MCC 1 cabinet. The circuit breaker provides electrical power to a VFD through a #2 American Wire Gauge Thermoplastic High Heat-resistant Nylon (AWG THHN) cable. The VFD provides electrical power to the disconnect switch in the disconnect enclosure through another #2 AWG THHN cable. The disconnect switch provides electrical power to the 75 horsepower motor. The disconnect switch is a 100 amp, 75 horsepower, heavy duty safety switch (Model 10), manufactured by General Electric (see Appendix B).

One Line Diagram of the Mill 1 Classifier Motor Circuit

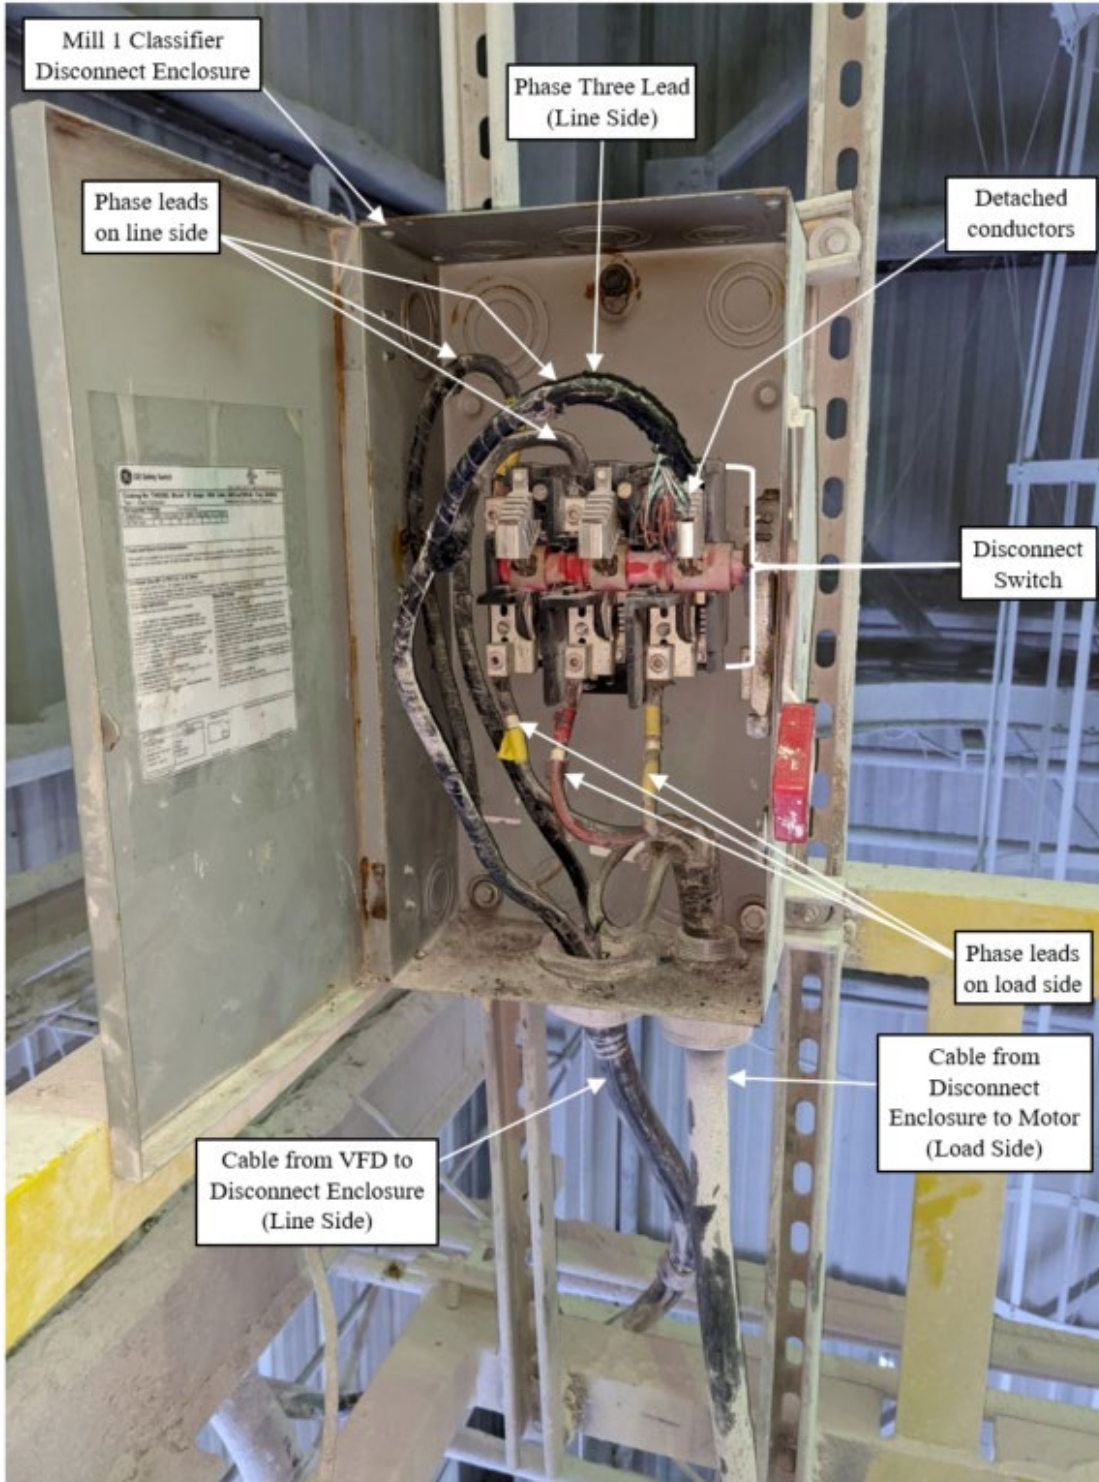
Appendix C

Investigators found severe heat damage inside the disconnect enclosure. The damage was on the disconnect switch and phase leads for the cable from the VFD (see Appendices C and D). The heat damage was particularly evident on the phase three lead and the location (terminal lug) where this lead was connected to the disconnect switch. MSHA concluded the damage was most likely the result of a poor connection in which the terminal lug was either not sufficiently tightened, or the phase three lead conductor was improperly inserted into the terminal lug. None of the other terminal lugs on the disconnect switch were sufficiently tightened to the torque specified by the manufacturer. The heat damage and improper connections indicated that routine maintenance being performed did not include cleaning, checking connections, and thermal scanning of electrical systems.

Investigators found a significant amount of electrical tape on the three phase leads on the line side of the disconnect switch. Heat damage was present on part of the electrical tape. All persons interviewed stated they had no knowledge of who applied the electrical tape.

Photograph of the Disconnect Enclosure and Switch

Corrective Action: The mine operator implemented a written plan to have an electrical contractor: 1) install new electrical components with proper ratings and current carrying capacities, 2) assure phase leads are properly connected, and 3) assure motors are provided with proper overload protection. The mine operator implemented a written plan for routine cleaning and maintenance, including checking the torque of the connection lugs, condition of cables, and performing thermal scans of electrically powered equipment at the mine. The mine operator trained all supervisors and miners, who are responsible for electrical equipment, in the provisions of this plan.

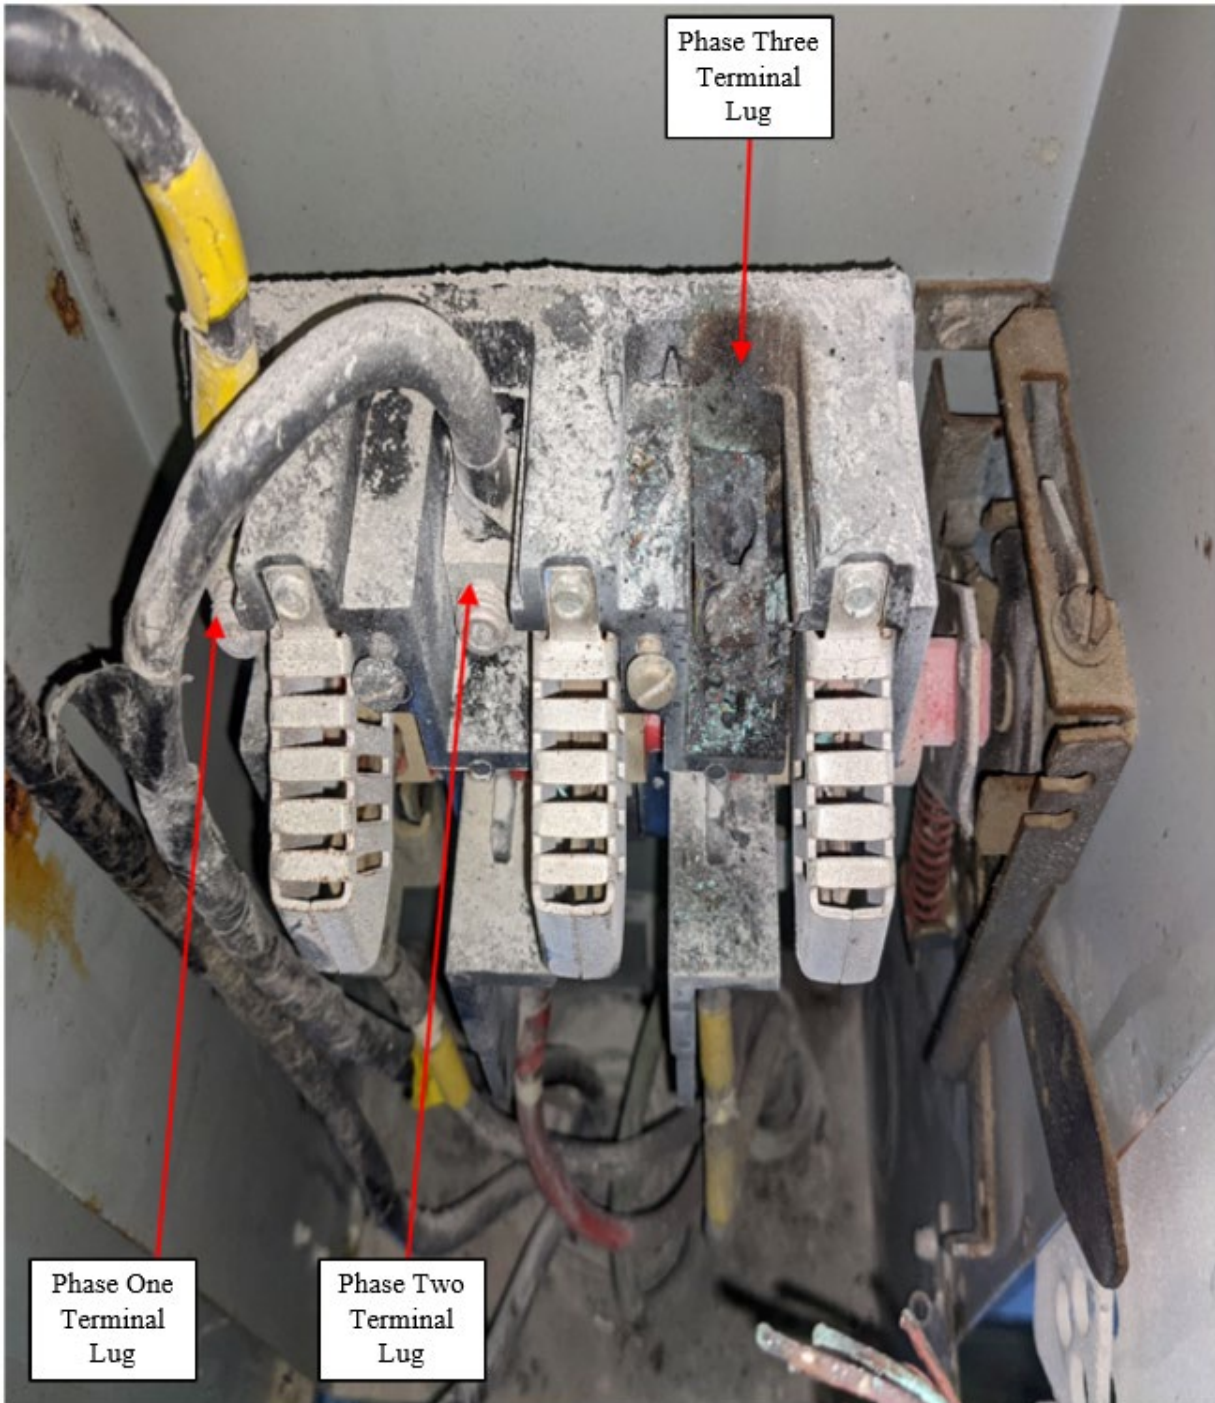
Appendix D

The damage was severe enough to cause the phase three conductor to completely detach from the terminal. Investigators concluded the detached end of this energized conductor was likely the component the victim contacted on the day of the accident.

Photograph of Damage to the Phase Three Line Side Connection Lug

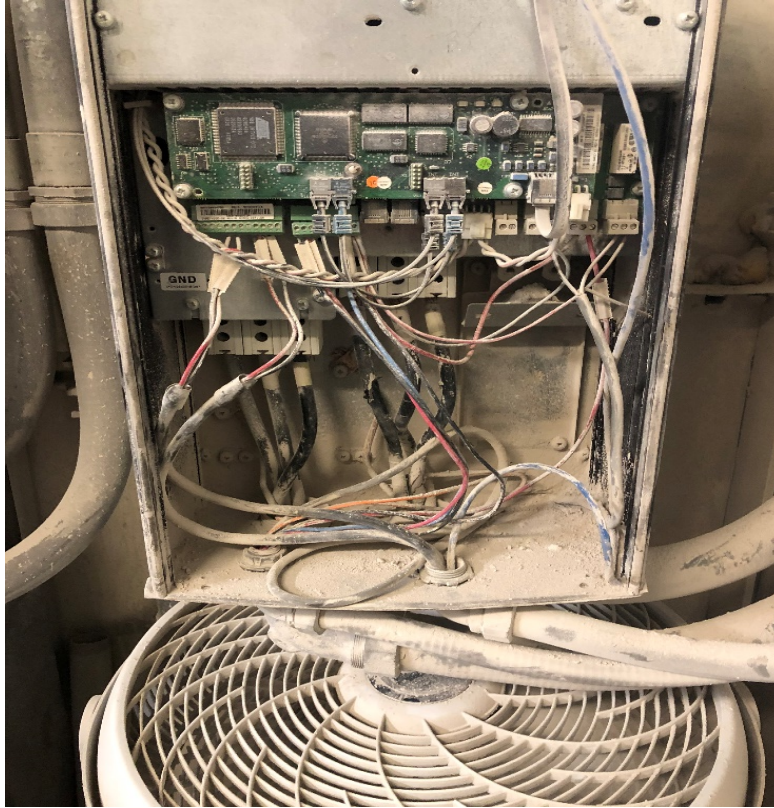
Appendix E

The mine operator did not provide overload protection for the Mill 1 Classifier motor circuit. The mine operator did not enable the motor overload protection feature of the VFD and did not provide any external means of overload protection (see Appendix E).

Photograph of the VFD for the Mill 1 Classifier Motor
