REPORT OF INVESTIGATION

Surface
(Construction Sand and Gravel)

Fatal Falling, Rolling, or Sliding Rock or Material of Any Kind Accident
August 18, 2020

HJ Hove
Hi-Grade Materials Co.
Robar Enterprises Inc
Indio, Riverside County, California
I.D. No. 04-01854

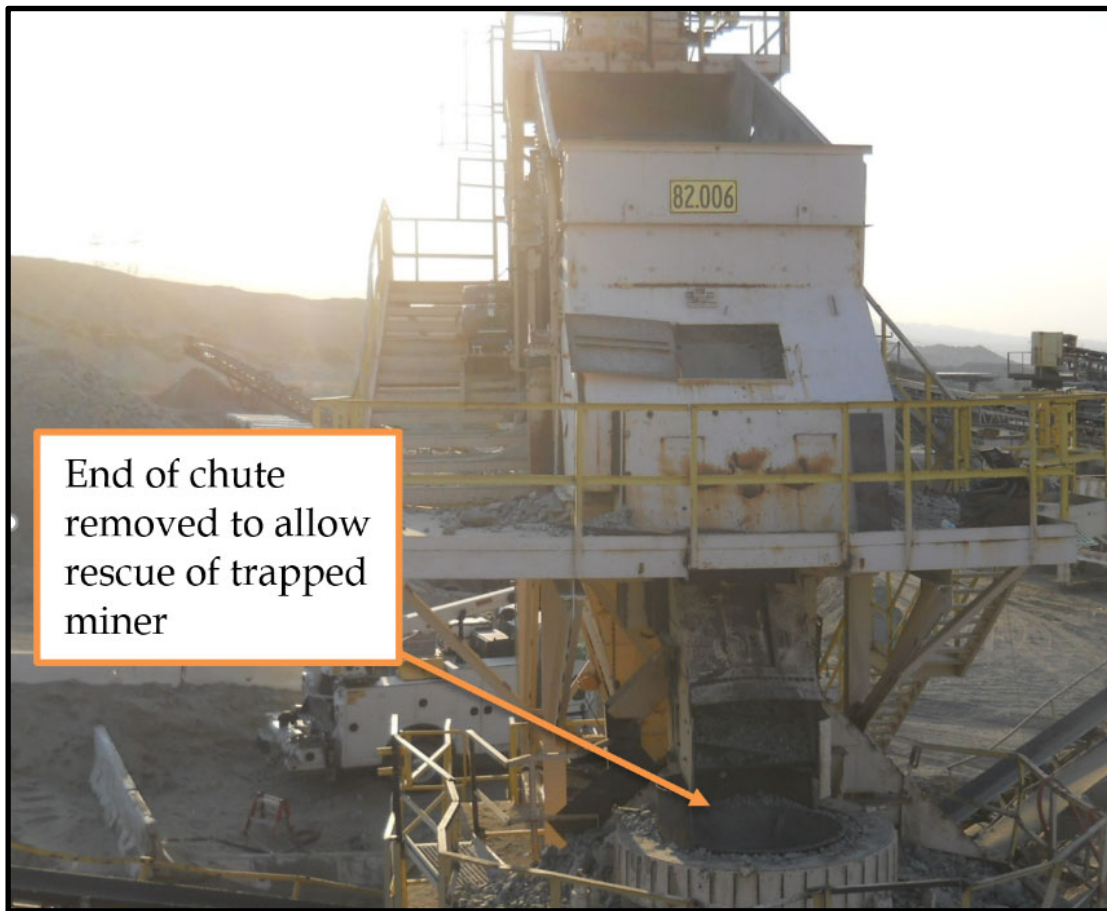
End of chute
removed to allow
rescue of trapped
miner

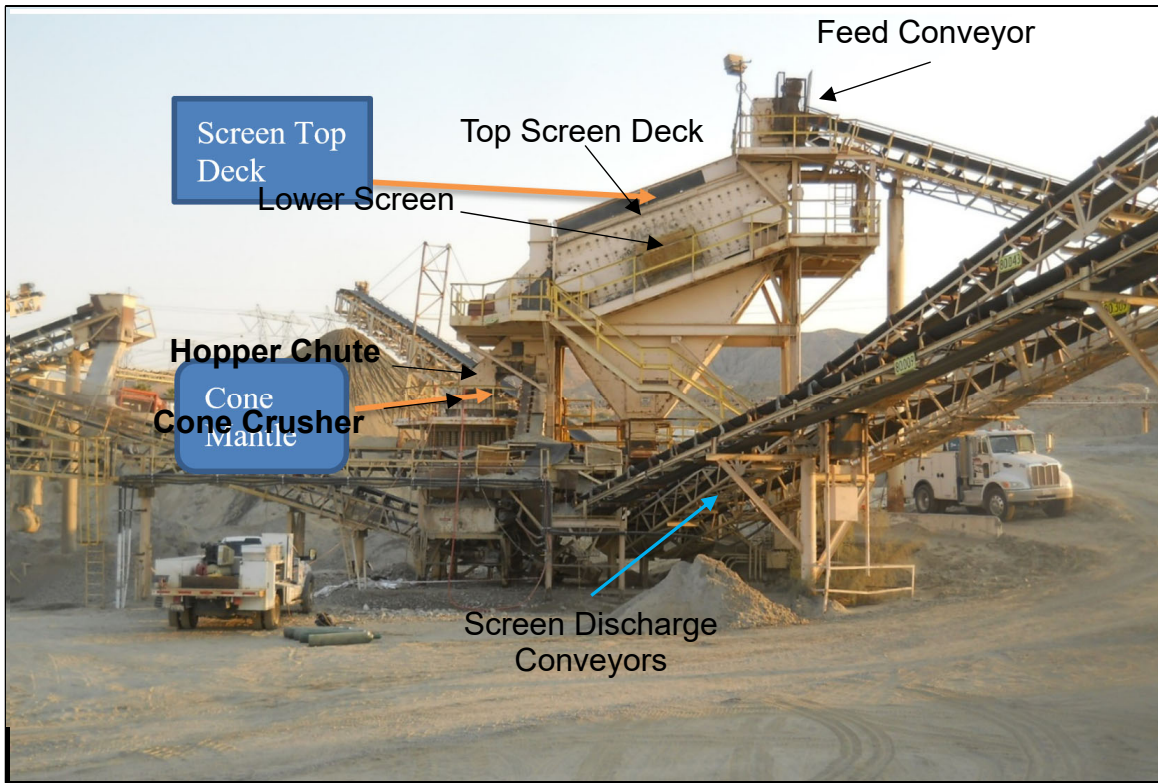
Appendix B
Side View of Plant

The accident occurred at the cone crusher, located roughly in the center of the plant near the stockpiles (see Appendix B).

Side view of the plant. The feed hopper had an estimated 12 ft. vertical drop from the top screen deck to cone crusher.

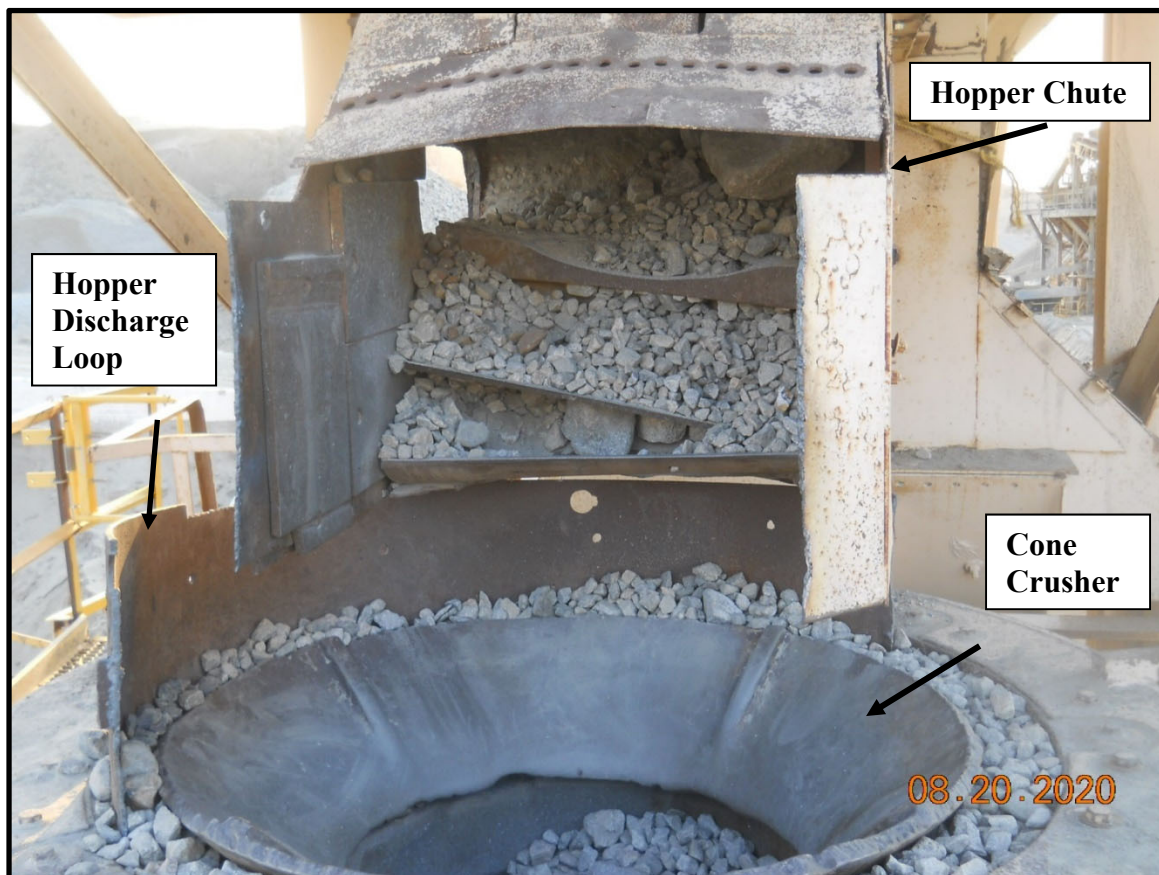
Appendix C
Scene of the Accident

A feed conveyor transports un-sized rock to a two-deck, TelSmith vibrating screen. The screen separates the rock into specific sizes. The top screen separates large rock, which moves through a hopper chute to the TelSmith D-style 66S cone crusher (see Appendix C). The bottom screen allows smaller sized rock to move through and drop onto conveyors for stockpiling. Prior blockages of material flow in the hopper chute and cone crusher had occurred frequently.

2. Root Cause: Mine management was aware of frequent material blockages in the hopper chute and cone crusher, and did not develop or implement measures to prevent blockages, nor did mine management provide safe points of access or safe procedures for clearing blockages when they occurred.

Part of the hopper discharge loop was removed during rescue operations.

Corrective Action: Hi-Grade Materials Co. analyzed the material flow through the hopper chute and cone crusher and made adjustments to allow the material to flow more freely. The company also modified access to the cone crusher to allow safe removal of blockages and has provided tools and PPE for use in such instances. The mine operator has trained all miners on the modified process, tools, and PPE.
