REPORT OF INVESTIGATION

Fatal Machinery Accident
August 21, 2020

Moore Quarry
Martin Marietta Materials Inc.
Gilmore City, Pocahontas County, Iowa
ID No. 13-02188

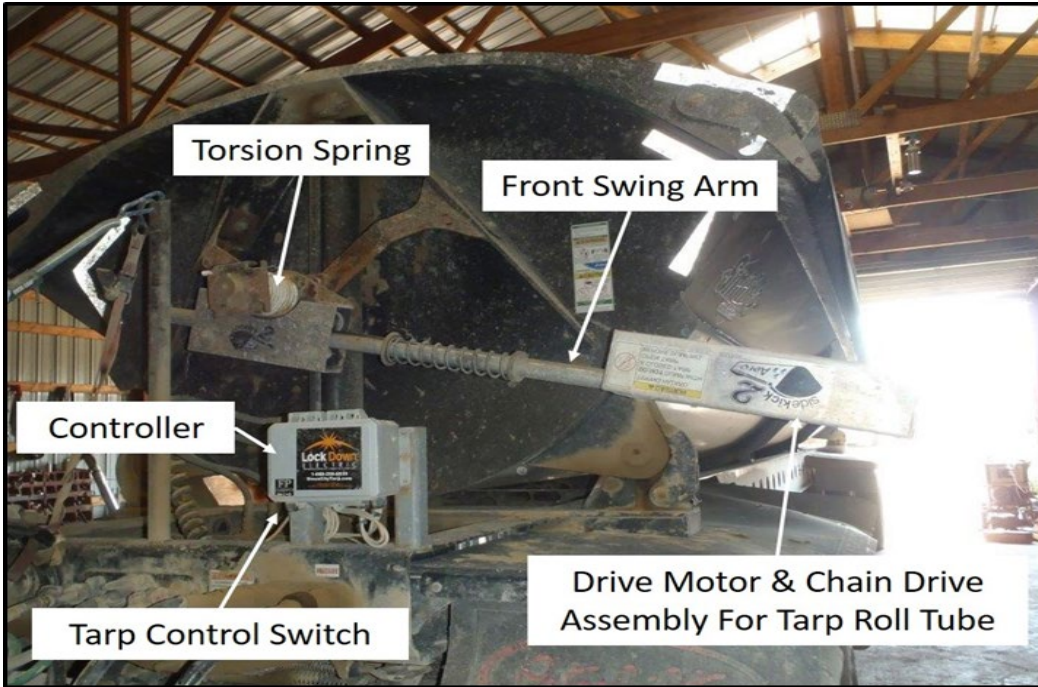
APPENDIX B
Tarp System Controls

After arriving in the designated tarping area, Dose exited the cab of the truck and initiated the trailer's Side Kick 2 tarp system near the front of the side dump trailer (see Appendix B) and walked along the driver's side of the dump trailer toward the trailer axel area (see Appendix C).

The tarp controller and control switch that control the direction of travel of the tarp system are located on the frame of the trailer's tongue (see Appendix B). The tarp controller allows the tarp system to continue to extend/retract without constant pressure applied to the control switch. Once the tarp system fully extends or retracts, the controller automatically switches to the off position.

Investigators determined that a non-automatic tarp control switch was initially installed inside the cab of the truck, but was replaced with an automatic-type controller with a built-in switch and repositioned to the frame of the trailer's tongue to enable this trailer to be attached to other trucks. The original non-automatic switch required constant pressure to be applied by the driver to extend or retract the tarp system.

Corrective Action: The owner is installing a switch that requires the driver to provide constant pressure to extend or retract the tarp system. The owner is also implementing a policy that requires persons walking or working near the trailer to wear hard hats, and is training persons not to enter the hazardous area while the tarp system is being extended or retracted. Furthermore, the owner is also placing signs at the end of each trailer that warn of potential struck-by hazards.

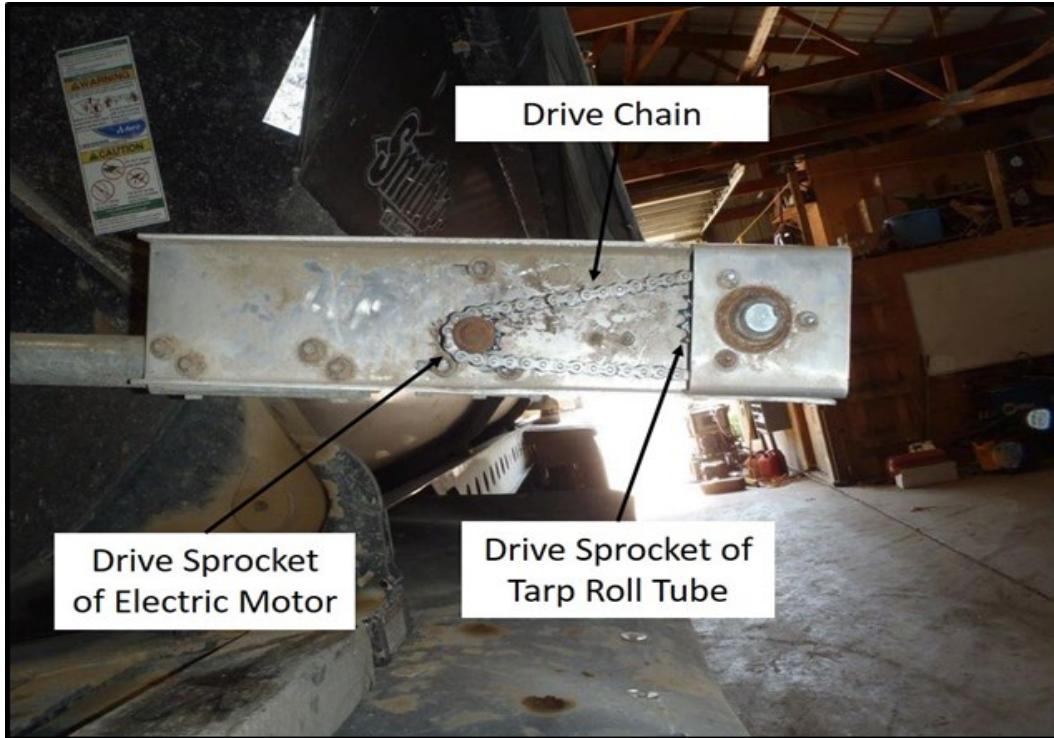
APPENDIX D
Drive Box Unit Assembly

As the Side Kick 2 tarp system deployed, the tarp's roller chain that restricts the speed of deploying the system with spring tension, came off the sprockets (see Appendix D). This allowed the tension of the swing arms torsion springs to release (see Appendix E) and allowed the roll tube to deploy uncontrollably and strike Dose in the head.

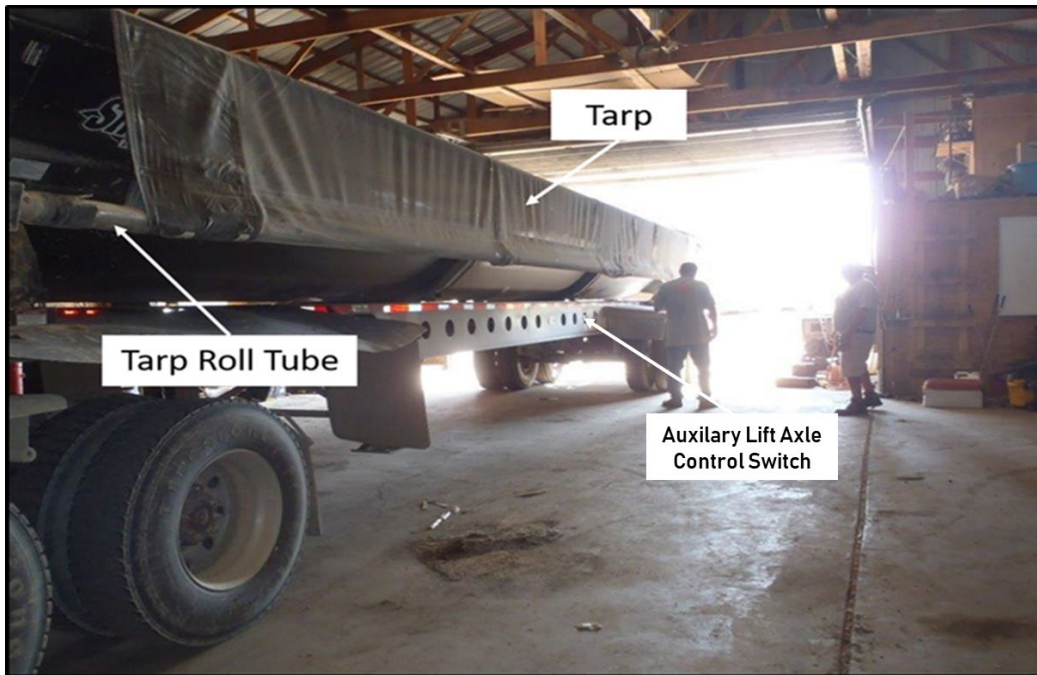
APPENDIX E
Roll Tube in the Fully-Opened Position with the Tarp Hanging Loosely

On August 21, 2020, at approximately 10:30 a.m., Nutrien Ag Solutions sent two truck drivers to the mine to pick up the victim's tractor-trailer. They found the tarp hanging loosely over the driver's side of the trailer and not rolled back to the tightened transport position. Ryan Hemer and Brady Pudenz, Truck Drivers, activated the truck's tarp system. Hemer and Pudenz both stated that the tarp system "made noise but did not move the tarp." Before moving the truck, Hemer and Pudenz removed the cover off the drive box and found the chain had slipped off the roll tube drive sprocket. They reinstalled the chain so the tarp could be rolled back to the tightened transport position. Hemer drove the truck off the mine site that day at approximately 10:45 a.m.
