UNITED STATES  
DEPARTMENT OF LABOR  
MINE SAFETY AND HEALTH ADMINISTRATION

REPORT OF INVESTIGATION

Fatal Fall of Roof Accident  
December 14, 2020

Avery Island  
Cargill Deicing Technology  
Avery Island, Iberia County, Louisiana  
ID No. 16-00509

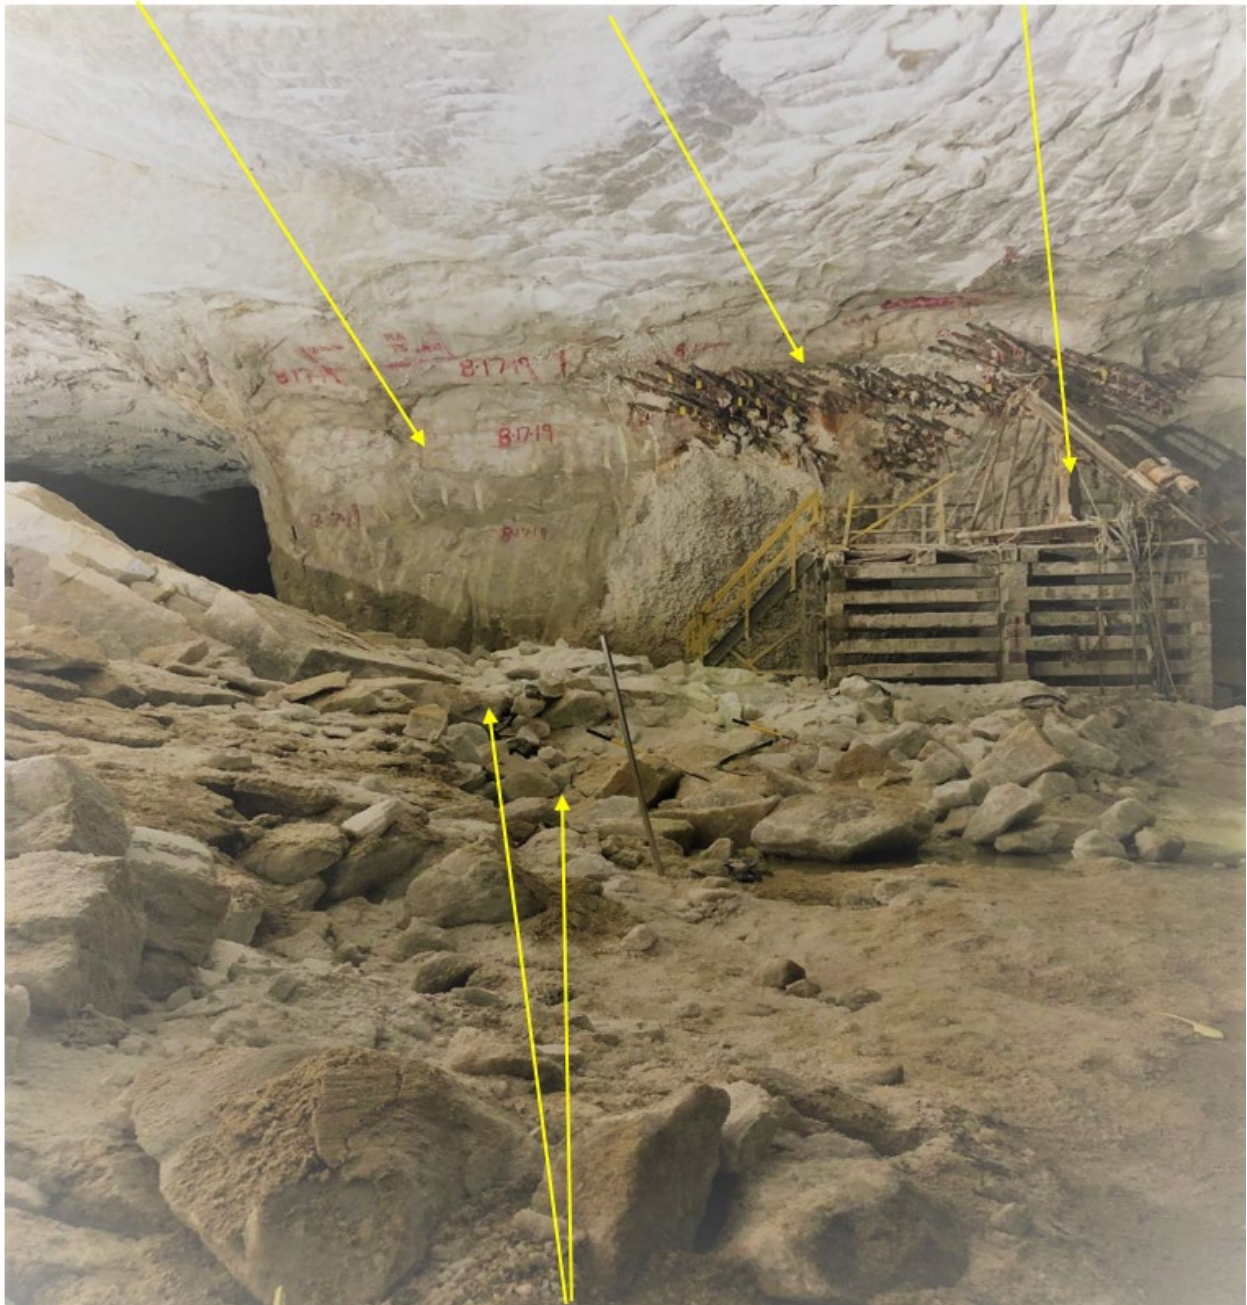
APPENDIX A – 1904 Drill Site

In September 2019, the mine operator installed a stationary Diamec U6 PHC (U6) drill at the 1904 drill site located in the I-13 room approximately ten feet east from the roof fall. The mine operator used the U6 drill to drill and inject grout into two-inch diameter holes 150 feet deep toward the J-10/K-11 junkyard area. Investigators observed 68 drill casings in this area.

Victim Locations

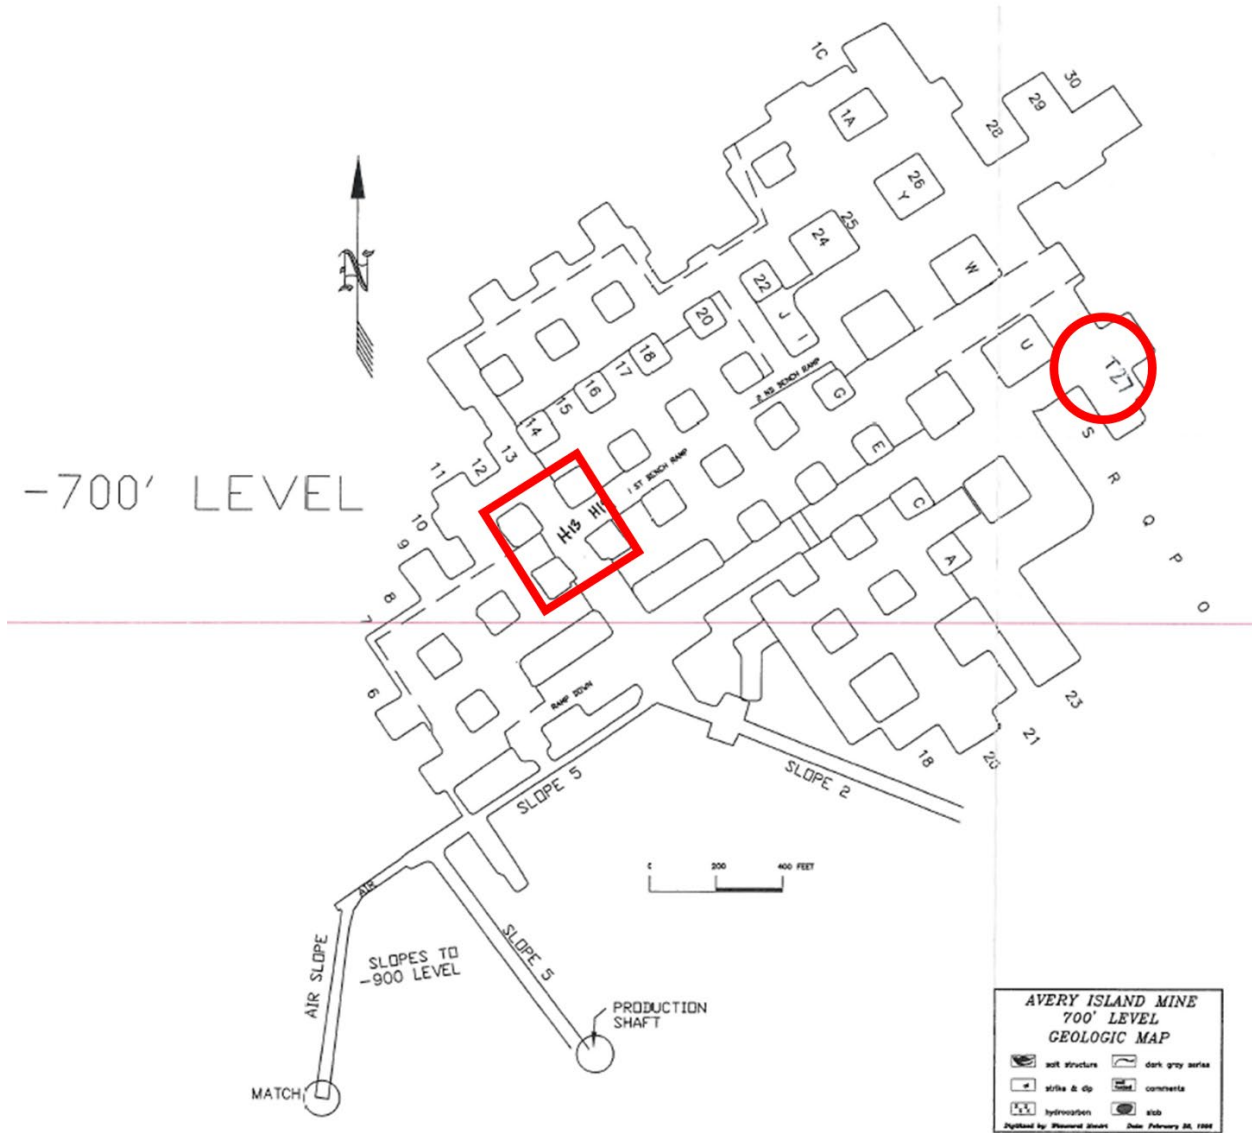
# APPENDIX C – Map of the 700 Level

The roof fall occurred in the H-13 intersection on the 700 level of the mine (see Appendix C). The mine refers to this area, which includes the H-13 intersection, I-13 room, and H-14 room, as the I-13 area. This level was used for escapeways and for drill site maintenance associated with water inflow mitigation since 1950, when mining in this area ended.

Investigators saw evidence of three additional roof falls on the 700 level. One roof fall occurred in the T-27 area in 2012. For the other two roof falls, investigators were unable to determine when they occurred. According to the mine operator, the T-27 area roof fall had communication with a different sinkhole on the surface and also had an area in the rib with water flowing from it. The water flow area from the T-27 rib was six feet by four feet. Statements during interviews indicated that the roof fell twice at T-27 and then the mine operator filled the area with foam. Because the T-27 area was filled with foam, investigators were unable to measure the height of the roof fall. Water is still being pumped from this area.

The area within the red square is referred to as the I-13 area. Details of this area are in Appendix E. The red circle shows the T-27 area.

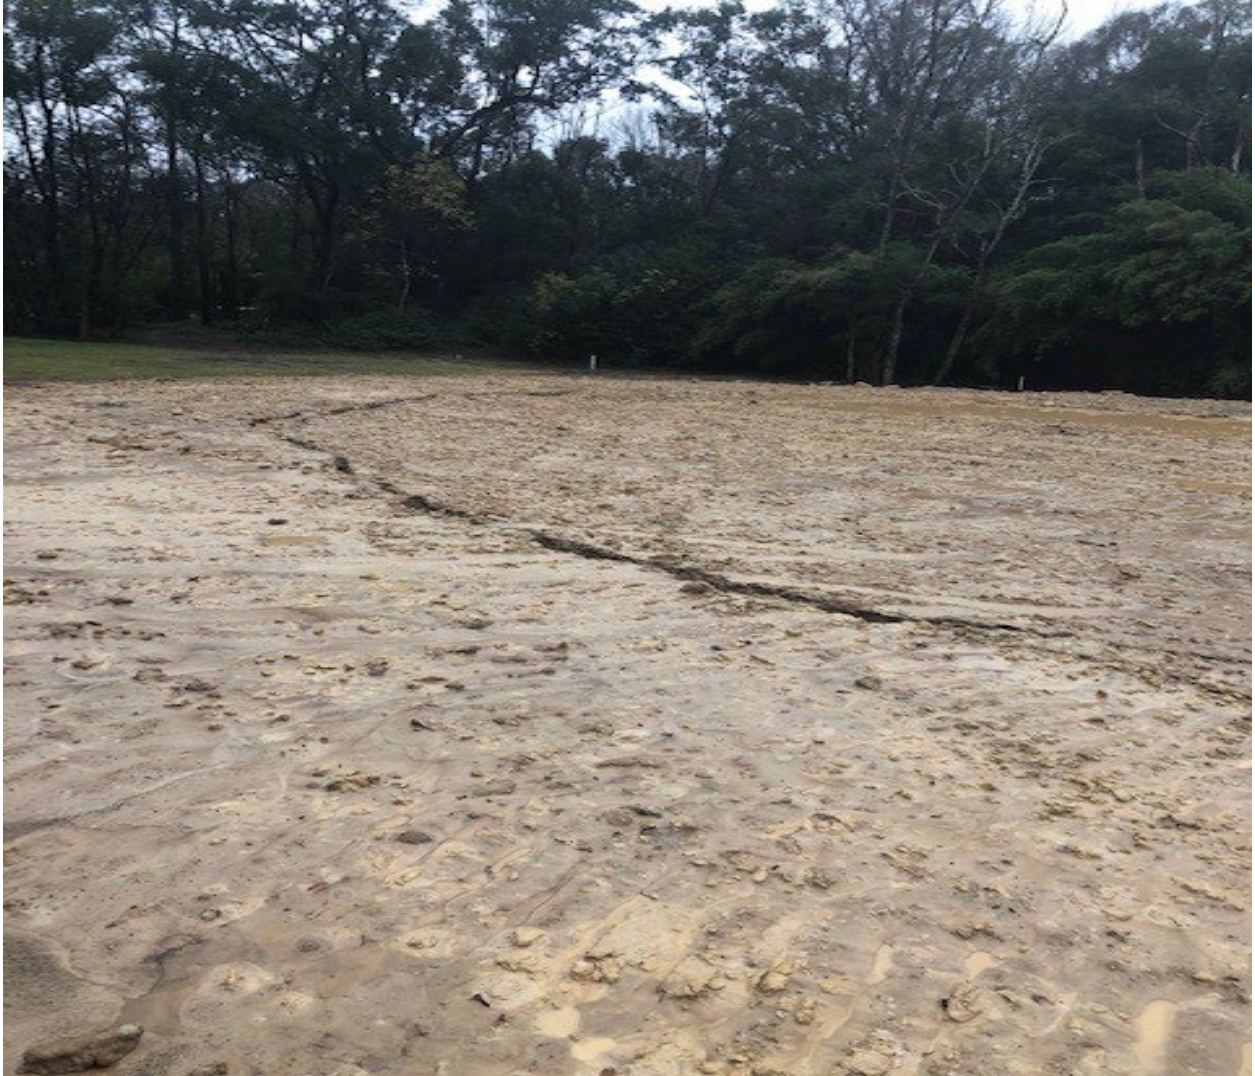
APPENDIX D – Froggy Bottom Sink Hole

In 2013, the mine operator became aware that water was entering the underground mine through the Froggy Bottom sinkhole. The operator retained Alpha Geoscience to investigate and report on the sinkhole. Alpha Geoscience documented in their 2013 Surface Stability Report that the Froggy Bottom sinkhole (see Appendix D) near the mine entrance was approximately 490 feet from the I-13 area (the location of the roof fall). Alpha Geoscience also noted that the sinkhole had a hydraulic connection to the J-10 and the I-13 areas. The sinkhole was between 125 and 150 feet in diameter in 2013. The sinkhole encompassed a large part of a neighboring yard, as well as the paved entry road to the mine. Since 2013, the mine operator continually filled in the area and repaved the road several times. At the time of this accident, the sinkhole was between 50 and 75 feet in diameter.

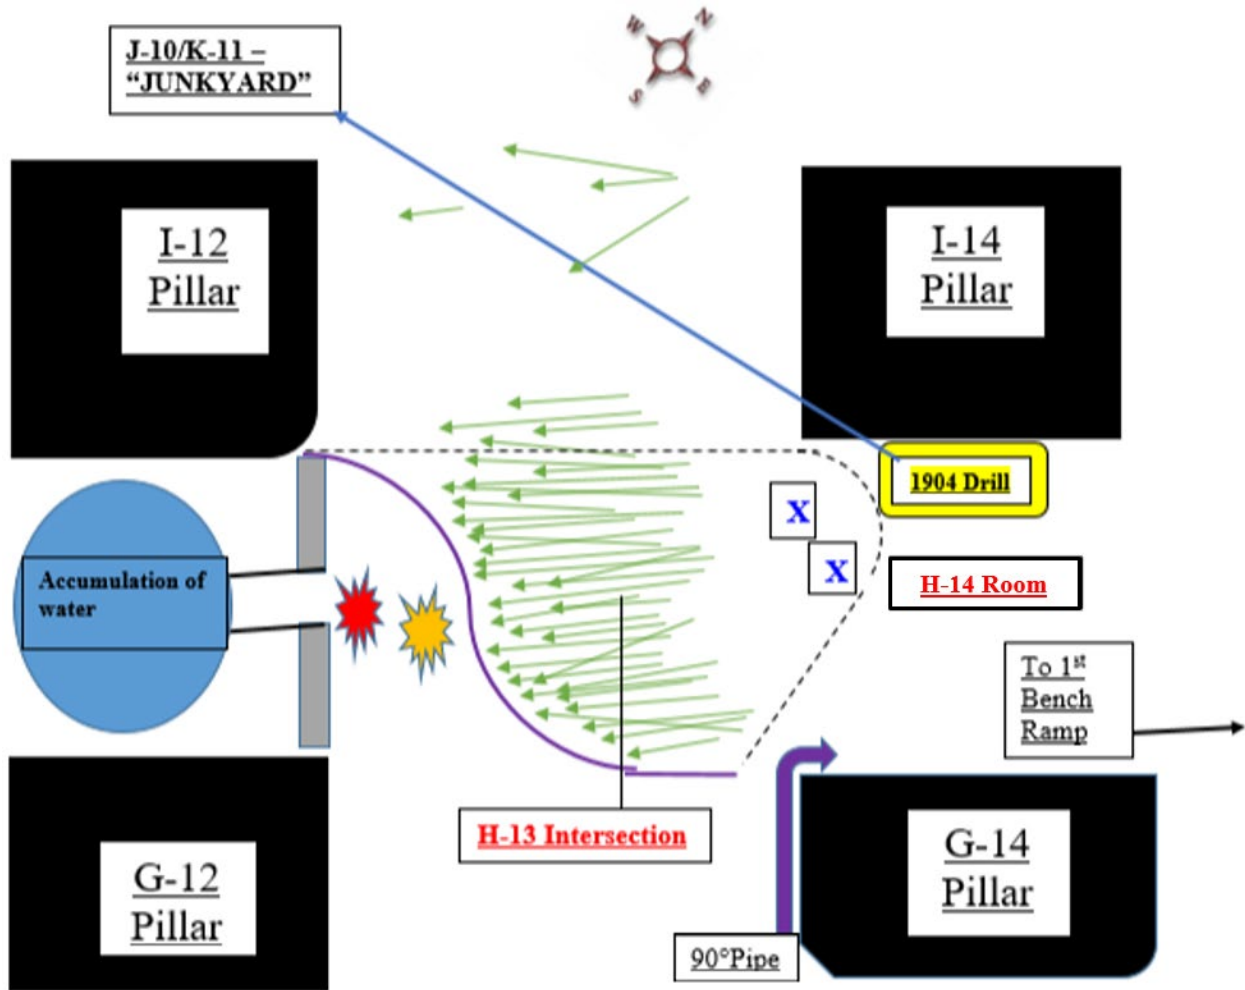
APPENDIX E – Map of the I-13 Area

After the blasts, the mine operator implemented mechanical scaling operations in the H-13 intersection, where a crack in the roof was clearly visible. According to the mine operator's grouter logs, the crack was approximately one-half to two inches wide by about 20 feet long. Sand, rocks, and water were discharging from the crack.

On November 30, 2020, supervisors and miners on all shifts noticed that the crack had expanded to approximately 75 feet long and approximately two to five inches wide. Drilling and injection grouting continued with the U4 portable drill in the H-13 area. Investigators concluded that the mine operator should have performed ground condition testing and examinations once the mine operator became aware of these hazardous ground conditions.

- Blue X's show the locations of the victims
- Purple line shows the crack in the roof beginning at the southeast corner of the I-12 pillar and extending toward the northwest corner of the G-14 pillar.
- Purple line and dotted line shows the area of the roof fall.
- Blue Arrow – holes drilled with U6 drill beginning in September 2019. 68 drill casings found.
- Green Arrows – 39 holes drilled with the U4 drill between November 3, 2020 and December 10, 2020
- Red Explosion Symbol – Location of first blast on November 2, 2020
- Orange Explosion Symbol – Location of second blast on November 2, 2020

Corrective Action: The mine operator installed a barricade and warning signage in the entry of the H-13 intersection to identify the hazardous ground condition and prevent further work or travel in the affected area. Areas of concern on the 500 and 700 levels were bolted and supported or blocked from access with barricades and warning signage to prevent entry. In addition, specific language regarding evaluation and determination of ground conditions was developed to address water and ground support. Also, the mine operator established and implemented new written procedures that address proper scaling where hazardous ground conditions are identified. The mine operator conducted training for all affected personnel on the new procedures.

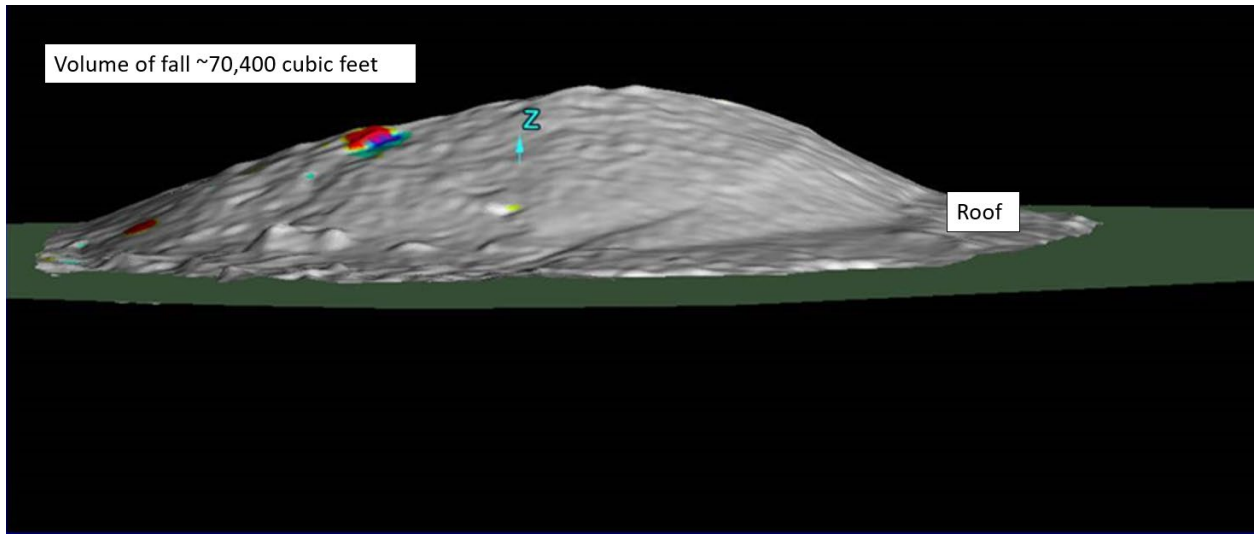
APPENDIX F – Three-Dimensional Representation of the Fall Cavity

The mining dimensions of the intersection between Drift H and Crosscut 13 were roughly 100 feet by 100 feet. These dimensions were calculated from Light Detection and Ranging (LiDAR) scans provided by the mine operator and are compatible with measurements taken underground by the accident investigation team. LiDAR is a remote sensing method that uses light in the form of a pulsed laser to measure distances and digitally recreate surfaces. The volume calculated using the LiDAR scan was approximately 70,400 ft<sup>3</sup> (see Appendix F). The roof fall material weighed approximately 4,743 tons.

Three-dimensional representation of the fall cavity, based on the mine operator's LiDAR scans.
