UNITED STATES
DEPARTMENT OF LABOR
MINE SAFETY AND HEALTH ADMINISTRATION

REPORT OF INVESTIGATION

Fatal Fall of Roof Accident
December 14, 2020

Avery Island
Cargill Deicing Technology
Avery Island, Iberia County, Louisiana
ID No. 16-00509

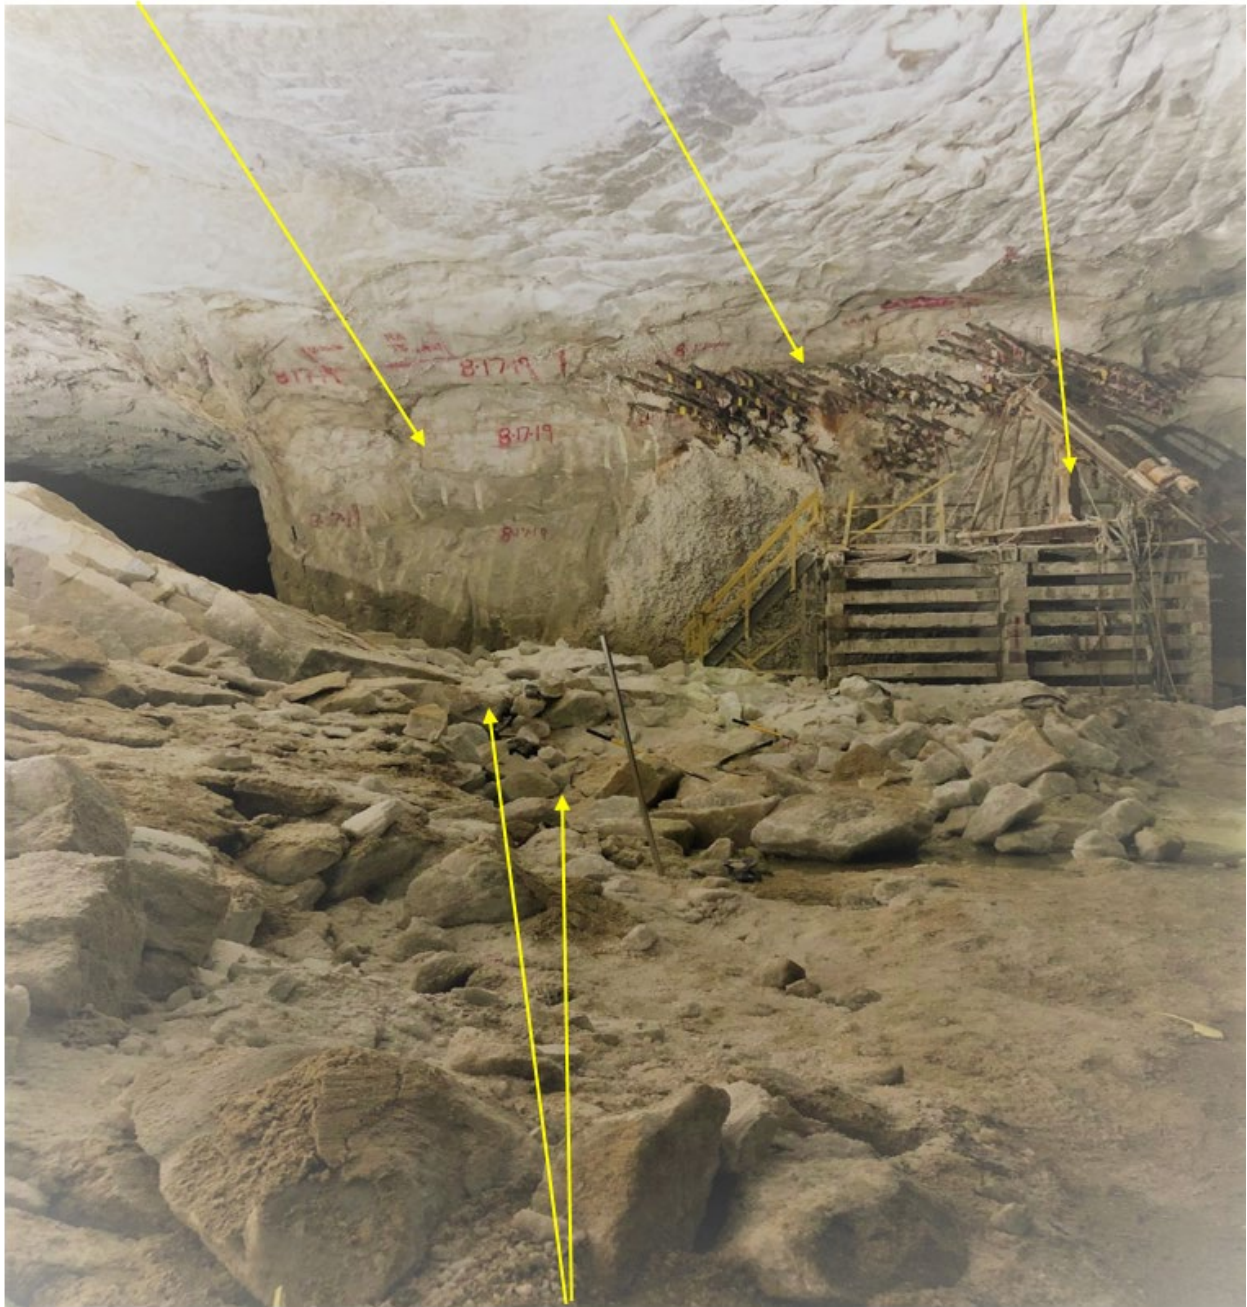
APPENDIX A – 1904 Drill Site

Begnaud and Romero were assigned to the 1904 drill site located in the H-14 room on the 700 level (see Appendix A). From the 1904 drill site, Begnaud and Romero were instructed to drill and inject grout toward the J-10/K-11 pillars.

In September 2019, the mine operator installed a stationary Diamec U6 PHC (U6) drill at the 1904 drill site located in the I-13 room approximately ten feet east from the roof fall. The mine

operator used the U6 drill to drill and inject grout into two-inch diameter holes 150 feet deep toward the J-10/K-11 junkyard area. Investigators observed 68 drill casings in this area.

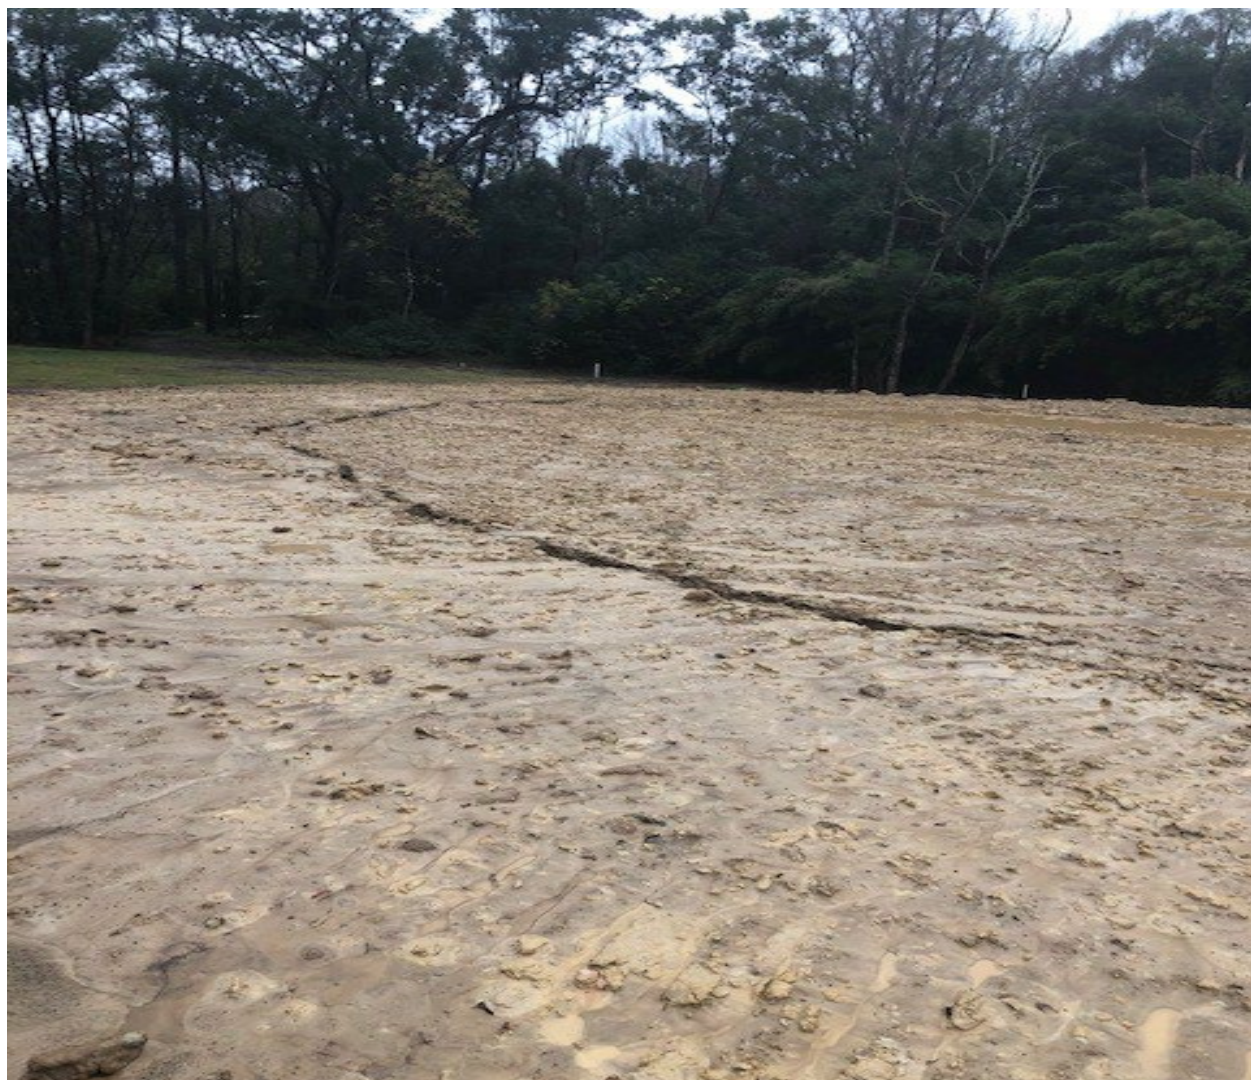
APPENDIX D – Froggy Bottom Sink Hole

In 2013, the mine operator became aware that water was entering the underground mine through the Froggy Bottom sinkhole. The operator retained Alpha Geoscience to investigate and report on the sinkhole. Alpha Geoscience documented in their 2013 Surface Stability Report that the Froggy Bottom sinkhole (see Appendix D) near the mine entrance was approximately 490 feet from the I-13 area (the location of the roof fall). Alpha Geoscience also noted that the sinkhole had a hydraulic connection to the J-10 and the I-13 areas. The sinkhole was between 125 and 150 feet in diameter in 2013. The sinkhole encompassed a large part of a neighboring yard, as well as the paved entry road to the mine. Since 2013, the mine operator continually filled in the area and repaved the road several times. At the time of this accident, the sinkhole was between 50 and 75 feet in diameter.
