REPORT OF INVESTIGATION

Underground
(Limestone)

Fatal Machinery Accident
July 24, 2020

Cisco Mine
Carmeuse L&S
Cisco, Murray County, Georgia
ID No. 09-01101

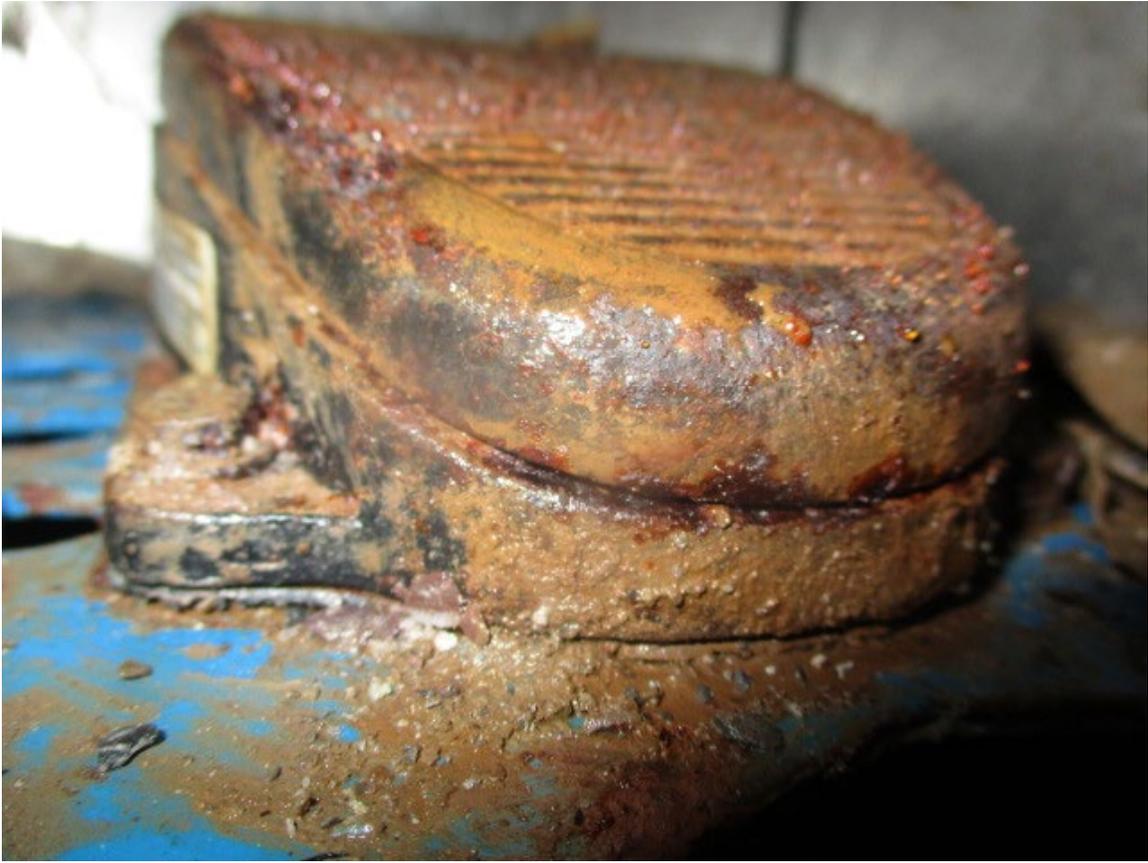
On July 24, 2020, Clapham assisted Adam Childers, Equipment Operator, with blasting preparation. At approximately 12:45 p.m., on level 3 of the North West 2 Face, Clapham and Childers were loading an ammonium nitrate fuel oil (ANFO) mixture into drill holes. Clapham and Childers loaded the bottom two rows of drill holes from the mine floor before accessing the personnel basket of an International Workstar 7500 truck (blasting truck) to load the remaining drill holes above. Childers engaged the boom lever to raise the personnel basket to the top row of drill holes located approximately two feet from the mine roof. As the personnel basket ascended, a sudden jolt caused Childers to lose his balance, release the boom lever, and lose contact with the personnel basket person-in-position foot switch (foot switch). At the same time, the personnel basket tilted and continued to move in an upward and forward direction due to a mechanical failure. Releasing the foot switch should have removed hydraulic power from the circuit, but it did not function as intended because the foot switch stuck closed (see Appendix A).

- 4) Investigators tested the foot switch and found it defective. The foot switch was dirty and corroded from prolonged use in the mine. When the equipment operator removed his foot from the switch, it did not stop the hydraulic power as it should have, allowing the machine to still operate. With the control level diminished by valve swelling/sticking, and the foot switch inoperable, the only method to stop the boom from raising was the emergency stop button, which, when engaged, would stop the engine from operating. Knowing that prolonged use and the harsh mine environment could diminish the effectiveness of the foot switch, the mine operator kept spares on-site. During interviews, MSHA determined the foot switch was installed by the mine operator in March 2020 as a replacement to another foot switch which had become defective. During testing, after the foot switch in use at the time of the accident was found to be defective, it was replaced and testing was repeated. The new foot switch stopped the hydraulic power, even with the hot oil impairing the operation of the boom levers.

Appendix A - Foot Switch Stuck in Closed Position
(Note the rust in the droplets of water and along the edges)

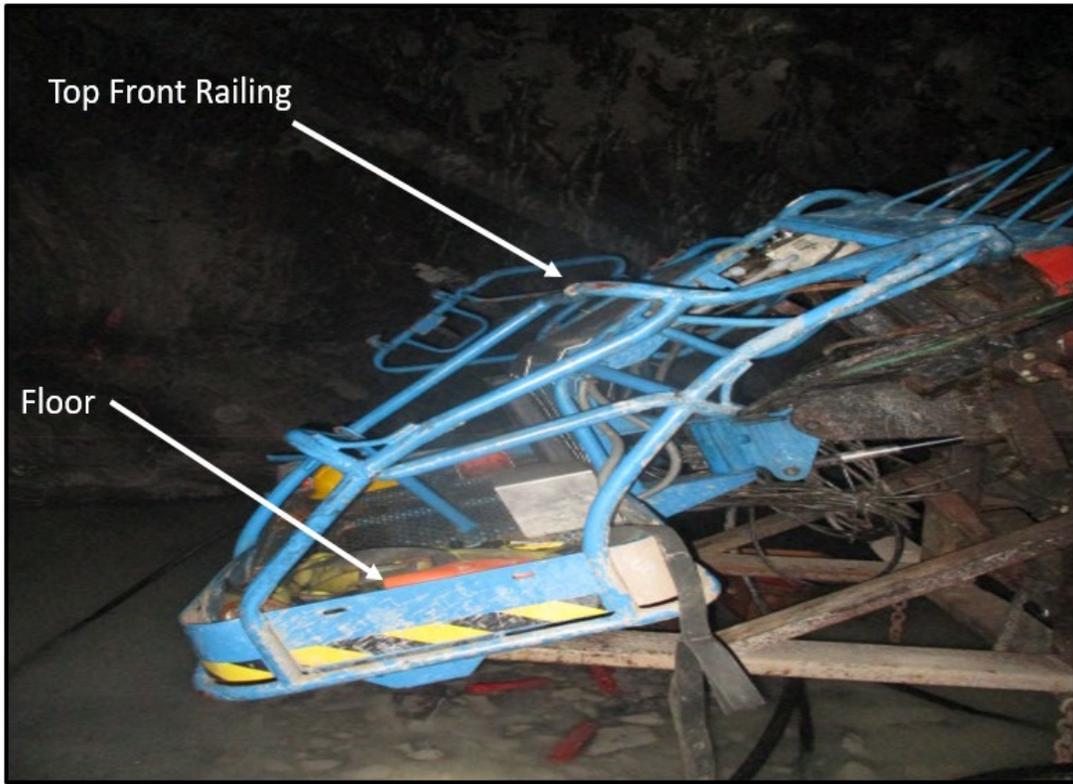
Appendix B - Personnel Basket of the Blasting Truck

- 6) Three days prior to the accident, the mine operator modified the blasting truck hydraulic system by swapping four hydraulic hose lines, altering two personnel basket functions (boom swing and knuckle) on the personnel basket valve bank. The swap caused the personnel basket's lever that would normally operate the swing function to operate the knuckle function instead. United Rentals personnel suggested the swap as a troubleshooting measure. The mine operator was troubleshooting for involuntary movement of the crane boom and personnel basket that had been reported by the miners. The labels on the controls in the personnel basket were not updated to reflect the swap, and the mine operator did not task train equipment operators regarding the modifications.

Hazardous conditions affecting the safe operation of the blasting truck's boom/personnel basket, including swapped hydraulic hose lines for the personnel basket's valve bank, which changed the functionality of individual personnel basket levers, and a malfunctioning personnel basket foot switch, existed prior to the accident. An adequate inspection by the equipment operator prior to placing the blasting truck into operation would have disclosed existing defects. Failure to perform an examination of equipment prior to placing it into service constitutes more than ordinary negligence and is an unwarrantable failure to comply with a mandatory standard.

Corrective Action: Mine Management retrained all miners regarding modifications to the personnel basket valve bank.

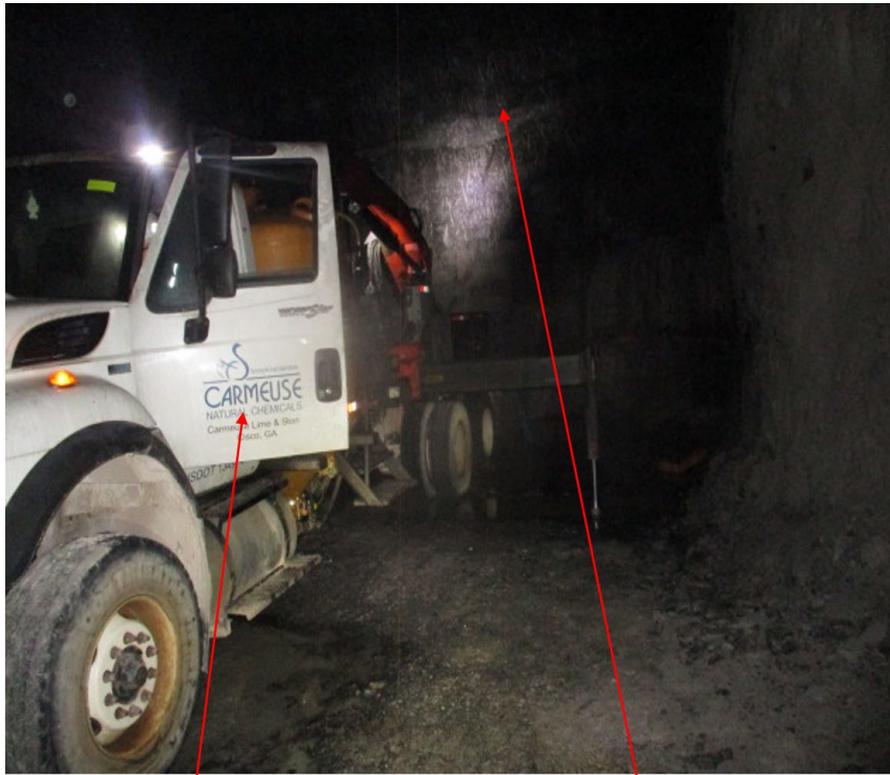
APPENDIX D - Photograph of the Accident Scene

The accident occurred on level 3 of the mine in the face of the North West 2 entry (see Appendix D). The entry measured 41 feet in width and nearly 48 feet in depth. The height at the face where the impact occurred was 22 feet-3 inches.

International Prostar
7500 Blasting Truck

Area on Level 3 of the North West
2 Face where accident occurred
