UNITED STATES
DEPARTMENT OF LABOR
MINE SAFETY AND HEALTH ADMINISTRATION

REPORT OF INVESTIGATION

Surface Mine
(Sand)

Fatal Slip/Fall Accident
September 1, 2020

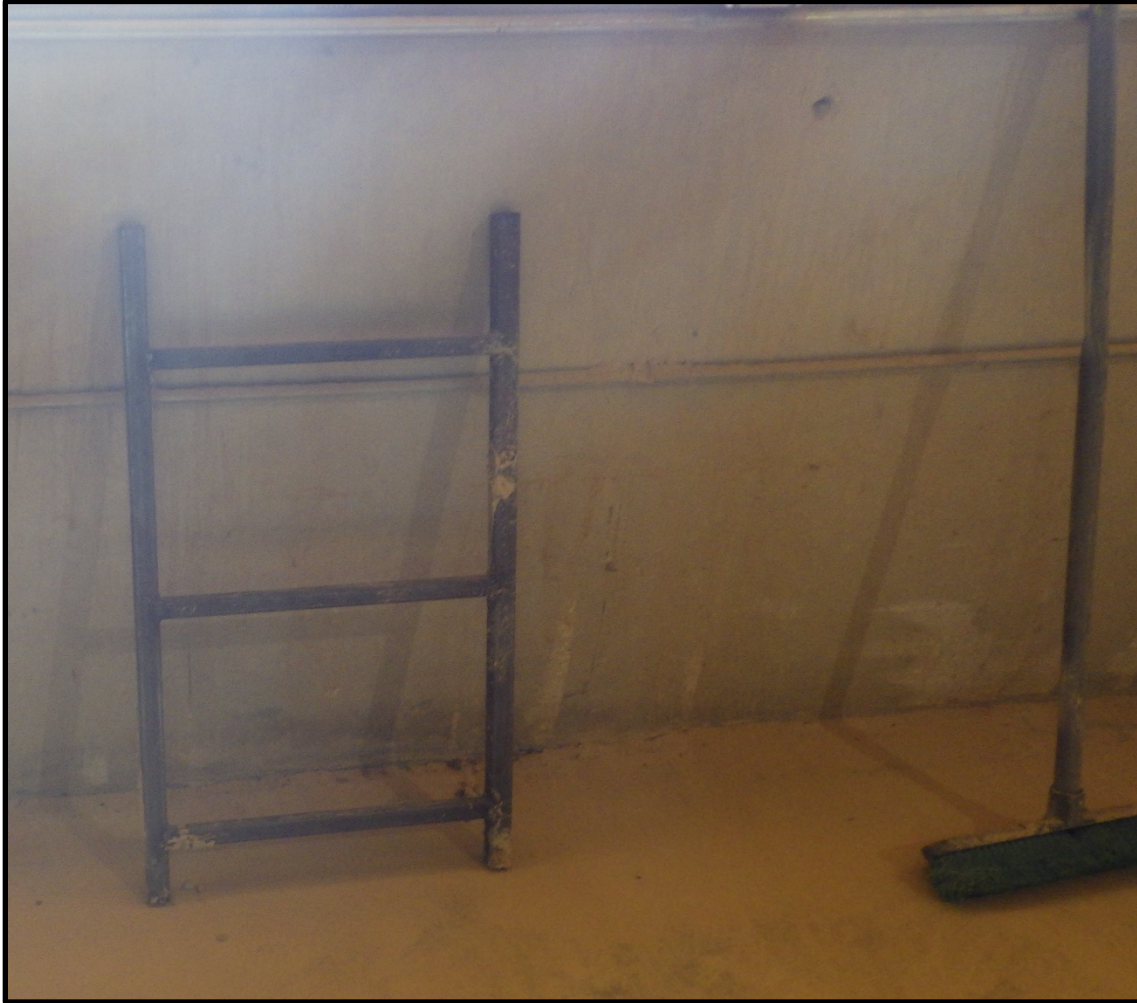
Appendix C - Replacement Sliding Ladder

In December 2019, the mine operator changed the load-out chute from a free-hanging rubber-boot style chute to a telescoping chute controlled by a scale attendant. With the installation of this new chute, the drawbridge previously used to access trucks in Lane 2 presented clearance obstructions. Therefore, the mine operator had it removed. A mine contractor designed and installed a vertical sliding ladder to allow access between the load-out platform and the top of the trailers. However, truck activity repeatedly damaged the ladders and the mine operator fabricated and installed numerous replacement ladders (see Appendix C).

When installing replacement ladders, the mine operator omitted two key safety features. First, replacement ladders did not include a hole for the insertion of a safety pin to ensure the ladders remained in the up position while not being used. Secondly, replacement ladders were not

equipped with a stop to prevent the ladders from sliding off the guides and free falling to the surface below, creating a struck-by hazard as well as a fall hazard.

On September 1, 2020, at approximately 12:10 p.m., a miner on the day shift reported that the sliding ladder in Lane 2 had fallen. The absence of this ladder created an approximate 33-inch vertical separation between the tops of the dry bulk trailers and the load-out platform. Without the ladder, the miners could not safely descend to the dry bulk trailer nor ascend to the load-out platform. The absence of the ladder also created an unprotected opening 19 inches wide between the railings and approximately 17 feet above the concrete surface (see Appendix D). Plant Manager Samuel Lopez directed the day shift miners to use a portable ladder for access. However, the miners had no way to secure this ladder to the trucks or to the load-out platform. When Johnson arrived at his work area for the evening shift, he was not told to use the unsecured portable ladder in Lane 2. Johnson proceeded to ascend and descend the approximately 33-inch vertical distance between the top of a dry bulk trailer and the load-out platform by lowering himself down to the top of a dry bulk trailer but, because there was no ladder, he was unsuccessful in pulling himself back up without a safe means of access.

Corrective Action: The mine operator has removed the drawbridge in lane 1, as well as the ladder access ways from Lane 1 and Lane 2. These three openings were sealed off with hand and mid-rails. Designated safe access racks were installed in another area of the mine to provide safe access. The operator has provided training in accordance with 30 CFR Part 46 to both the miners and over the road truck drivers.

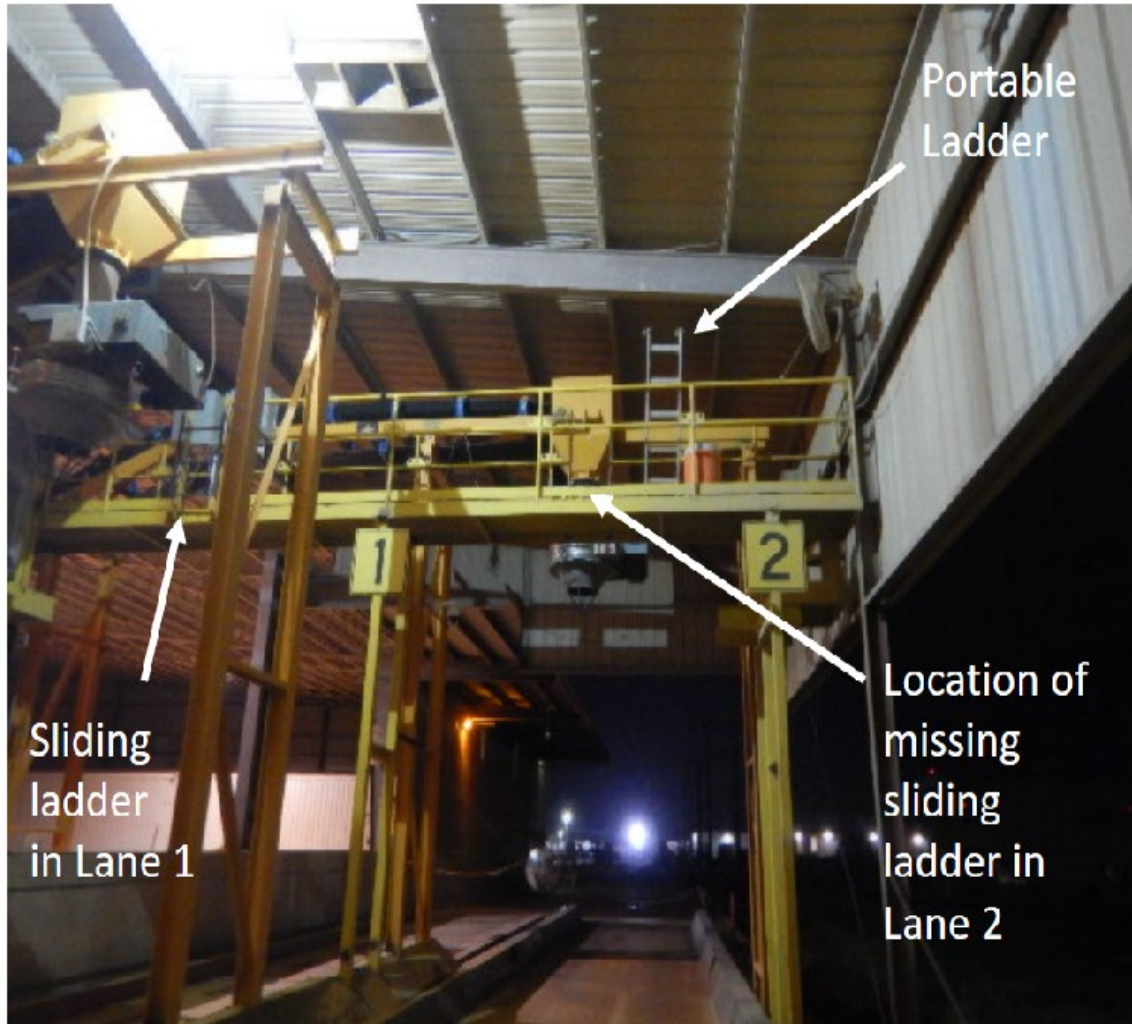
Appendix D - Lanes 1 and 2

The accident occurred in Lane 2 of the load-out lanes. See Appendix B for an aerial view of the mine site with the approximate location of the accident.
