REPORT OF INVESTIGATION

Surface  
(Construction Sand and Gravel)

Fatal Powered Haulage Accident  
April 22, 2021

Broadfoot Pit #2  
Broadfoot Sand & Gravel Inc.  
Kearney, Buffalo County, Nebraska  
ID 25-01118

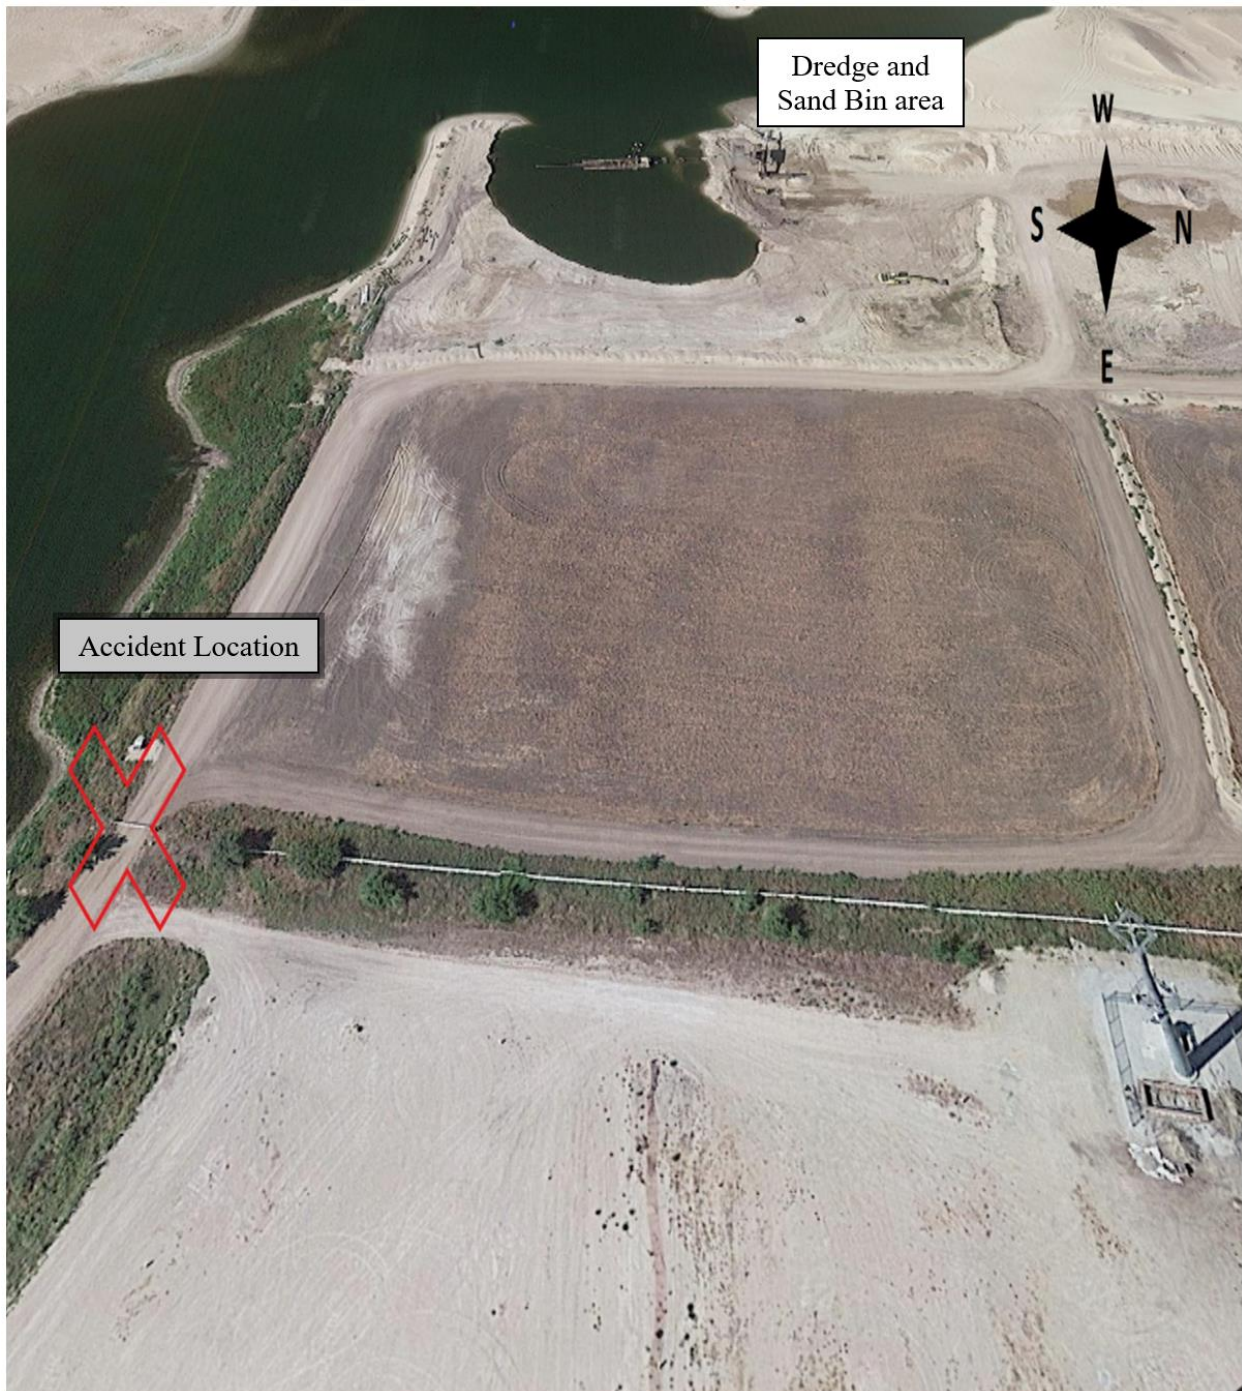
Appendix B  
Aerial View of the Accident Scene

The accident occurred at the northeast haul road entrance barrier gate, which is southeast of the north dredge pit (see Appendix B). Investigators measured the entrance barrier gate to be 19 feet in length. The portion of the gate that struck the pick-up truck is 48 inches above the roadway. The northeast haul road entrance barrier gate is constructed out of three-inch by three-inch square tubing (see Appendix C).

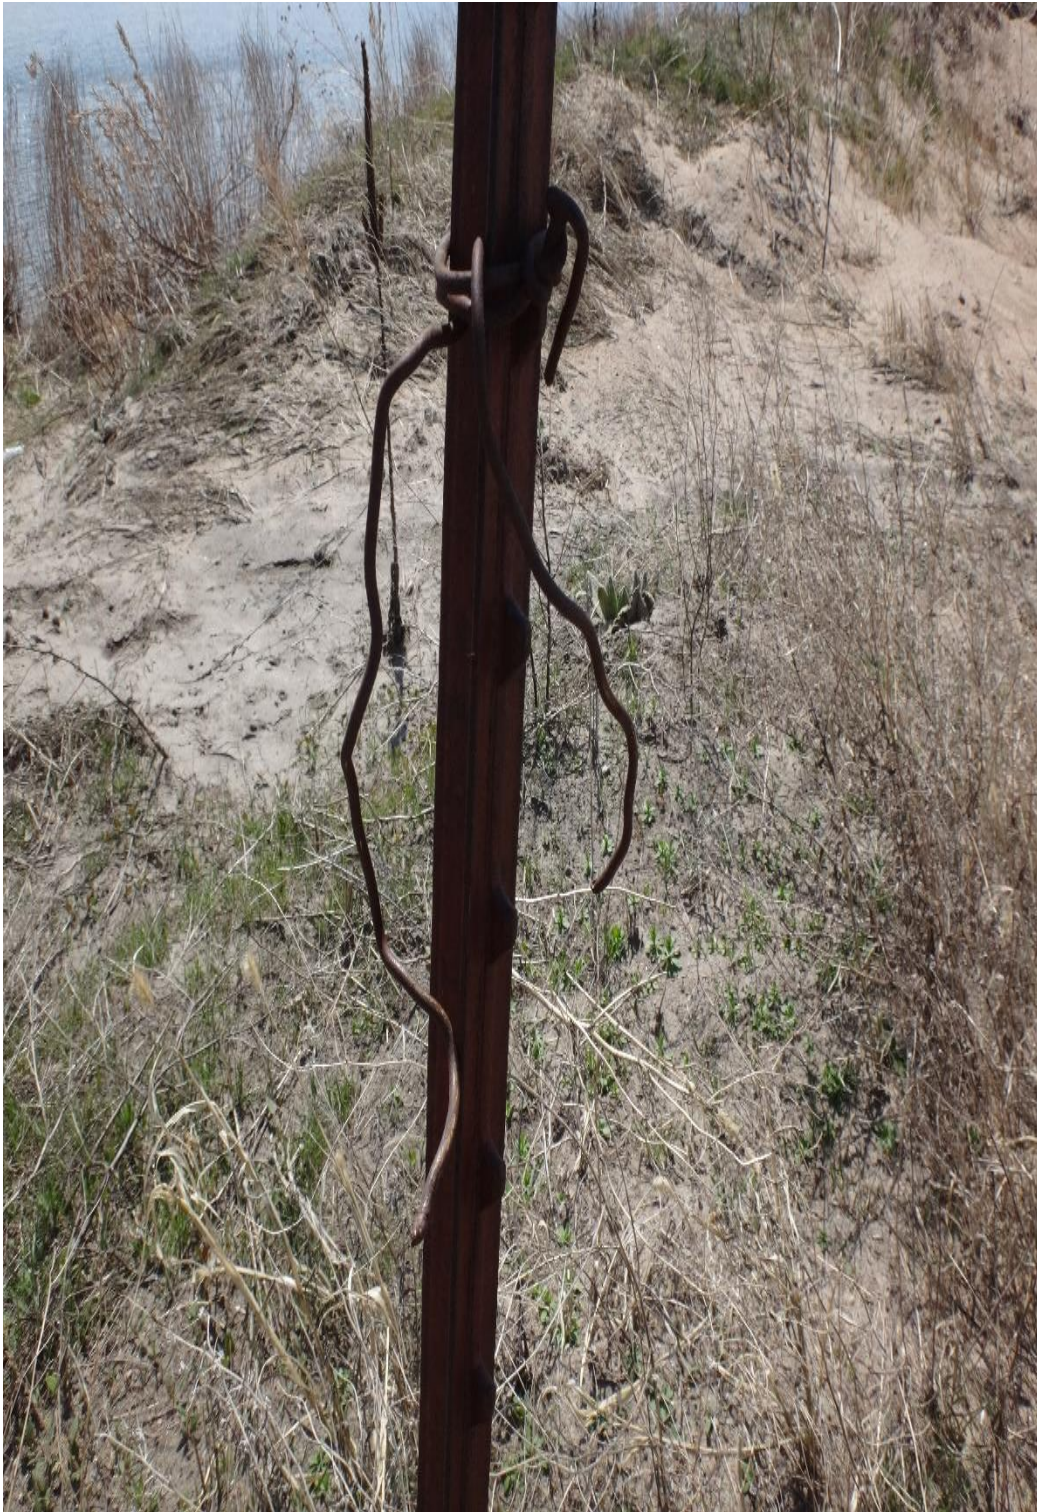
Appendix D  
Photograph of the T-Post Stop and the Number Nine Wire

The entrance barrier gate opens from the north side of the entrance, rotating to the southwest, stopping against a steel T-post. A single piece of number nine American Wire Gauge wire was available to wrap around the post to secure the barrier gate in the open position (see Appendix D). The wire was not sufficient to secure the barrier gate open. Without the barrier gate securely fastened to the post, the wind that day was able to blow the barrier gate partially closed.

1. Root Cause: The mine operator did not assure that the manual barrier gate was securely fastened in the open position.

Corrective Action: The mine operator has secured all barrier gates on mine property with a chain or strap attached to a post. Additionally, the mine operator painted all of the barrier gates, applied reflective tape to the gates, and installed signs on the approaches to the gates to warn drivers that gates are near. Further, the mine operator developed a written policy that all barrier gates on mine property must remain open and secured during normal business hours. When a barrier gate is in need of any work, a supervisor will be made aware of the situation and will implement necessary corrective action.
