REPORT OF INVESTIGATION

Fatal Inundation Accident
August 1, 2021

Gentry Mine #3
Gentry Mountain Mining LLC
Huntington, Emery County, Utah
ID No. 42-02263

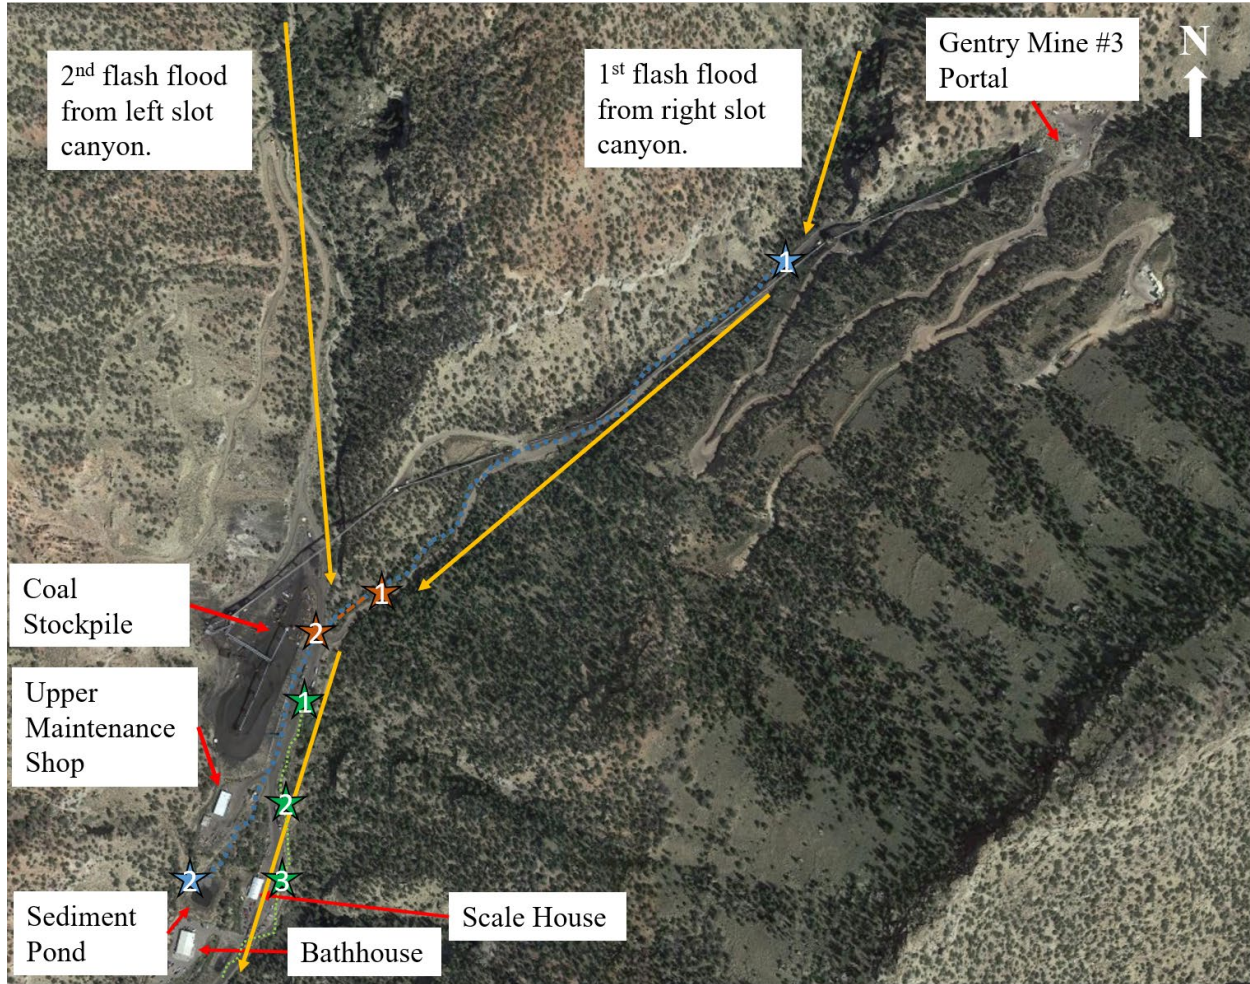
APPENDIX A – Aerial View of the Area Showing the Events during the Flash Floods

On the day of the accident, there were two flash floods that affected the travelway leading to the Gentry Mine #3 portal. See Appendix A for an aerial view of the area showing the following events during both flash floods. While both personnel carriers traveled up the mountain towards the Gentry Mine #3 portal, the miners were unaware that the first flash flood struck the No. 10 personnel carrier and was forcing it downhill. At 10:08 p.m., the No. 8 personnel carrier turned right onto the elevated mine access dirt road, which runs along a narrow slot canyon adjacent to a creek bed, located a quarter of a mile from the bathhouse.

The accident occurred in the narrow slot canyon on a haulage road between the bathhouse and the Gentry Mine #3 portal. The bathhouse and the portal are 6,758 feet apart. When the first flash flood struck, the No. 6 personnel carrier was 792 feet from the bathhouse and the No. 8 personnel carrier was 1,690 feet from the bathhouse. The floodwaters moved the No. 6 personnel carrier 370 feet and the No. 8 personnel carrier 581 feet back toward the bathhouse. The No. 10 personnel carrier was 3,062 feet from the portal when the first flash flood hit. The floodwaters moved the No. 10 personnel carrier 3,379 feet away from the portal and it ended up 317 feet from the bathhouse (see Appendix A).

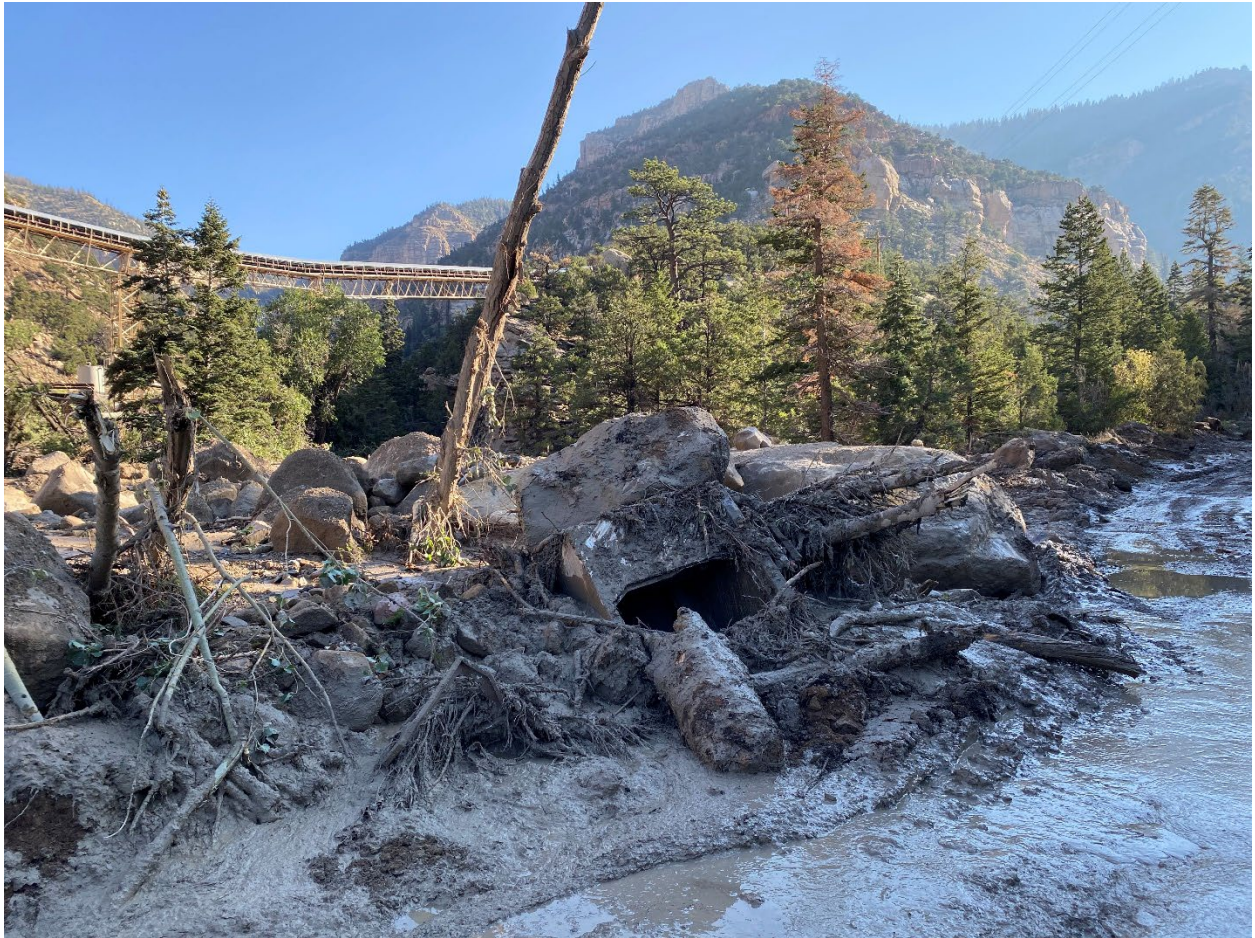
APPENDIX B – No. 8 Personnel Carrier Final Location

The first flash flood hit the No. 8 personnel carrier head-on. The flash flood contained large boulders and broken pine trees and engulfed the narrow slot canyons. The first flash flood pushed the No. 8 personnel carrier downhill, causing it to flip over four times and become stuck on its side in the debris at the wye of the road and river bed (see Appendix B). The miners in the enclosed passenger's rear compartment worked to free themselves. Nunez kicked the back window out. B. Lyons helped remove the back door. The rest of the miners in the No. 8 personnel carrier were able to exit the passenger's rear compartment. At this point, the miners from the No. 8 personnel carrier battled the deep water. B. Lyons swam to solid ground and noticed that the lights at the coal load-out were off. This was because the mine lost power due to the flood.

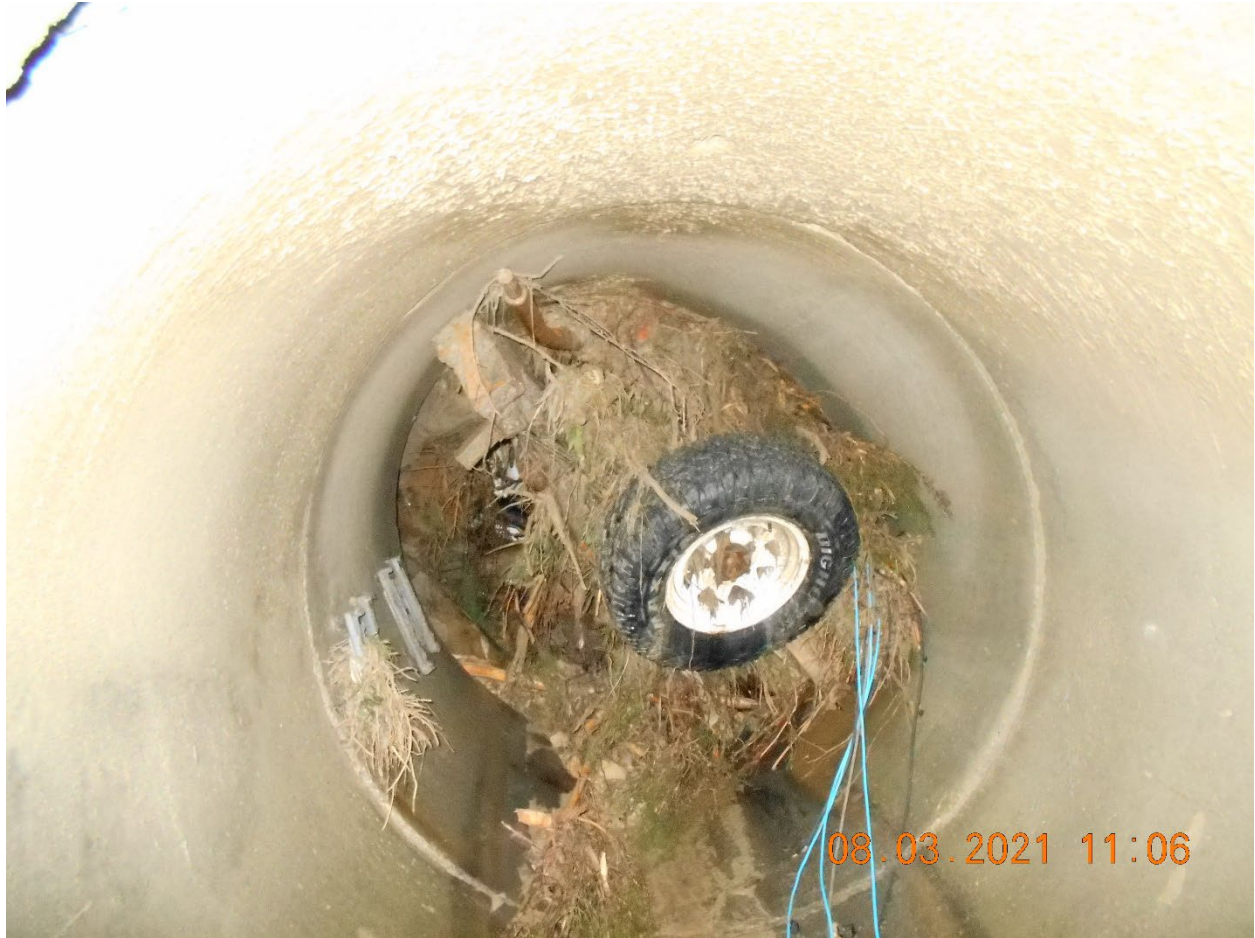
APPENDIX C – No. 10 Personnel Carrier Final Location in the Concrete Culvert

The floodwaters pushed the No. 10 personnel carrier down the mountain towards the scale house. Fullmer pushed the driver's side door open and exited the personnel carrier. The No. 10 personnel carrier ended up stuck in a concrete culvert (see Appendix C). The second flash flood caused Fullmer to float on his back until he came to a stop. While on the side of the coal pile, the miners from the No. 8 personnel carrier waited until the floodwaters from the second flash flood subsided before moving towards the upper maintenance shops. The miners continued to move along the high ground towards the sediment pond and assisted in the rescue of Fullmer, who was holding onto a large rock.

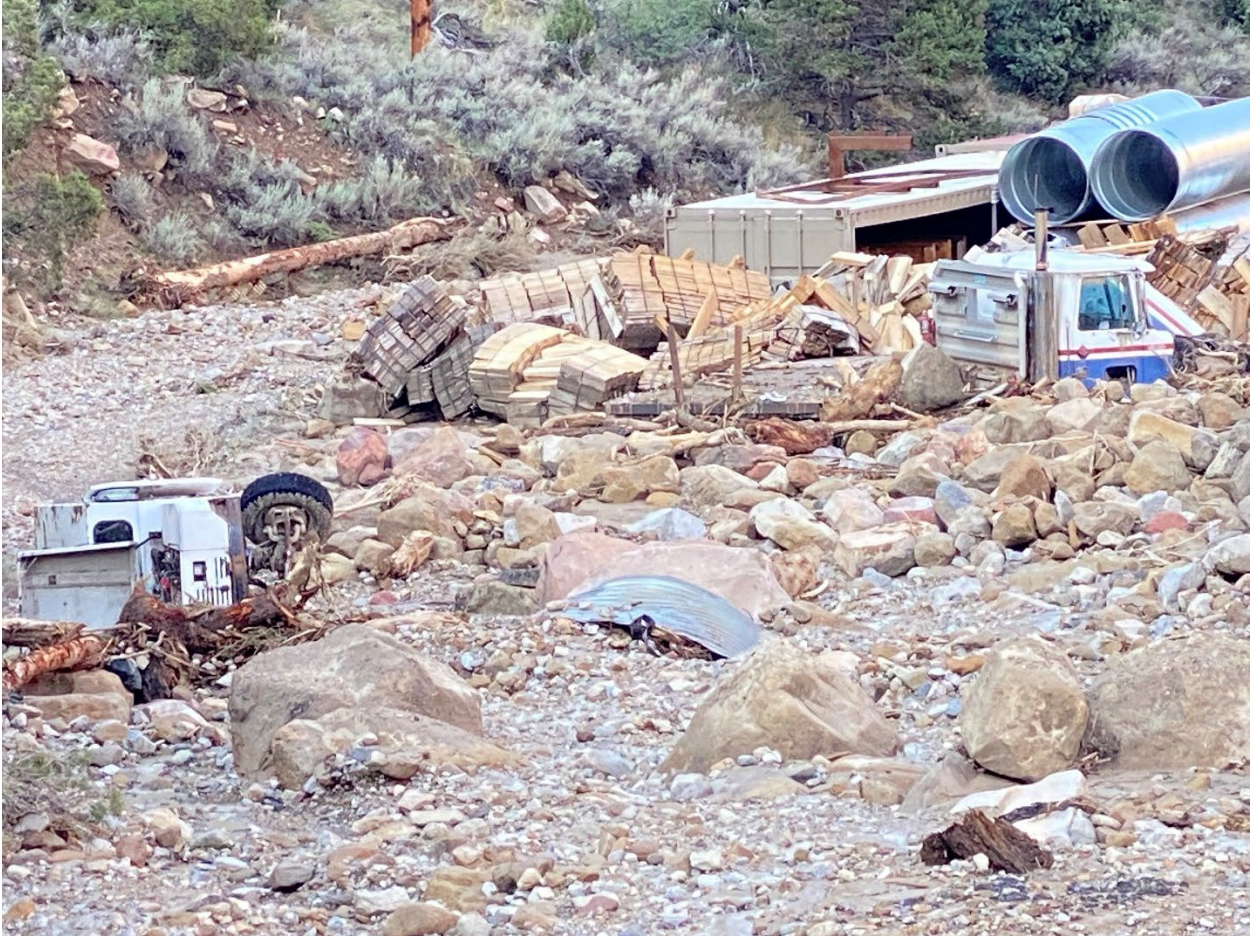
APPENDIX D – No. 6 Personnel Carrier Final Location and Debris Field

The No. 6 personnel carrier, which had departed shortly after the No. 8 personnel carrier, encountered the first flash flood 0.16 miles from where they started at the road's junction leading to the upper maintenance shop. Stoddard was driving and D. Ewell was in the front passenger seat when it flipped on its side from the force of the first flash flood (see Appendix D). Nelson and D. Ewell exited the cab and started helping the rest of the crew exit out of the No. 6 personnel carrier. Each member of the crew sought higher ground to get out of the first flash flood. D. Ewell was standing on an elevated area next to Nelson, who was standing in knee-high water. D. Ewell turned to help other miners out of the No. 6 personnel carrier when the second flash flood hit the personnel carrier. D. Ewell turned to look for Nelson but could not locate him. When the floodwater receded, the remainder of the miners in the No. 6 personnel carrier safely traveled towards the bathhouse.

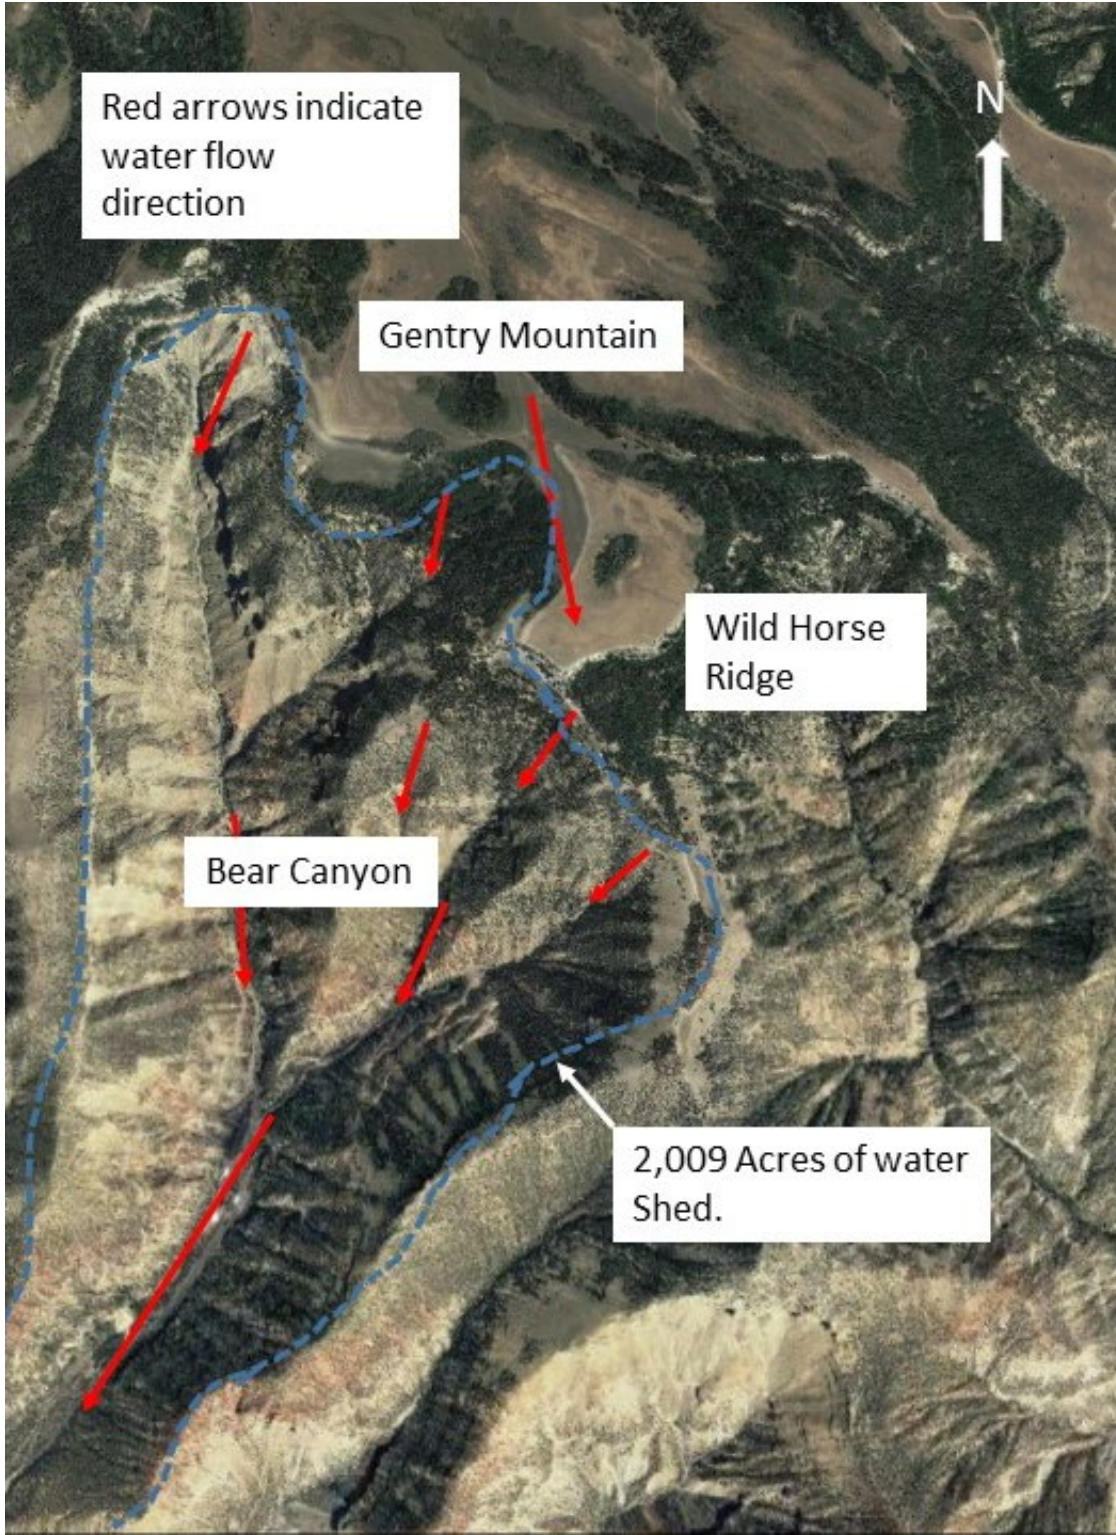
APPENDIX F – Aerial View of Bear Canyon and Water Flow through the Watershed

The Gentry Mine #3 is located approximately 12 miles northwest of Huntington, Utah, just off State Highway 31 in Bear Canyon. The mine is located in the Plateau region of Eastern Utah, in the Manti-La Sal National Forest, directly below the Gentry Mountain, extending to the Wild Horse Ridge. This area consists of large plateaus with deeply incised canyons with five multiple-slot canyons that merge. The canyons rapidly descend in elevation, with numerous geological benches descending from the mesa at an elevation of 9,600 feet. The valley of the canyons is below at 6,400 feet in elevation. The geological terrain is conducive to accelerated water run-offs from weather conditions on the top of the mesa, which drain down to the plateaus. Normal drainage flows naturally occur in the ravines' contours and strategically placed culverts through the drainage field direct water flow to the valley below. The estimated watershed area for the Bear Canyon is 2,009 acres (see Appendix F).

The atmospheric conditions over the Gentry Mountain and the Wild Horse Ridge can cause recurrent and significant rainfall, which at times creates flash floods. The storm deposited several inches of precipitation on top of the mesa, which saturated the ground and produced an abnormal amount of drainage down to the edge of the plateaus. The water on the plateaus converged and proceeded to the canyons below. Several low areas exist in the slot canyons, which caused water to impound, and allowed a build-up of debris that breached and released a

large amount of water. The sudden release of water created the flash flood, which generated a large amount of force, and collected debris as the flash flood water moved downhill into the canyons. Investigators were not able to review the history of flash floods because Emery County does not document flash floods in this area because of its seclusion and lack of a weather station.

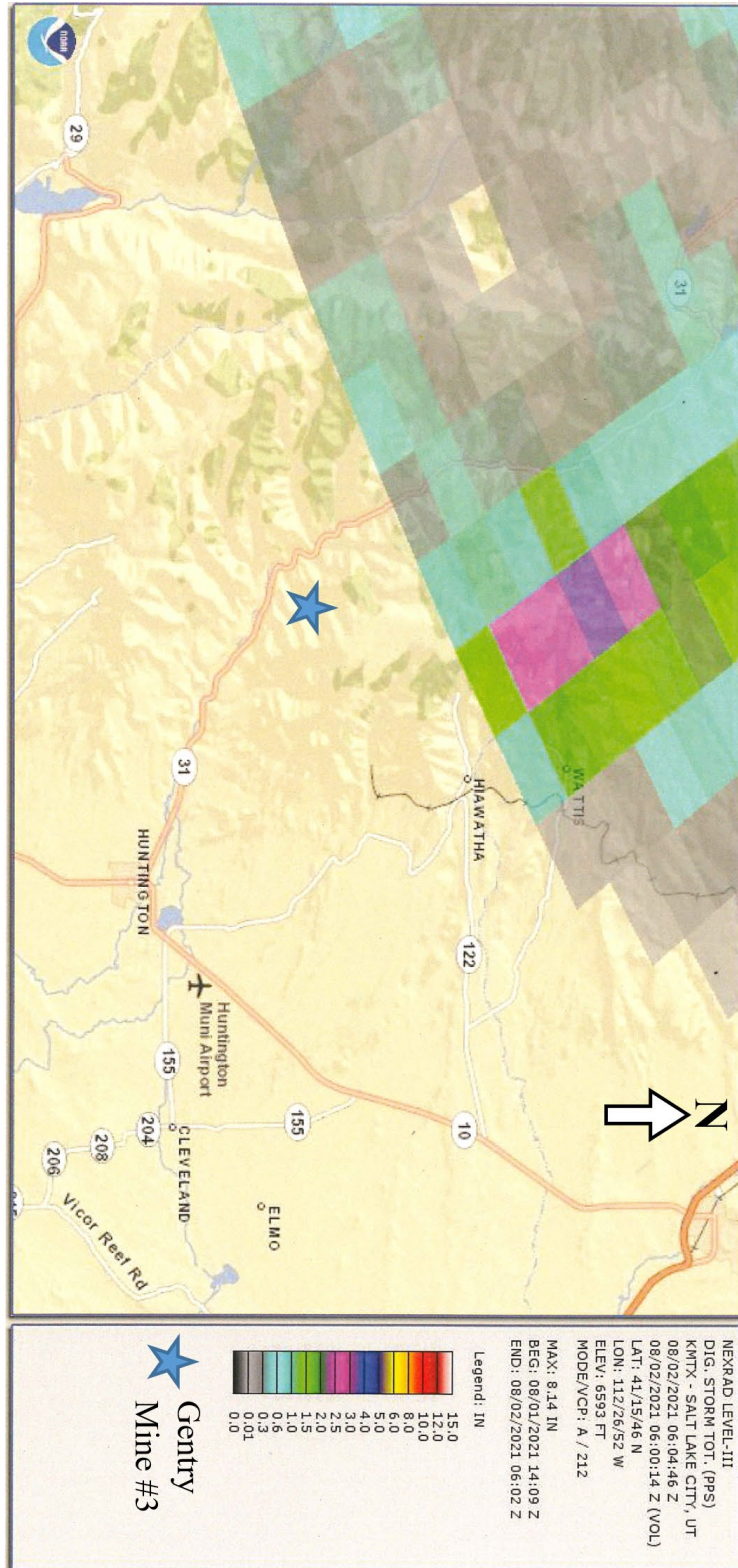
APPENDIX G – Precipitation Contour Map from the Certified National Weather Report

The weather at the time of the accident was 66 degrees Fahrenheit with significant rainfall on top of the mesa, but light rainfall at the bathhouse. The Certified Weather Report indicated a maximum rainfall of 8.14 inches from August 1, 2021, at 8:09 a.m. to August 2, 2021, at 12:02 a.m. (see Appendix G). Investigators determined that weather was a contributing factor to the accident.

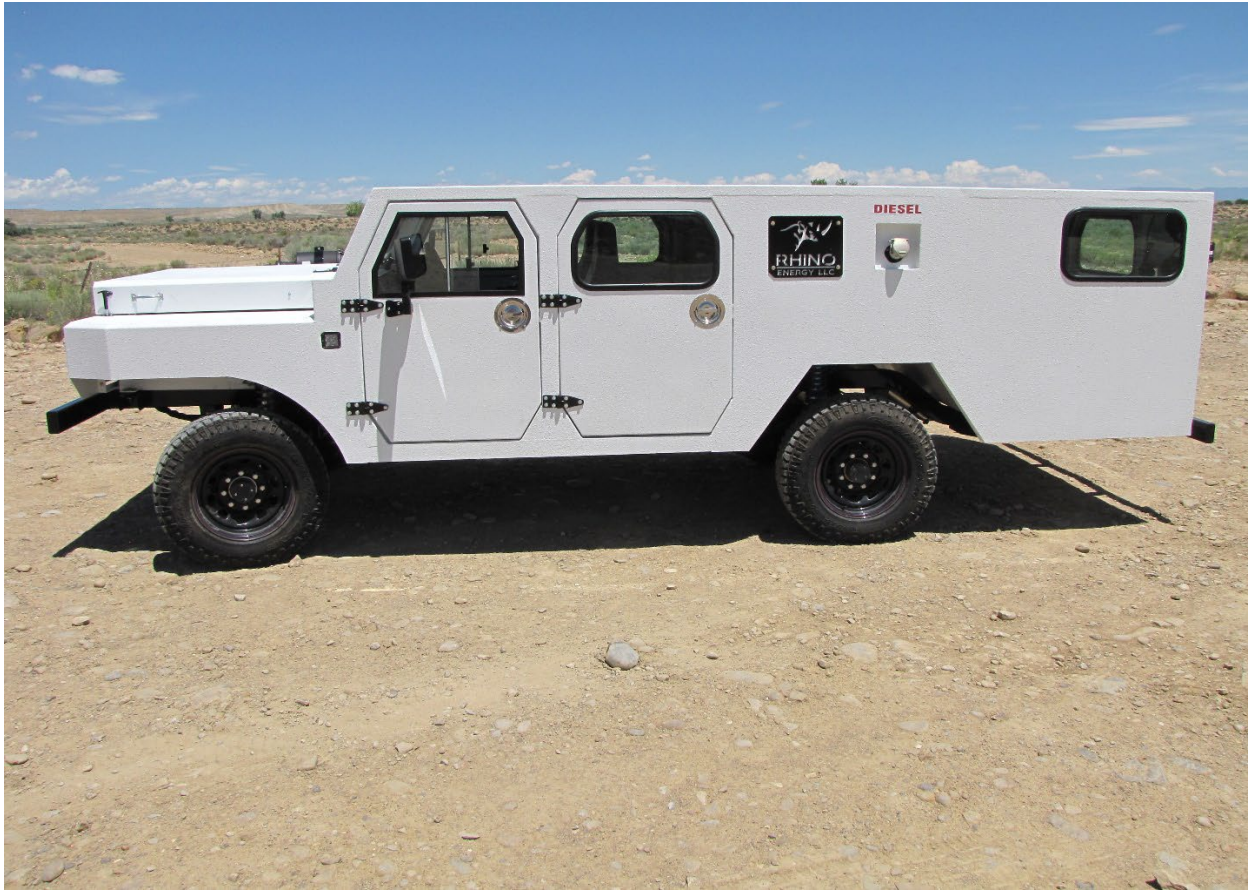
APPENDIX H – Genco Geep Personnel Carrier

The personnel carriers used by the mine are Genco Geep personnel carriers (see Appendix H). Investigators were unable to examine the personnel carriers due to the damage caused by the flood.
