REPORT OF INVESTIGATION

Fatal Powered Haulage Accident  
August 11, 2021

HWM Truck Lines, Inc. (E467)  
Summersville, West Virginia

Star Bridge Preparation Plant-Rail Load  
Carter Roag Coal Company  
Mill Creek, Randolph County, West Virginia  
ID No. 46-06736

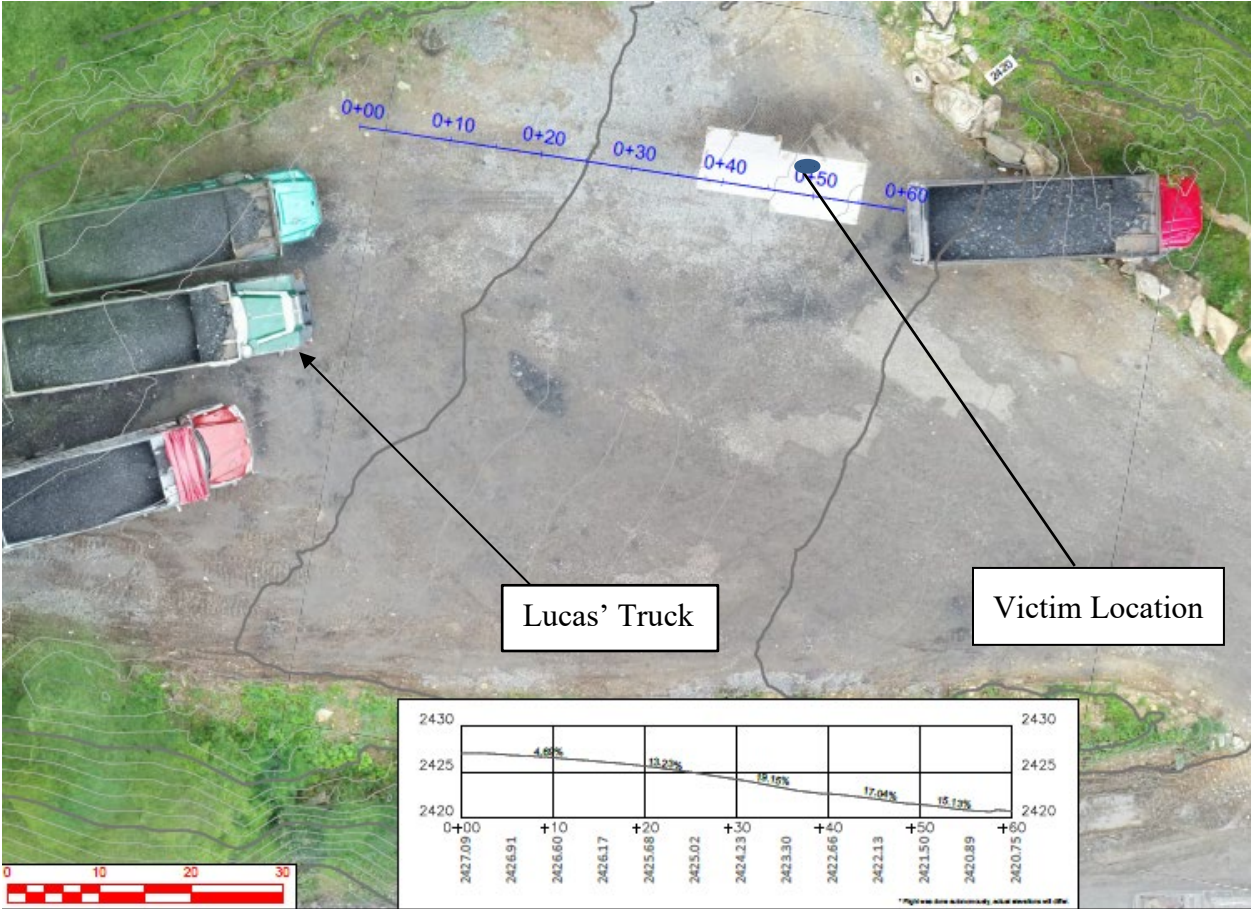
APPENDIX C – Aerial View of the Accident Scene

The accident occurred in a gravel lot near haul road marker five. The four loaded HWM trucks were directed by McHenry II to use the gravel lot as a temporary parking location the previous afternoon (see Appendix C).

Investigators found Collins' truck rolled over a rock berm with the front tires in the ditch. The grade along the truck's path of travel increased in steepness as the truck moved away from its parked position. The grade ranged from approximately 4.5 to 19 percent. The defined tire tracks left in the mud indicated the tires on the truck were rolling, not sliding, demonstrating the parking brakes did not stop the truck.
