UNITED STATES
DEPARTMENT OF LABOR
MINE SAFETY AND HEALTH ADMINISTRATION

REPORT OF INVESTIGATION

Fatal Powered Haulage Accident
August 3, 2021

Bridgeport Stone Plant
TXI Operations LP
Bridgeport, Wise County, Texas
ID No. 41-00007

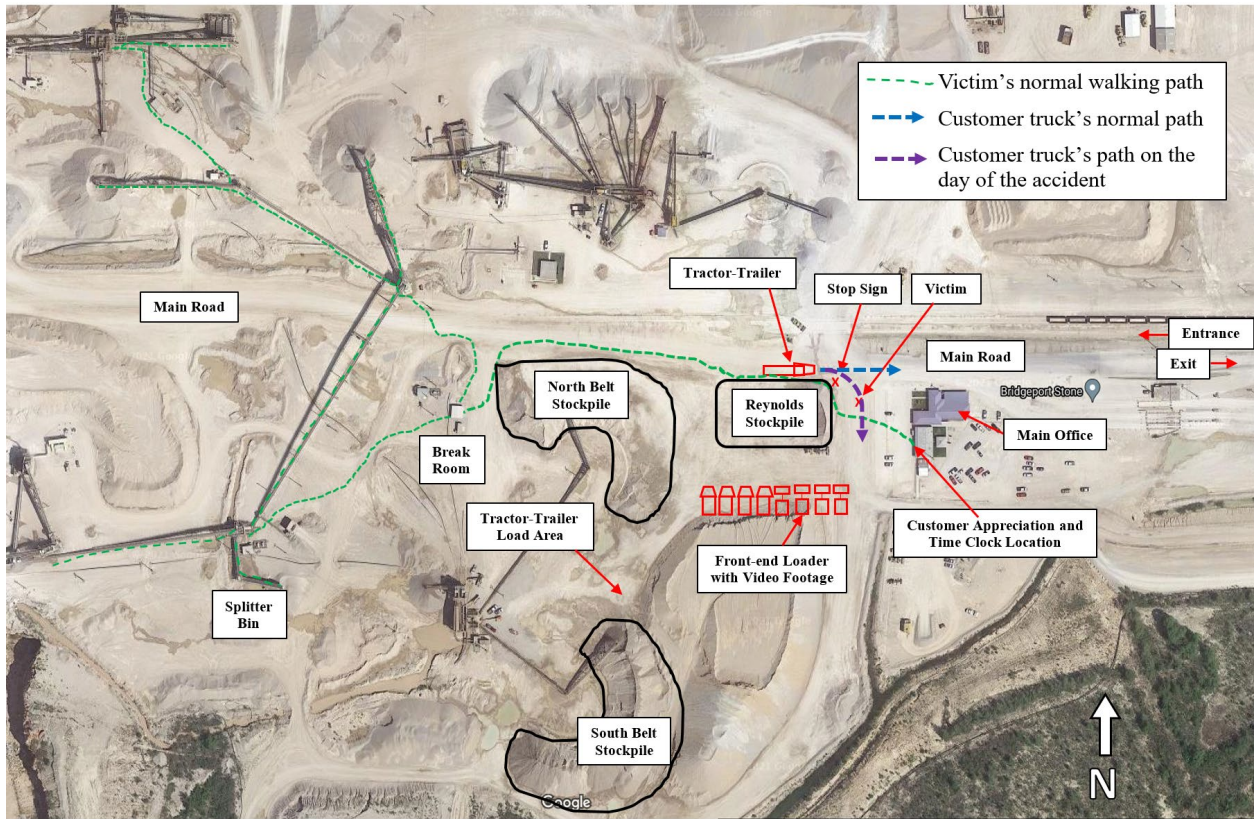
APPENDIX B – Aerial View of Bridgeport Stone Plant

The accident occurred on the roadway in the area between the main office and the Reynolds stockpile (see Appendix B).

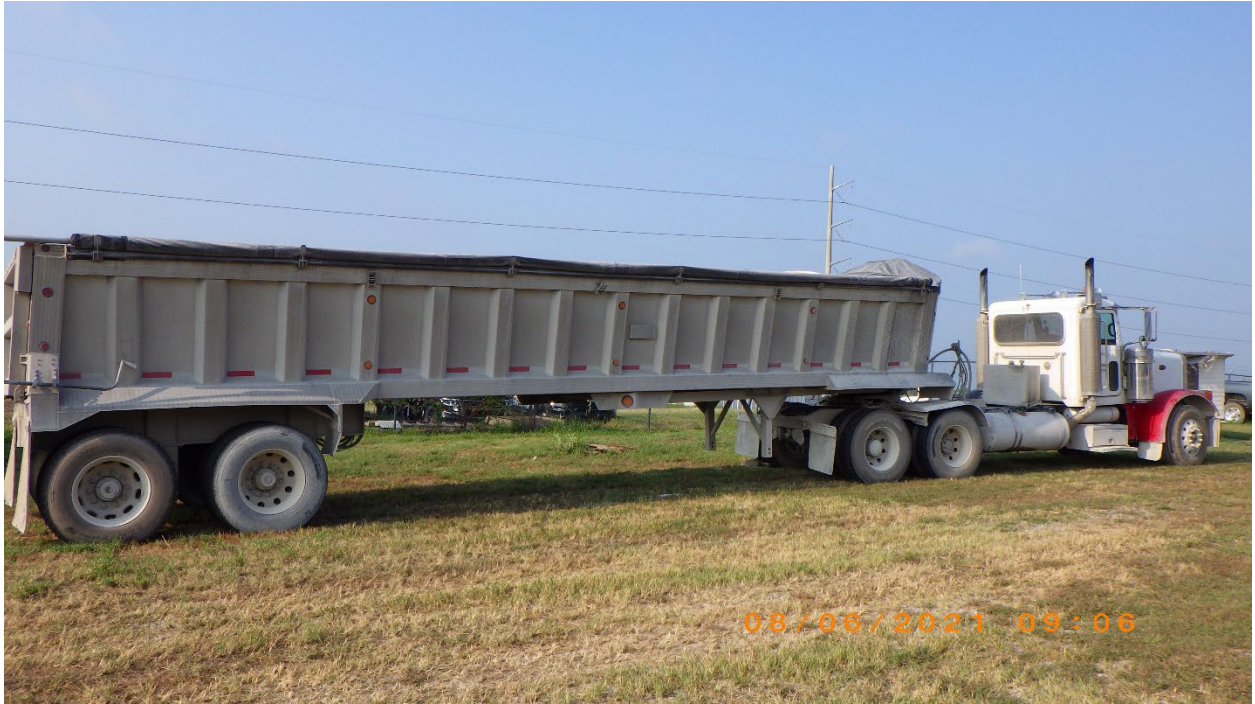
APPENDIX C – Haul Truck Owned by Rivas Transport

The mine customer's tractor-trailer was a 2006 Peterbilt commercial over-the-road haul truck owned by Rivas Transport, which was pulling an end dump trailer (see Appendix C). The truck was loaded with a net product volume of 26.6 tons of manufactured sand. The gross vehicle weight of the truck was 41.37 tons. The Gross Vehicle Weight Rating (GVWR) for the tractor is 52,000 lbs. (26 tons) and the GVWR for the trailer is 68,000 lbs. (34 tons), for a total GVWR of 120,000 lbs. (60 tons). Investigators determined that the tractor-trailer was not overloaded.

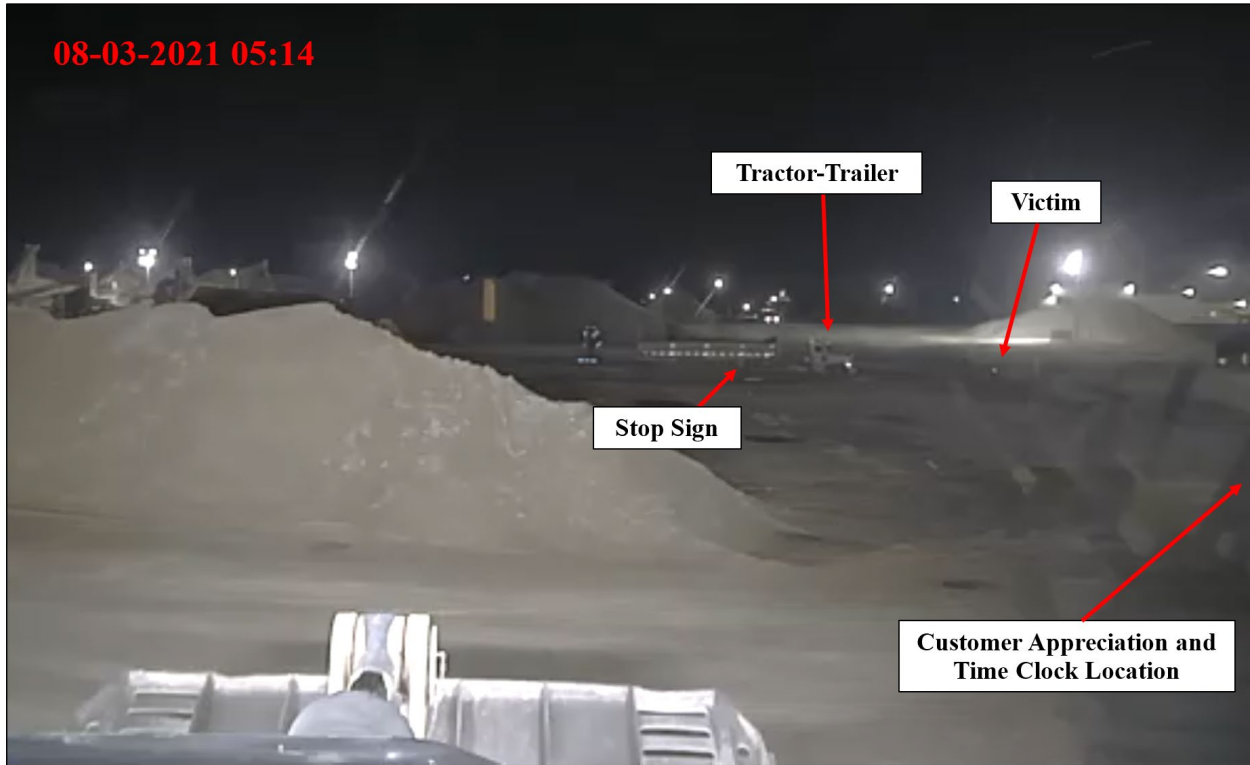
APPENDIX D – Still Image from Video of Accident Scene

A Komatsu WA900 front-end loader with an onboard video camera system was parked on the fleet equipment line, 226 feet south of the accident scene. The loader was parked facing the accident scene and the video camera recorded the accident. The video footage showed that Gutierrez-Olivas traveled past the posted stop sign on the main mine road without stopping, made a right-hand turn in front of the main office building, and struck Lovington as he crossed the roadway (see Appendix D).
