UNITED STATES
DEPARTMENT OF LABOR
MINE SAFETY AND HEALTH ADMINISTRATION

REPORT OF INVESTIGATION

Fatal Powered Haulage Accident
December 13, 2021

Liberty Ranch
Martin Marietta Materials Southwest, Inc.
Liberty, Liberty County, Texas
ID No. 41-05268

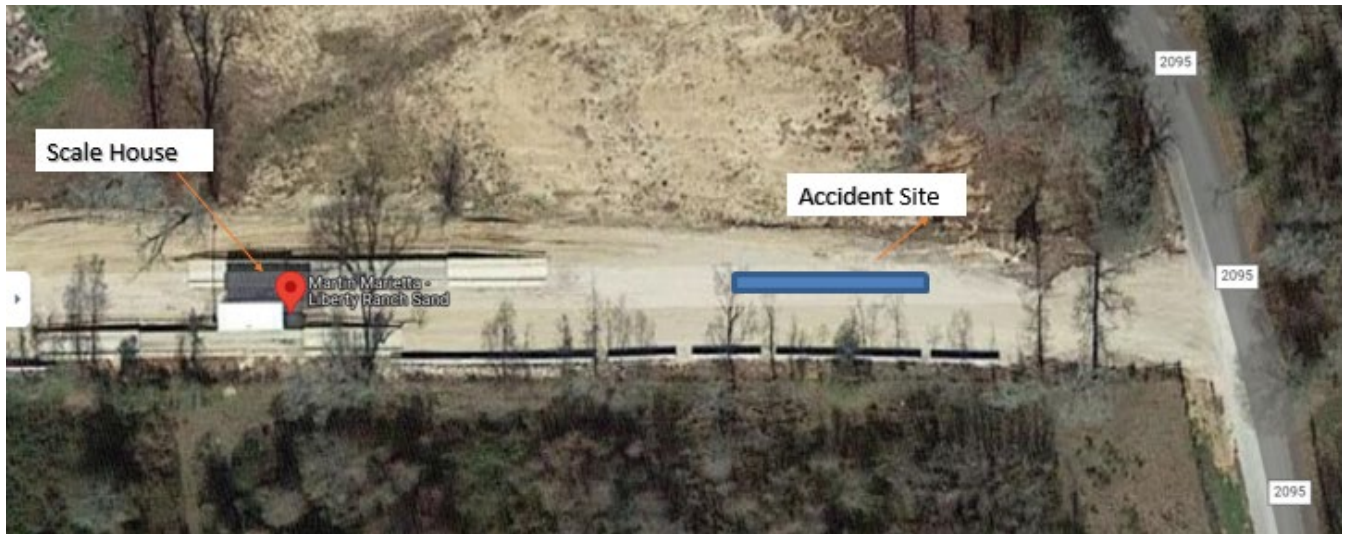
APPENDIX B – Photograph of the Accident Scene

The accident occurred on the main exit road approximately 300 feet from the scale house. The main exit area also serves as a tarping area for haul trucks. The tarping area is approximately 200 feet from the end of the scale house and is wide enough for trucks to pass (see Appendix B). The grade of the road where the accident occurred was approximately one to two percent. When investigators tested the brakes, the truck immediately rolled when the driver released the foot brake without the hand brake being set. There was no sign telling customer truck drivers to stay in their vehicles unless actively tarping, or to chock the wheels when parked in the tarping area. The mine operator did not assure truck drivers followed the established parking procedures when trucks parked on a grade.

Corrective Action: The mine operator installed signs in the tarping area that are understandable and instruct customer truck drivers to set their parking brake and chock their wheels when exiting their trucks. In addition, the mine operator has regraded the tarping area to a zero percent grade.

Corrective Action: The mine operator is now requiring that parking brakes will be set and wheel chocks will be placed in front of the tires while in the tarping area. The mine operator provided chocks for customer truck drivers. Scale house personnel will monitor the customer truck drivers using the wheel chocks. The mine operator installed an additional sign instructing drivers to remain in their trucks until they are in the tarping process. In addition, the mine operator created two tarping lanes to prevent trucks from having to stop directly behind each other.

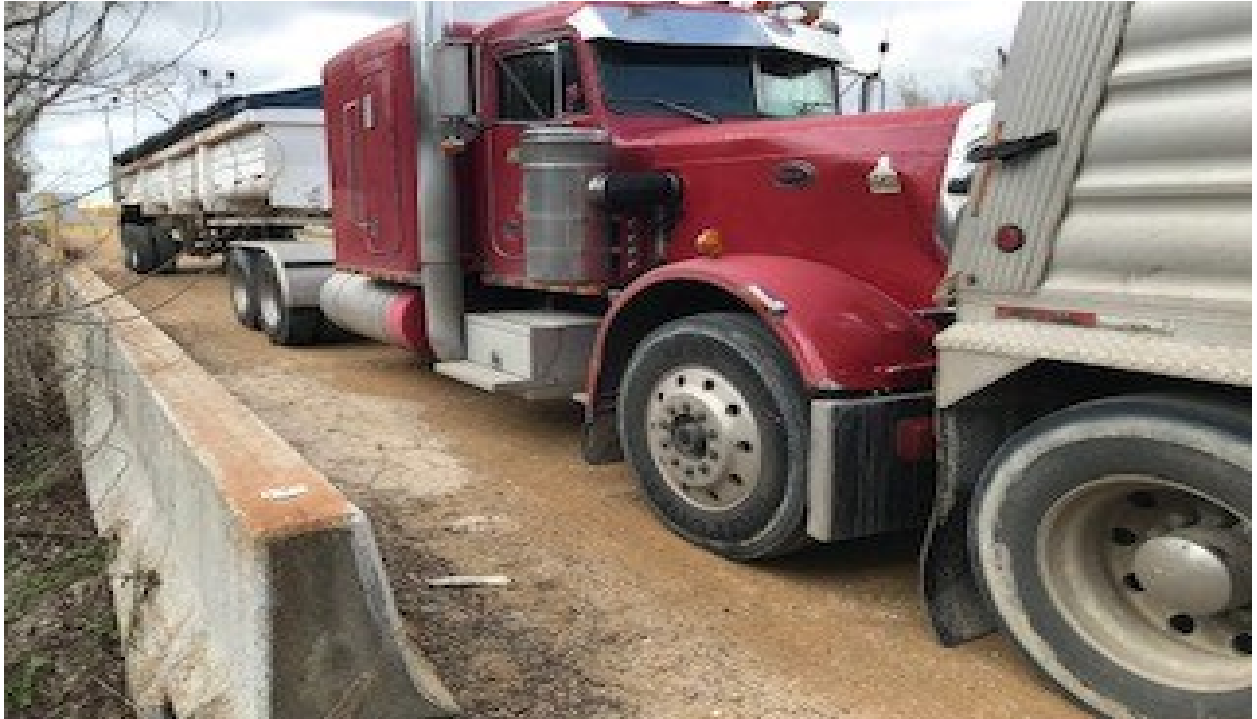
APPENDIX C – Photograph of the Equipment Involved

The customer truck is a 1980 Peterbilt Model 359M19 tractor, equipped with a Ranco end dump trailer (see Appendix C). Examination of the truck (tractor and trailer) did not reveal mechanical deficiencies or defects that contributed to the accident. Investigators found the hand brake on the trailer, and the service brakes and parking brakes on the tractor, functioned when tested and did not contribute to the accident.

Based on interviews and the functional parking brake test, investigators determined that Jimenez-Gonzales set the hand brake prior to leaving the truck. Truck drivers use the hand brake to engage the trailer brakes to maintain control of the trailer. Truck drivers can also use the hand brake while dumping a load out of the trailer to allow the tractor to move backward or forward while the trailer is being raised or lowered. The hand brake clearly states on the handle “Not for parking.” When the hand brake is set to a pressure of 35 pounds per square inch, it is designed to release on its own after approximately five seconds. Investigators determined that the trailer hand brake’s auto-release and the truck’s parking brake not being set contributed to the accident.

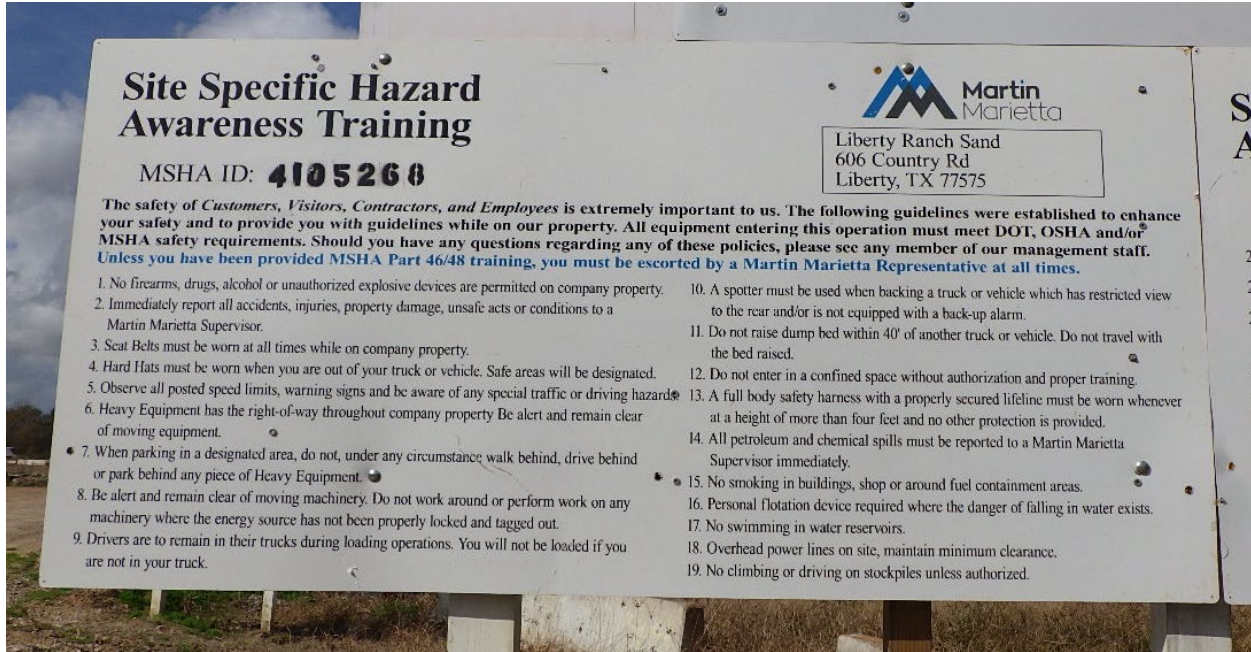
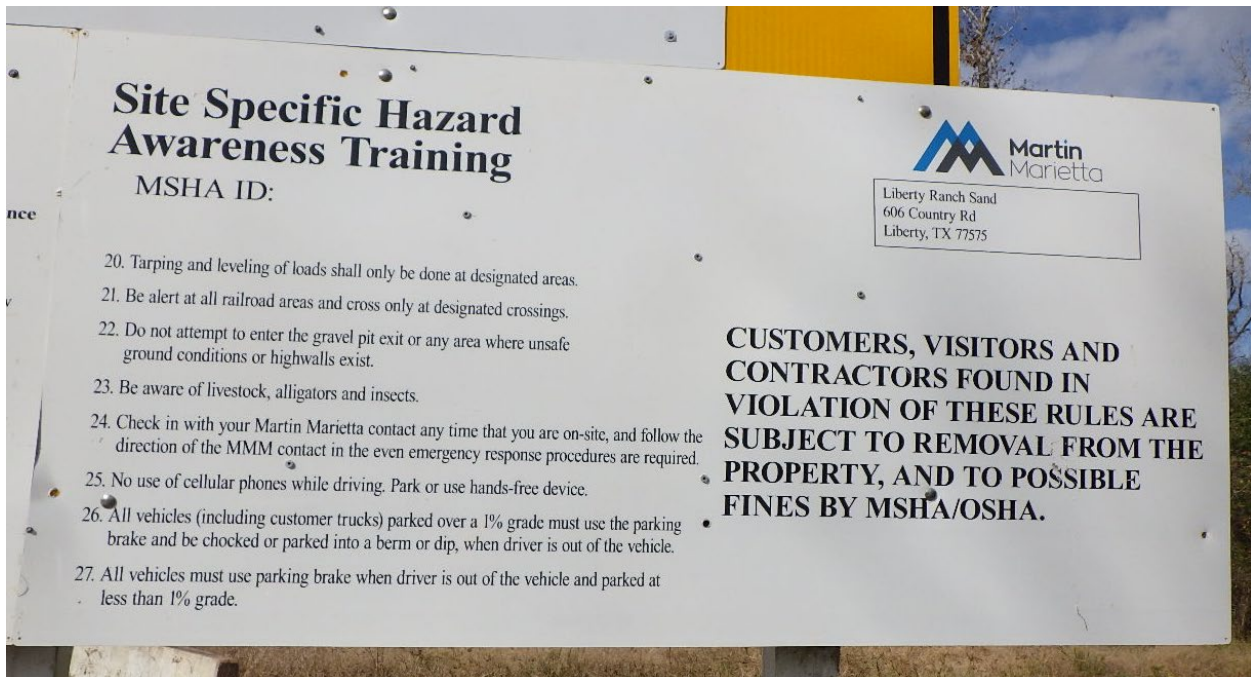
APPENDIX D – Site-Specific Hazard Awareness Training Signs

Jimenez-Gonzales had four years of experience driving the tractor trailer truck involved in the accident. Gonzales received site-specific hazard awareness training from the mine’s two, four-foot by eight-foot posted signs at the front gate (see Appendix D). There were 27 items listed on the two signs, which would not be clear and understandable for incoming customer truck drivers to read as they enter the mine. One of the items stated, “All vehicles (including customer trucks) parked over a 1% grade must use the parking brake and be chocked or parked into a berm or dip, when the driver is out of the vehicle”. Another item stated, “All vehicles must use parking brake when driver is out of the vehicle and parked at a less than 1% grade.” The mine operator did not have signs in the tarping area where the accident occurred to warn of the one to two percent grade that is not immediately obvious to customer truck drivers. The mine operator did not provide adequate site-specific hazard awareness training for the hazard posed by the grade of the tarping area.
