REPORT OF INVESTIGATION

Fatal Machinery Accident  
December 13, 2021

Imerys Carbonates USA, Inc  
Whitestone Mine #4  
Marble Hill, Pickens County, Georgia  
ID No. 09-00047

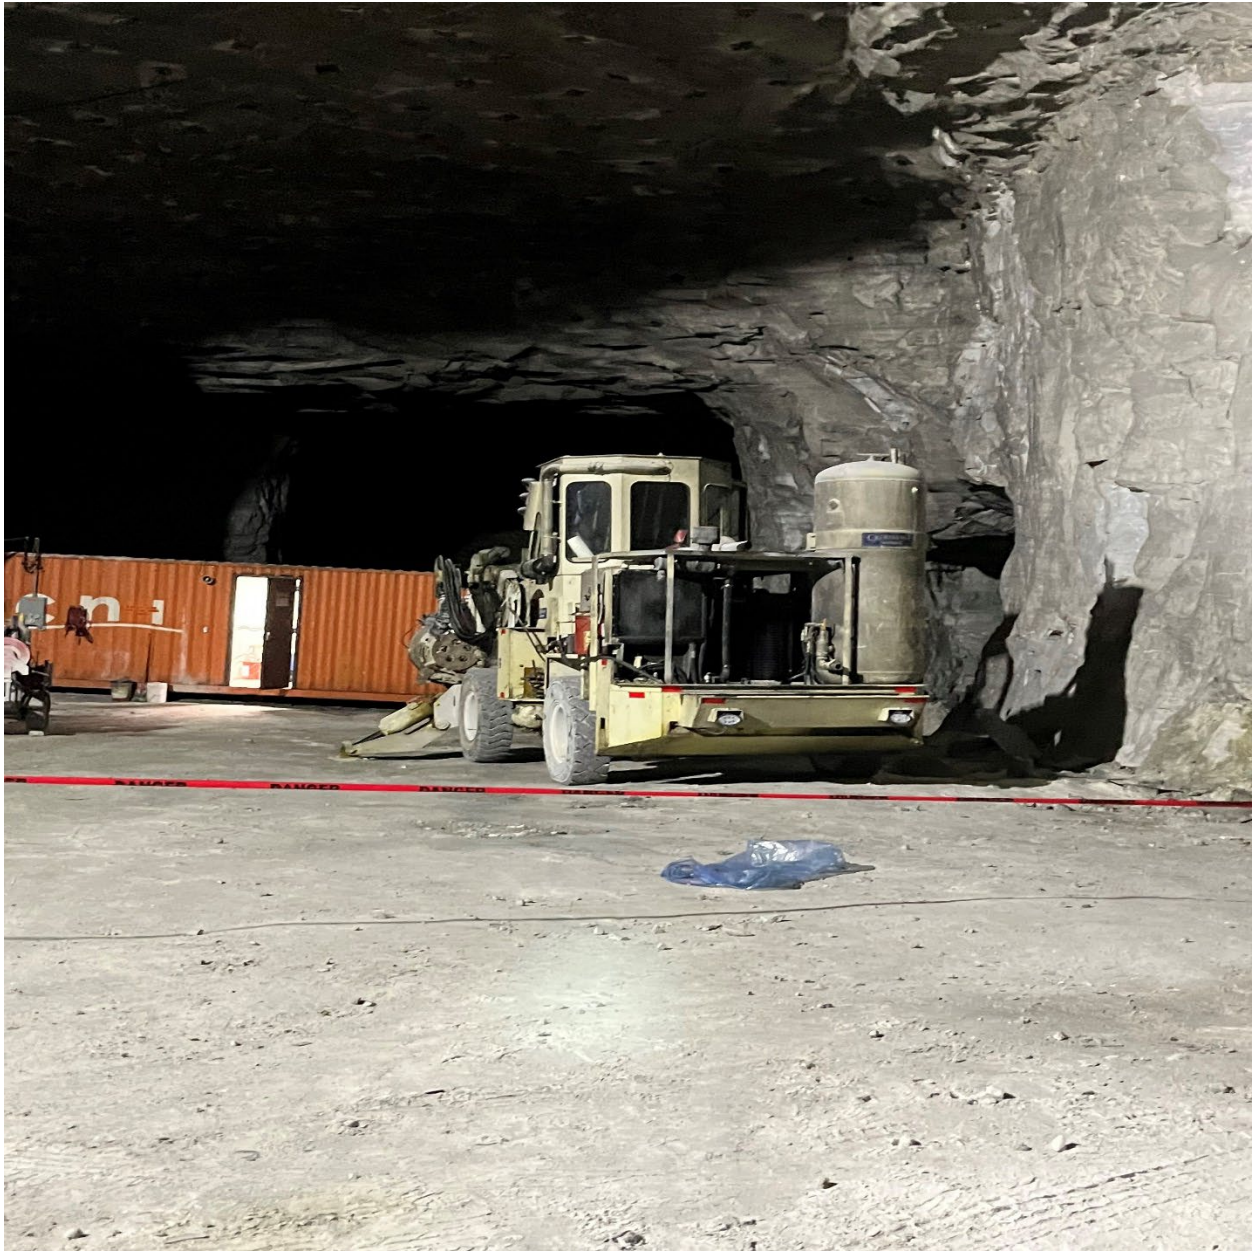
APPENDIX B – Accident Scene

The accident occurred at the 740-parking area in front of the underground maintenance shop. At the time of the accident, the roof bolting machine was the only piece of equipment parked in the 740-parking area (see Appendix B). Soon after the accident, a puddle existed on the ground near where the hydraulic hose had been replaced and where Dutton was found (see Appendix C). Investigators were unable to evaluate the fluid in the puddle because it had evaporated and/or seeped into the ground by the time they arrived.

Photograph of the rear of the roof bolting machine, parked in the 740-parking area.

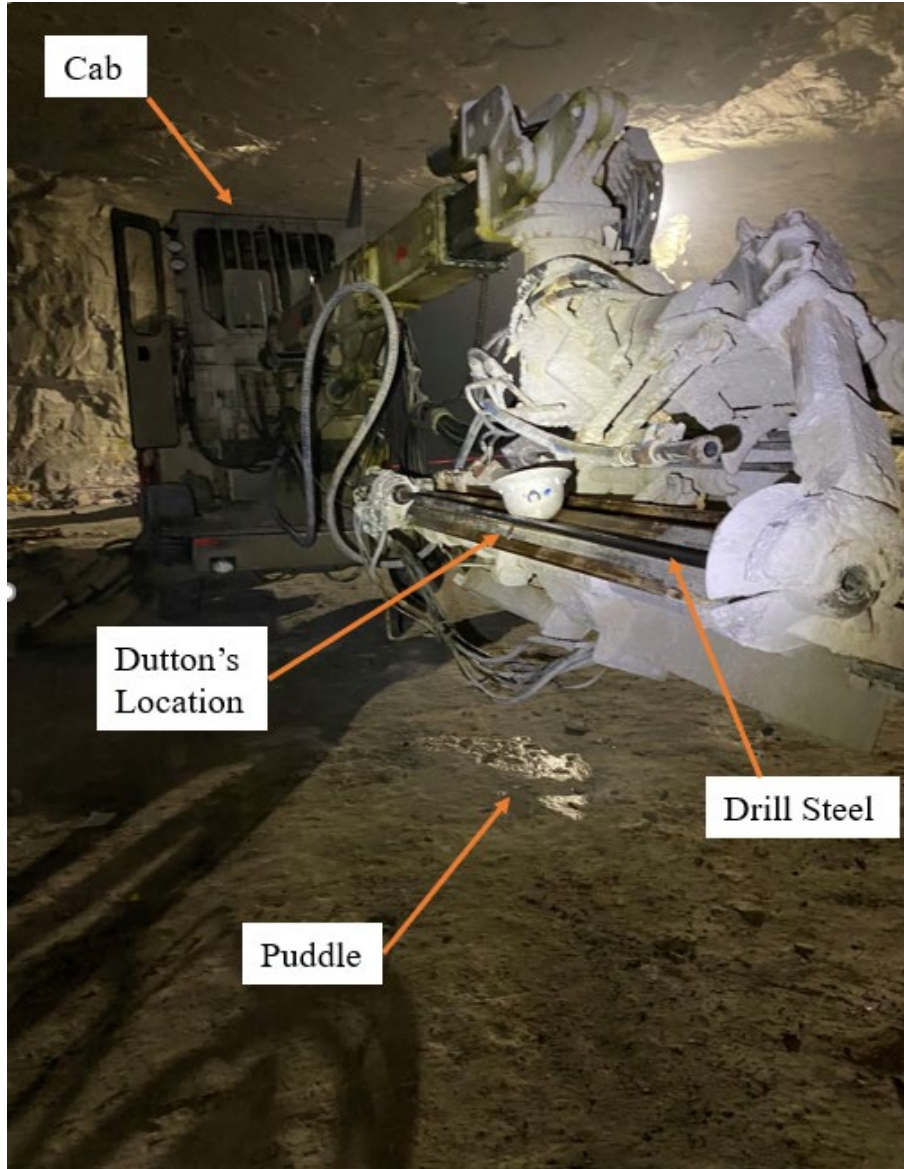
APPENDIX C – Equipment Involved

The roof bolting machine involved in the accident was an Oldenberg model DPI1HD-RB3-8 Mechanical Roof Bolter purchased in 2015. The roof bolting machine consists of a diesel engine-powered main body, and a hydraulically manipulated articulating boom that houses the rock drill and roof bolt installation machinery. From within the enclosed operator's cab, the roof bolting machine operator can remotely drill holes and install bolts into the mine's roof and pillars to stabilize the mine's tunnels.

As Dutton approached the rotating drill steel, it entangled his shirt and safety vest and pulled him tightly against the roof bolting machine, causing asphyxiation. To safely evaluate the repairs, the power should have been de-energized and the equipment should have been blocked against hazardous motion.

Photograph of the roof bolting machine boom, from the front.

Corrective Action: The mine operator developed and implemented written procedures that included de-energizing, locking-out and tagging-out, and blocking equipment against hazardous motion, before engaging in maintenance or repairs. The mine operator trained all affected miners in the new procedures.
