UNITED STATES  
DEPARTMENT OF LABOR  
MINE SAFETY AND HEALTH ADMINISTRATION

REPORT OF INVESTIGATION

Fatal Confined Space Accident  
December 6, 2021

Palm Beach Aggregates LLC  
Palm Beach Aggregates LLC  
Loxahatchee, Palm Beach County, Florida  
ID No. 08-01160

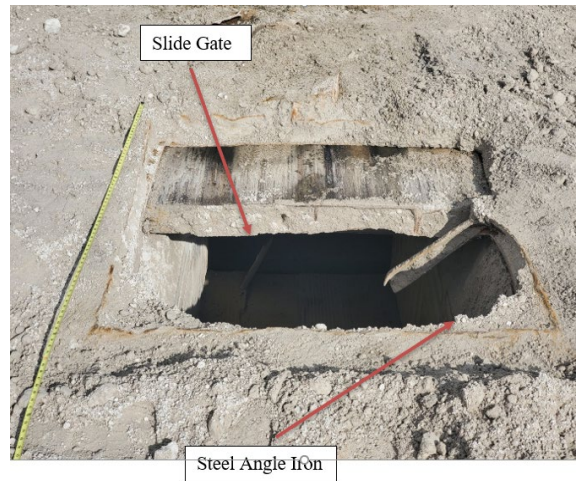
At approximately 5:00 p.m., Paul Evans, Maintenance Tech, arrived at the plant and joined the maintenance crew in the tunnel under the surge pile. Case, Thomas, Hill, Samuels, and Evans attempted to close the slide gate in the chute above the feeder by using the hydraulic cylinder levers. The slide gate isolates the feeder from the stone surge pile to prevent material from falling into the feeder during maintenance work or repairs. According to interviews, the miners could see that the slide gate was less than halfway across the four-foot opening, leaving a gap. They also saw material in the feeder. Samuels then left the tunnel to go to the control tower in case the feeder had to be turned on to empty it before replacing the wear plate liners. The remaining miners tried to close the slide gate again by opening it fully and closing it, but it still remained partially open. Thomas manually raked some material out of the feeder and looked inside. He observed a piece of steel angle iron (angle iron) blocking the slide gate (see Appendix A).

The feeder is installed below an opening in the roof of the concrete surge pile tunnel. This square opening in the tunnel is approximately four-foot by four-foot and constitutes a draw hole or opening in the roof of the tunnel through which material in the surge pile can flow onto the feeder. Steel plates form a chute and bridge the gap between the draw hole and the feeder. The draw hole is framed with steel angle iron to prevent damage to the concrete opening. Just below the opening is a four-inch slot for the slide gate to close and open. This slide gate regulates the flow of material from the surge pile into the feeder, and can normally be fully closed, preventing any material from passing into the feeder. On the day of the accident, the angle iron prevented the slide gate from closing fully. This was a contributing factor to the accident.

In October 2021, the surge pile was depleted to a level that exposed the top of the concrete tunnel. An excavator was used to remove the remnants of the surge pile to supply the feeder and continue plant operations. The piece of steel angle iron that blocked the slide gate from closing was part of the frame in the opening of the draw hole. Investigators believe that the teeth on the bucket of the excavator caught the lip and bent the steel angle iron down, blocking the slide gate. No report was made of this damage prior to the surge pile being resupplied, which concealed the damage.

Slide Gate Blocked by Steel Angle Iron (Photo taken after the surge pile was removed)

Corrective Action: The mine operator removed the surge pile and repaired the slide gate. The mine operator also implemented a written confined space program which identifies confined spaces at the mine and the protective measures miners must take before entering confined spaces. The mine operator trained all affected employees on the new procedures.

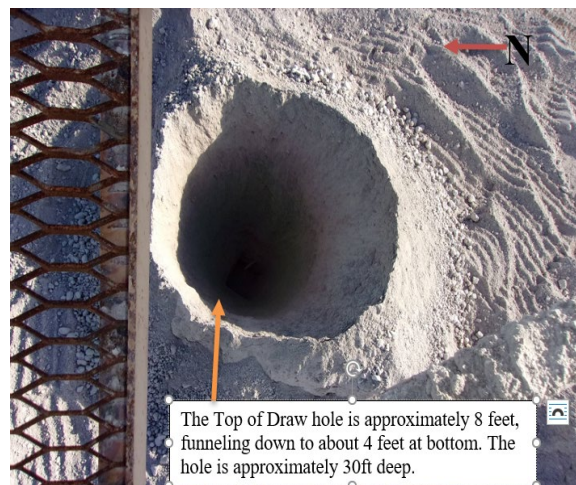
Thomas opened the slide gate completely and called Samuels to operate the plant and feeder to empty the surge pile draw hole, the feeder, and the tunnel belt conveyor. After approximately 20 minutes, Samuels turned everything off and left the area to work on other assigned tasks. After the plant was shut down, Case recommended to Thomas that they continue operating the feeder for a little longer to knock any potentially loose material down, but Thomas did not agree. Case and Thomas tried to close the slide gate again with no success. Thomas instructed Case to climb into the feeder and cut the angle iron to free the slide gate. Case climbed up and leaned inside the feeder to observe the conditions of the workplace. Case saw a four-foot diameter hole extending upward through the surge pile for approximately 30 feet. Case noticed that the walls of this hole were nearly vertical. This describes a condition known as "coning-out" or a "rat-hole," where material in a pile over an opening flows out and leaves a cylindrical hole or void in the pile with nearly vertical walls (see Appendix B). In such a condition, the material in the

surge pile is unstable, and can collapse into the void without warning. Case described this hole as “looking like a Pringles Potato Chip can.”

Without the slide gate to isolate the material in the surge pile, the potential for the material in the surge pile to collapse and fall into the feeder presented an imminent danger to miners entering the feeder to work. To have performed this work safely, the material in the surge pile should have been pulled back and removed.

Photograph Looking Down into Surge Pile Draw Hole

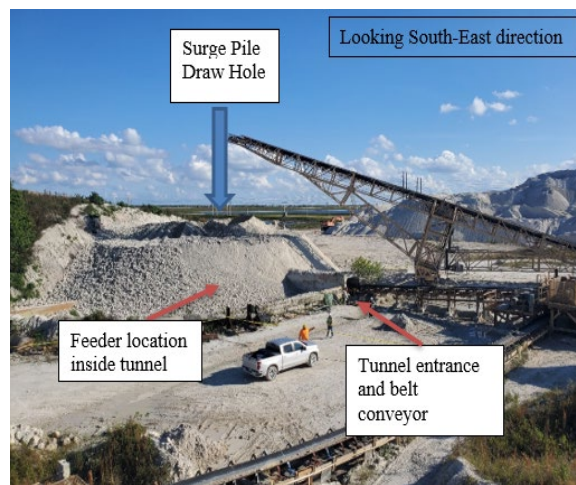
Case refused the work assignment in the feeder, and Thomas instructed Case to get out of the feeder. Thomas then climbed inside the feeder and reached into the chute to work on removing the piece of angle iron. As Thomas began to cut the angle iron with the oxygen acetylene torch, the tip clogged with material. Thomas instructed Case to get a new tip from the truck, and Case turned to walk out of the tunnel. After taking two steps, Case heard a loud crash in the feeder. Case turned to see that a mass of material from the surge pile had fallen through the draw hole, filled the chute and feeder, and engulfed Thomas.

Photograph of the Accident Site

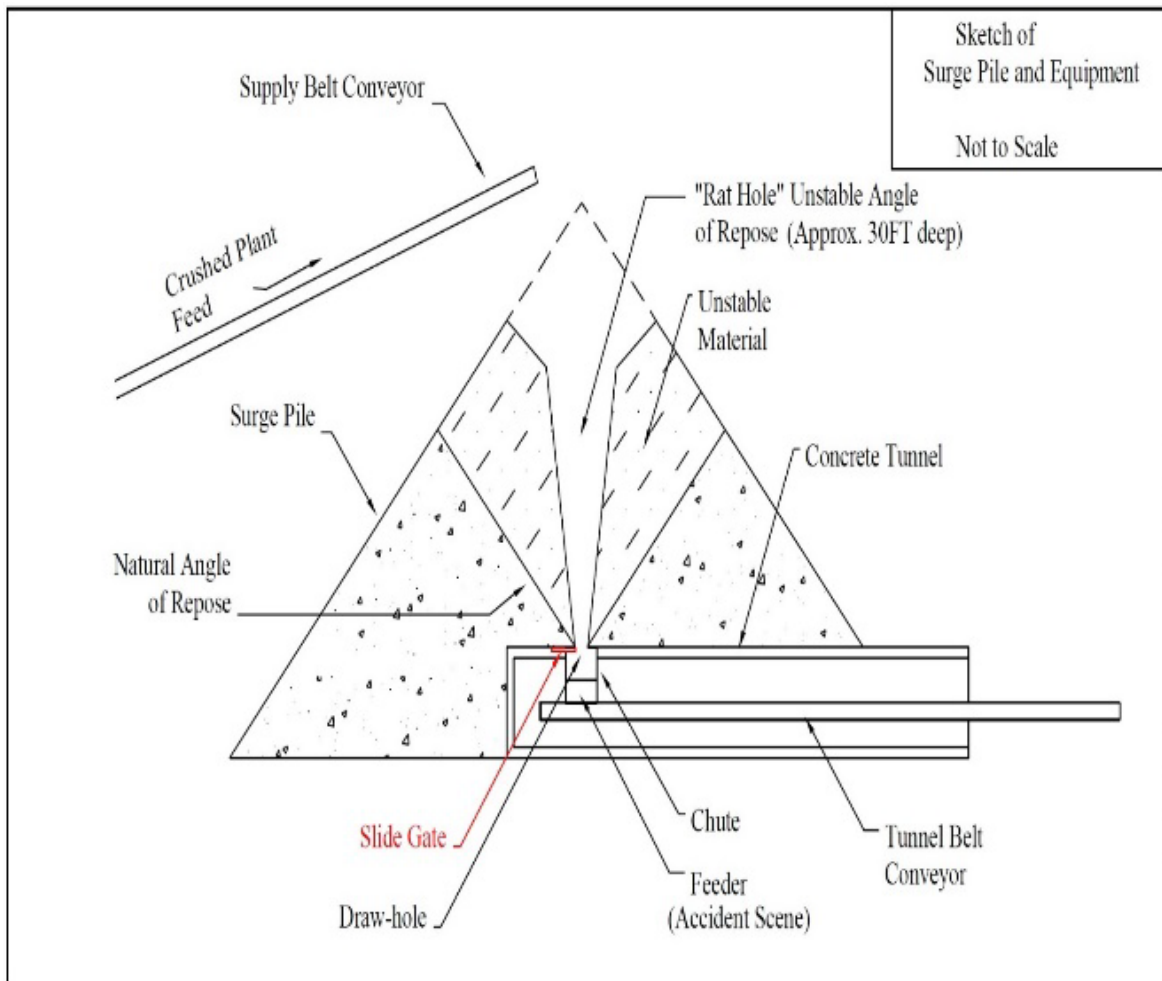
APPENDIX B – Sketch of Stone Surge Pile and Equipment

The accident occurred beneath the surge pile draw hole, where the material discharges from the surge pile through a chute into the feeder, and flows onto the tunnel belt conveyor. At the time of the accident, the surge pile was approximately 30 feet in depth and approximately 100 feet in diameter at its base. The surge pile forms a cone of material on top of the feed tunnel, above the slide gate, feed chute, and feeder.
