UNITED STATES  
DEPARTMENT OF LABOR  
MINE SAFETY AND HEALTH ADMINISTRATION

REPORT OF INVESTIGATION

Fatal Powered Haulage Accident  
February 22, 2021

Immel Mine  
Nyrstar Tennessee Mines, Strawberry Plains LLC  
Mascot, Knox County, Tennessee  
I.D. No. 40-00170

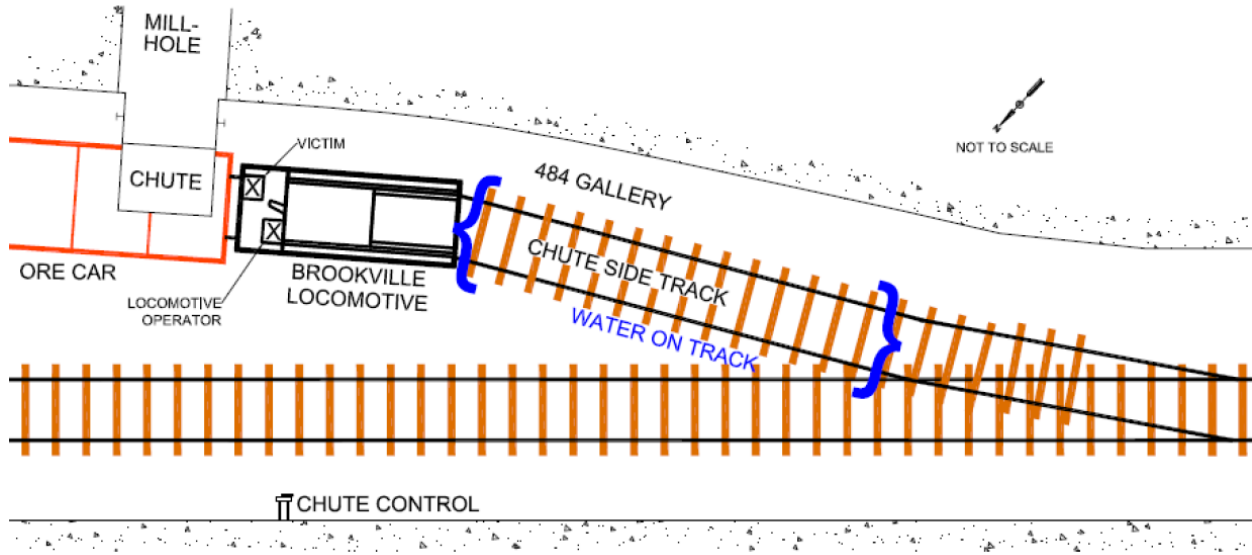
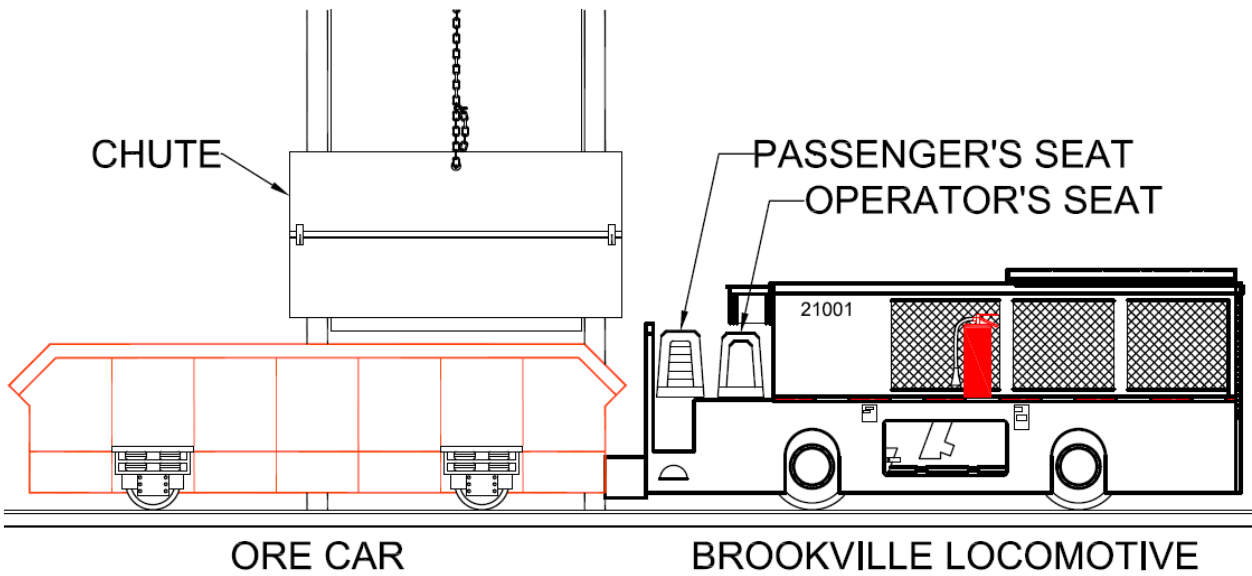
Appendix A – Drawing of the Accident Scene

The accident occurred at the 484 Gallery chute located on the 484 level in the underground mine. The mine operator's video surveillance continually monitors the loading process at the 484 Gallery. Monitors are located on the mine surface, which allows the mine operator to observe the loading process in real time. One of the monitors is located in the mine superintendent's office, however, no one witnessed the accident because the mine operator did not require continuous observation of the monitors.

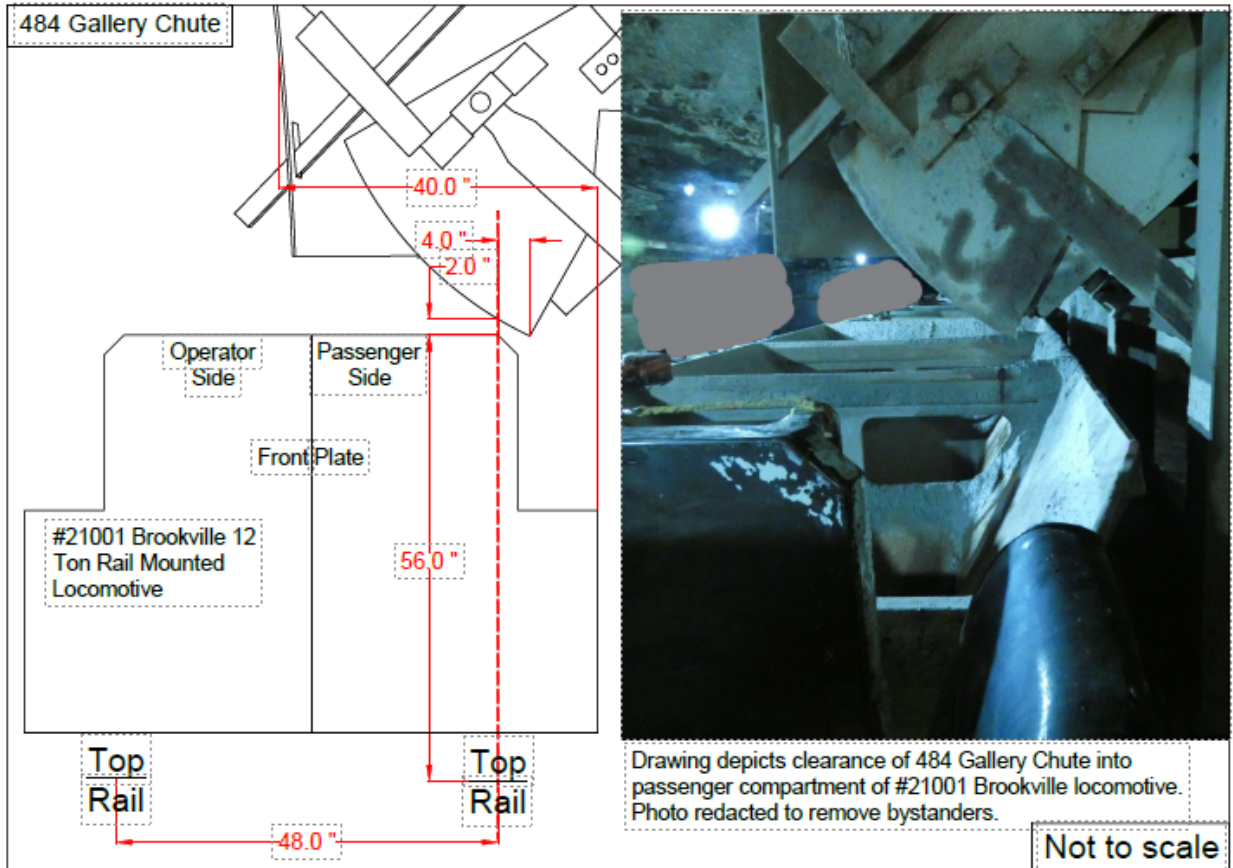
Appendix D – Measurements at the Accident Scene

The suspended stationary chute is two inches above the front plate of the operator's compartment on the locomotive (see Appendix D). In addition, the chute extends 40 inches into the track

haulageway. The ore cars are lower than the chute and can pass underneath it. However, the operator's compartment in the locomotive is higher than the front plate and cannot pass under the chute. Testimony indicated miners did not realize that the front plate of the locomotive would pass under the chute resulting in the chute intruding into the operator's compartment of the locomotive (see Appendix D).

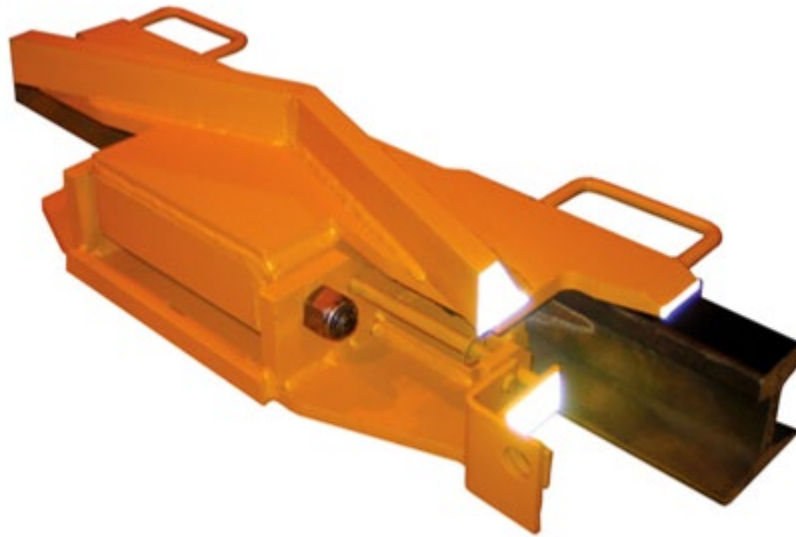
**Nolan's HDM mine derail**

1. Stop blocks, derail devices, or other devices were not installed to stop the locomotive before colliding with the chute.

Corrective Action: The mine operator developed a written program containing proper procedures for operating the locomotive. The procedures require the first ore car, behind the locomotive, to be loaded in the middle of the car, which adds an additional five feet of clearance from the locomotive to the chute. Additionally, the mine operator installed two concrete bin blocks and a Nolan derail system behind the chute near the end of the track to prevent the locomotive from contacting the chute (see Appendix E). The mine operator also turned the locomotive engine around so that the locomotive engine is closest to the chute and the operator's deck of the locomotive is farther from the chute. The mine operator trained all locomotive operators/chute pullers on these procedures.
