REPORT OF INVESTIGATION

Surface
(Aggregates)

Powered Haulage Accident
February 8, 2021

Washington County Aggregates Inc.
Potosi, Washington County, Missouri
ID No. 23-02077

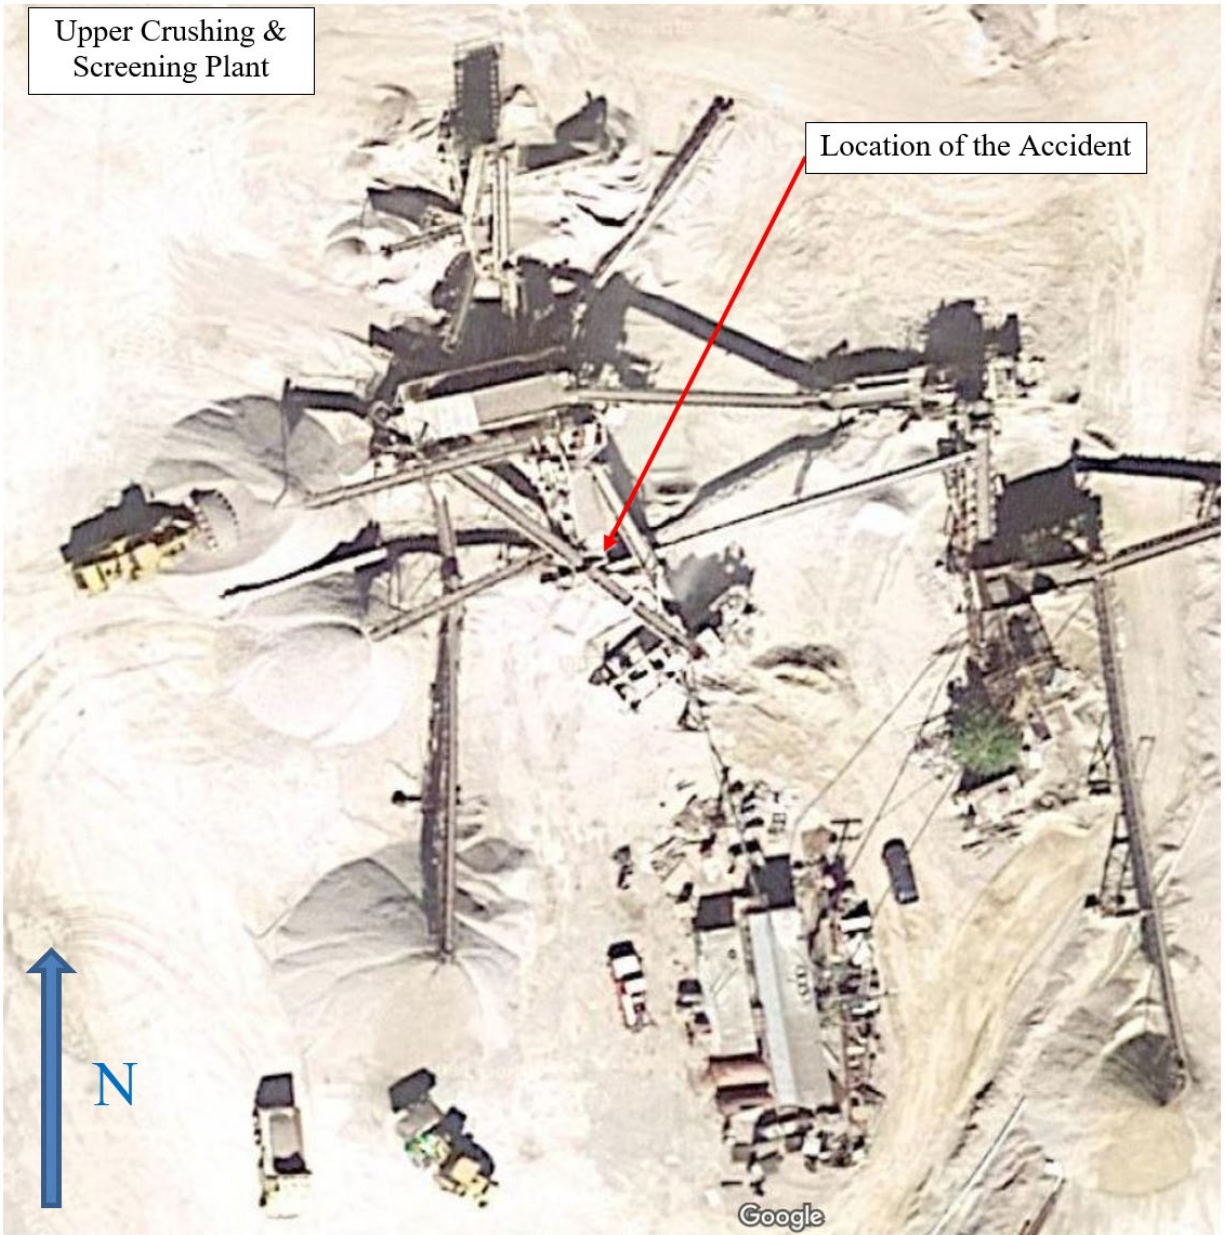
APPENDIX B – Photograph of the Accident Scene

The accident occurred at the tail pulley of the bypass belt conveyor, which is located under the discharge chutes for the Telsmith screen at the Upper Crushing & Screening Plant adjacent to the quarry pit (see Appendix B). Investigators were unable to determine who had removed a section of the area guard to access the bypass belt conveyor's tail pulley. The area guard enclosed three self-cleaning tail pulleys for three separate belt conveyors. The three separate belt conveyors are referred to as the stacker belt, the bypass belt conveyor and the Telsmith belt conveyor. Based on Solomon's normal duties and information gathered during the investigation, investigators concluded that Solomon entered this area to clean spilled material.

The area guard was constructed of multiple panels of expanded metal. The area guards were not securely attached to the belt conveyor structure. The mine operator had set the relatively small area guard panels on straight horizontal pins so that they could be easily removed or defeated. MSHA determined that the tail pulleys were improperly guarded. There were no warning signs to warn miners of the multiple hazards inside the guard or to instruct miners to turn the belt conveyors off and block against hazardous motion prior to entry.

Corrective Action: The mine operator has installed appropriate equipment guards on all three of the belt conveyors enclosed by the area guard at the accident scene, and has completed a review of all other equipment guarding on the mine site.

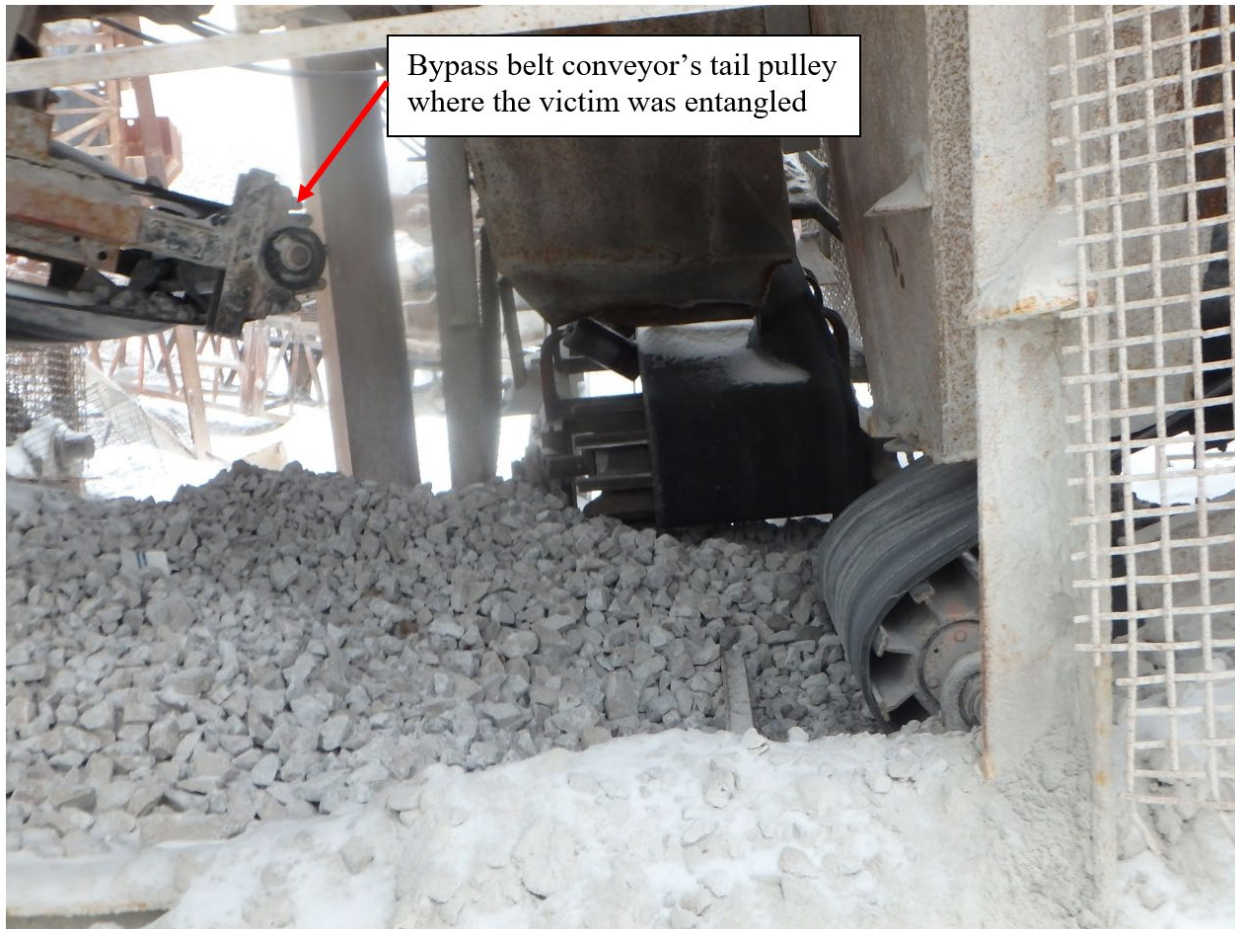
APPENDIX C – Photograph of the Equipment Involved

The bypass belt conveyor was equipped with an 8.5-inch diameter self-cleaning tail pulley (see Appendix C). The bypass belt conveyor can feed the horizontal shaft impactor at the plant or bypass the impactor and recirculate the rock back to the cone-crusher. Investigators found the belt conveyor in the bypass mode at the time of the accident. All three belt conveyors were not powered off or secured against hazardous motion before performing maintenance on the machinery.

Based on examination of the accident scene, investigators concluded that Solomon's coat was unzipped because of a broken zipper which caused the front of the coat to flap open. Solomon's coat became entangled in the self-cleaning tail pulley of the bypass belt conveyor.

Corrective Action: The mine operator developed a new written procedure for cleaning and performing maintenance on conveyor belts. The procedure requires the power to the conveyor belt to be turned off, locked and tagged out, and tested to assure power is off before guards are removed and cleaning or maintenance is performed. The mine operator retrained all miners in the procedure. The mine operator has provided locks and tags for the miners' use.
