REPORT OF INVESTIGATION

Fatal Machinery Accident
January 16, 2021

Red Dog Operations
Teck Alaska Incorporated
Kotzebue, Northwest Arctic Borough, Alaska
ID No. 50-01545

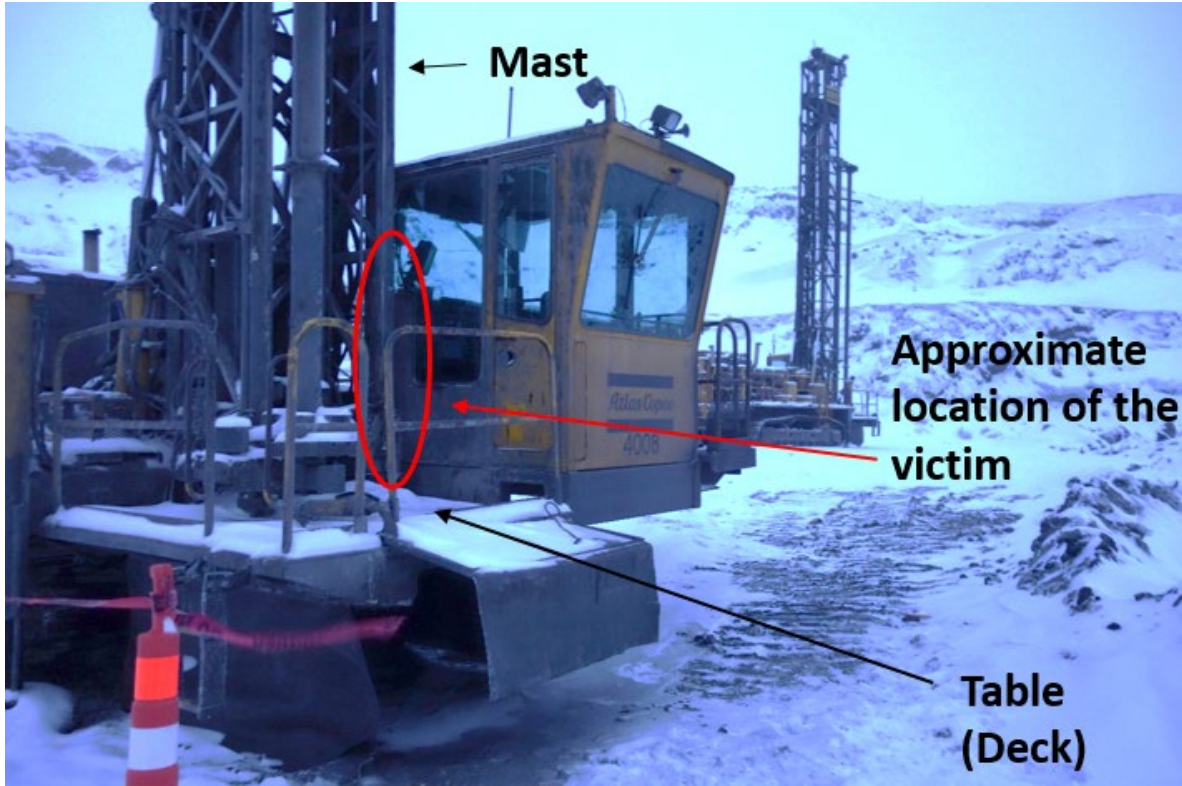
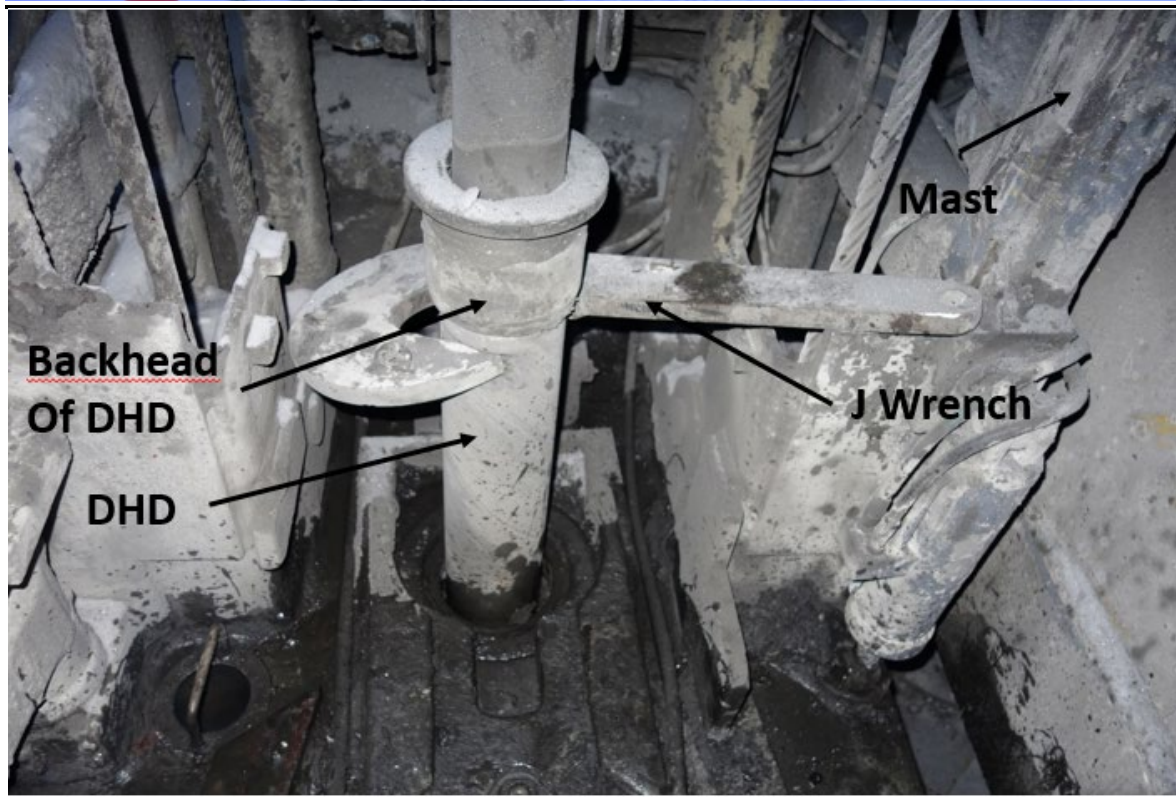
APPENDIX B – Photographs of Company Drill #40-008

The drill involved in this accident is a track-mounted Atlas Copco drill (see Appendix B). The DHD is an air-driven, piston-powered device used for drilling hard rock. The manufacturer's manual states that the J wrench must be placed on the backhead so that the J wrench is slightly above the deck when being used. Investigators found the J wrench 27 inches above the deck on the backhead.

Investigators inspected the drill, observed drill function, including drill rotation, and did not find defects that contributed to the accident. The investigators were unable to replicate or determine the cause of the rapid counter-clockwise rotation.

Corrective Action: Red Dog Operations implemented a new written policy in conformance with the manufacturer's manual for de-tooling the DHD. The mine operator trained miners and managers on the new written policy, which includes placing the J wrench on the backhead so that the J wrench is slightly above the drill's deck, and remaining clear of pinch points as stated in the manufacturer's manual.
