REPORT OF INVESTIGATION

Underground
(Coal)

Fatal Powered Haulage Accident
January 22, 2021

Davy Branch Mine
Aracoma Coal Company, Inc.
Logan, Logan County, West Virginia
ID No. 46-09574

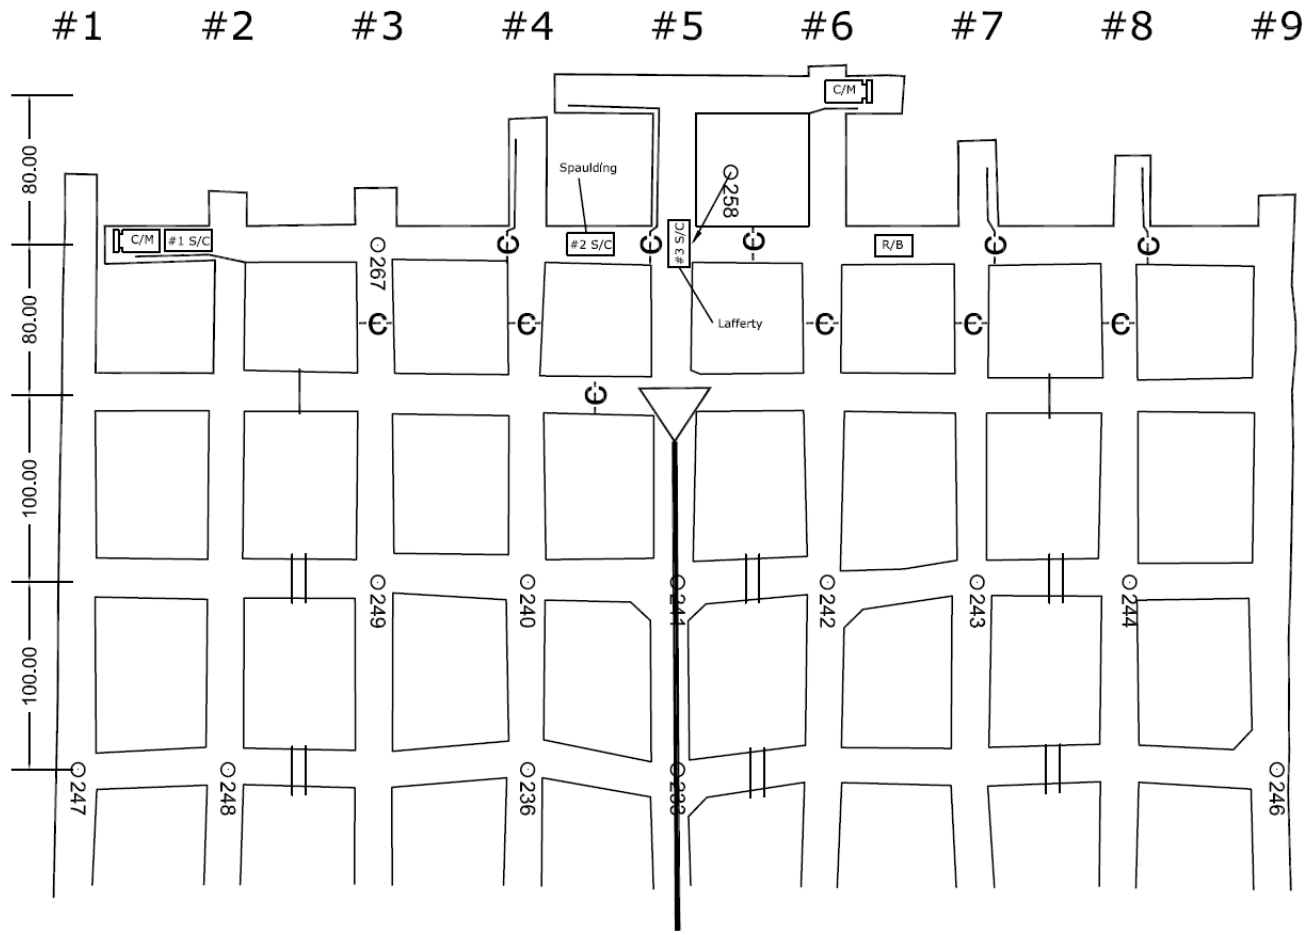
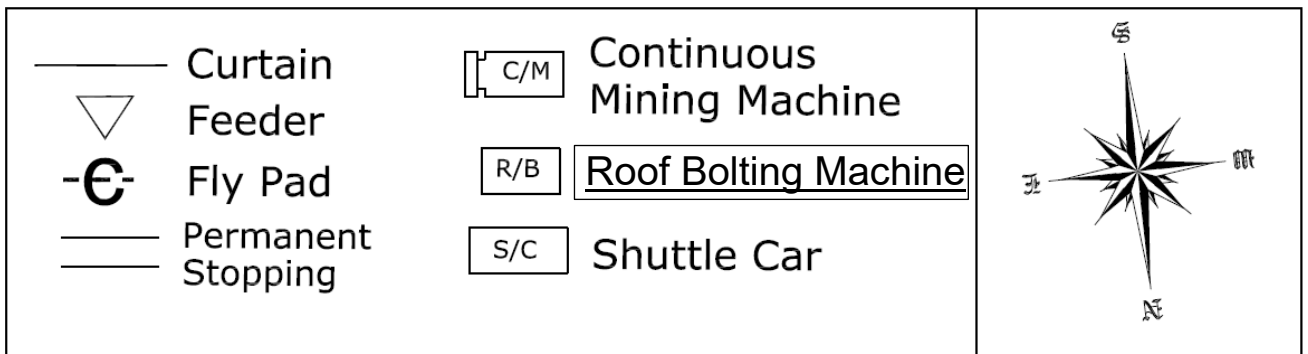
Appendix A – Drawing of the No. 1 Section

At approximately 7:00 a.m., the section crew began producing coal. Lafferty was operating the No. 3 shuttle car from the No. 6 right crosscut, and Chad Spaulding, Shuttle Car Operator, was operating the No. 2 shuttle car from the No. 2 left crosscut. Both were traveling outby to the section feeder located in the No. 5 entry (belt entry). The two shuttle cars shared the No. 5 entry from the intersection at survey station (SS) 258 to the section coal feeder (see Appendix A).

At approximately 7:40 a.m., Lafferty was traveling outby in the No. 5 entry into the intersection at SS 258, while Spaulding traveled through the No. 5 left crosscut and flypads, entering the intersection at the same time (see Appendix A). The boom portion of Spaulding's shuttle car entered the operator's compartment of Lafferty's shuttle car, striking Lafferty's right hip and leg. Spaulding stated he heard Lafferty yell. Spaulding immediately stopped his shuttle car, walked through the flypads and saw his shuttle car on Lafferty. Lafferty told Spaulding his leg was hurt. Spaulding told Lafferty he was going to back the shuttle car off him. After backing the shuttle car away, Spaulding went back to check Lafferty again.

This accident occurred in the intersection of the No. 5 entry on the No. 1 Section at SS 258. (See Appendix A).

Lafferty's shuttle car. Investigators did not find any violations on the shuttle cars, flypads, or roadway that would have contributed to the accident. Investigators determined that equipment operators are unable to determine if another shuttle car is arriving at the intersection at the same time where flypads are used. The flypads and intersections create line of sight restrictions.

Corrective Action: The mine operator revised their approved ventilation plan addressing haulage equipment traveling through flypads. The revision includes discontinuing the practice of shuttle cars from different MMUs sharing a common intersection where flypads are used. Mine management trained all miners on the revised policies and procedures which were incorporated in the Approved Ventilation Plan. Miners also received training on Safeguard No. 9291763 issued as a result of the investigation (see Enforcement Actions item 2).
