REPORT OF INVESTIGATION

Fatal Fall of Face, Rib, Side or Highwall Accident
July 13, 2021

Immel Mine
Nyrstar Tennessee Mines, Strawberry Plains LLC
Mascot, Knox County, Tennessee
ID No. 40-00170

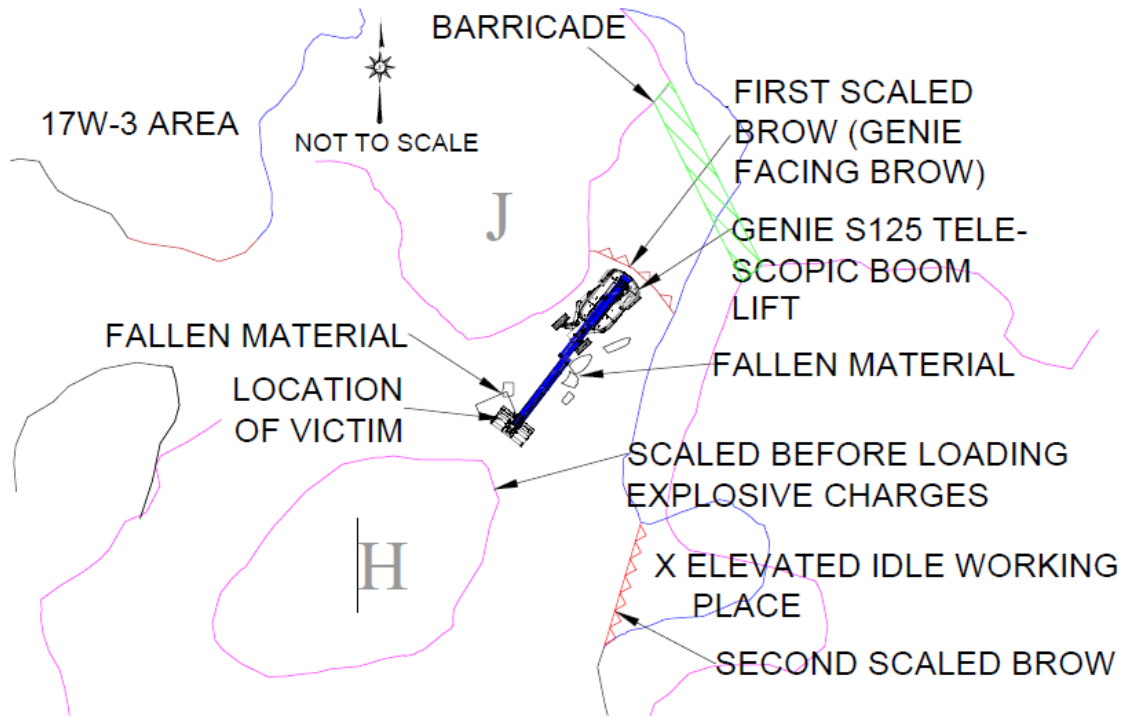
APPENDIX A - Sketch of the 17W-3 Area and Accident Scene

This accident occurred in the 17W-3 area of the mine, near the J-Pillar and H-Pillar.

On the left side of the H-Pillar, a vertical crack extended from the bottom of the pillar to approximately 37 feet above the mine floor. Miners were in the process of using explosives to remove the vertical rib crack. When observed from the upper left side, the top of the H-Pillar showed serious deterioration and loose, unconsolidated, potentially hazardous material. The adjacent pillar (J-Pillar) had an overhanging rock near the top of the rib, and it was clear to investigators that some rock had broken loose and fallen, leaving additional loose rock hanging. Investigators determined that the lift being used to scale the area could not be placed in a safe location while scaling.

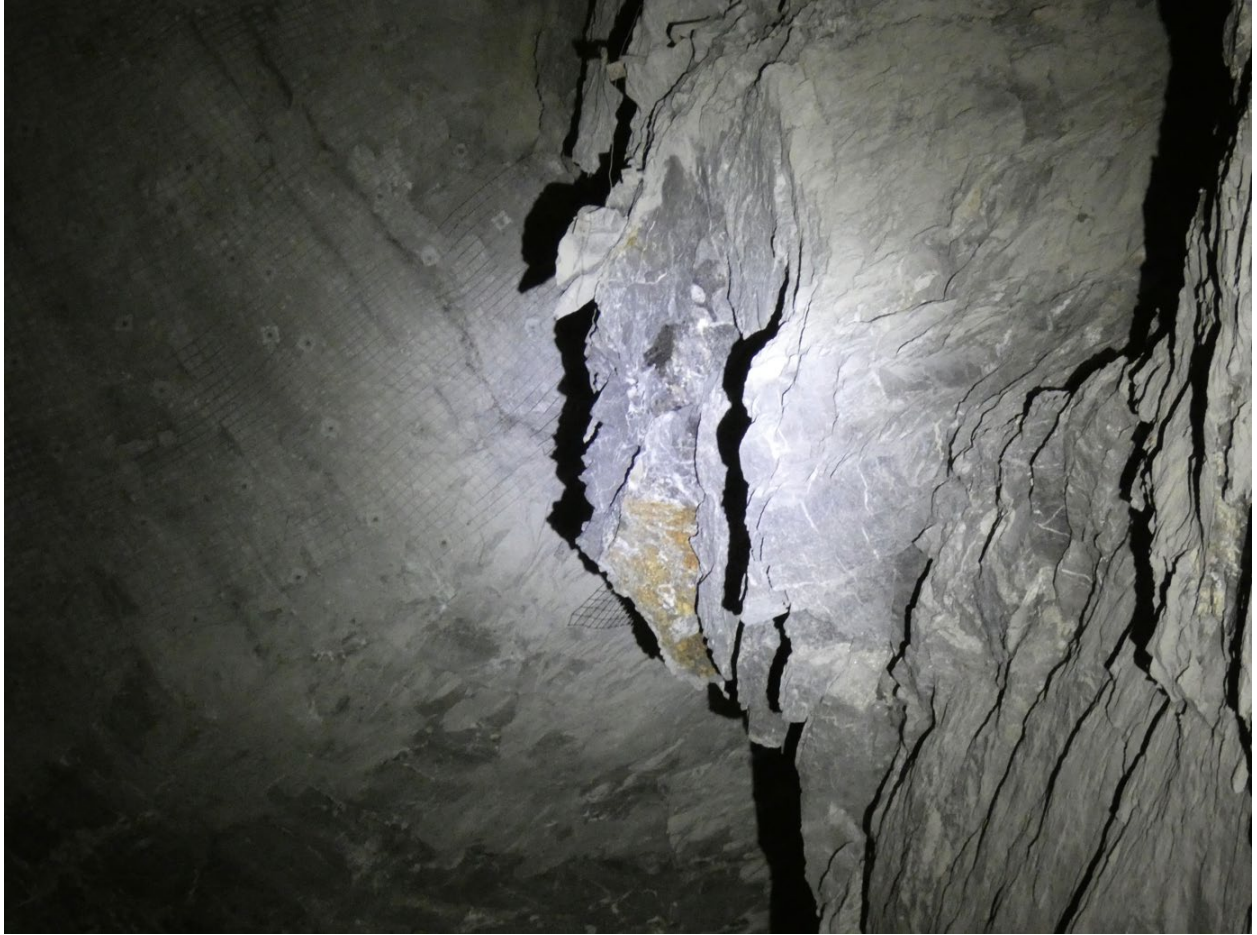
APPENDIX C - Photograph of Fall Origin

Interviews revealed that on the day prior to the accident, several rocks had fallen while miners loaded material onto trucks. This required further clean up and barricading of the area. There were several loose rocks laying on the mine floor that had fallen from either the ribs or the roof the day before. The rocks were too large for the loaders to move and had to be blasted to reduce their size. The mining height was normally 25 to 30 feet, but at the accident scene was 108 feet. The rock that struck Turbyville fell from the rib of the J-Pillar, located on the right side of the lift. The rock was 79 feet above the mine floor, weighed 3.32 tons, and measured approximately seven feet long, five feet wide, and 19 inches thick (see Appendix C).

3. These growing hazards culminated on the day of the accident when a rock fell from the rib of J-Pillar, 79 feet above the mine floor. The rock weighed 3.32 tons and fatally injured one miner and severely injured a second miner. Several of the

seven-foot friction (split set) galvanized roof bolts were pulled from the mine rib and were visible in the fallen material.

Corrective Action: The mine operator identified and examined all high mine roof and rib areas with the expertise of geologists, engineers, and mine management. The mine operator implemented written procedures that address scaling, meshing, and additional support to correct hazardous conditions when encountered. The mine operator trained miners on the new written procedures.

Corrective Action: The mine operator implemented written procedures for the development of future high roof areas, which includes eliminating any areas that cannot be mechanically scaled. All miners have been trained on the procedures.

Corrective Action: The mine operator implemented a written procedure for any area that has the potential to become a high roof area, defined as areas having roof heights over 35 feet high. These areas will be pattern-bolted with screen which extends a minimum of 3 feet down the rib. The screen must extend down the ribs/pillars/brows/overhangs to a level where proper ground control support activities can be undertaken by the equipment. All miners have been trained in the new procedure.
