REPORT OF INVESTIGATION

Fatal Machinery Accident
July 21, 2021

Black Thunder
Thunder Basin Coal Company LLC
Wright, Campbell County, Wyoming
ID No. 48-00977

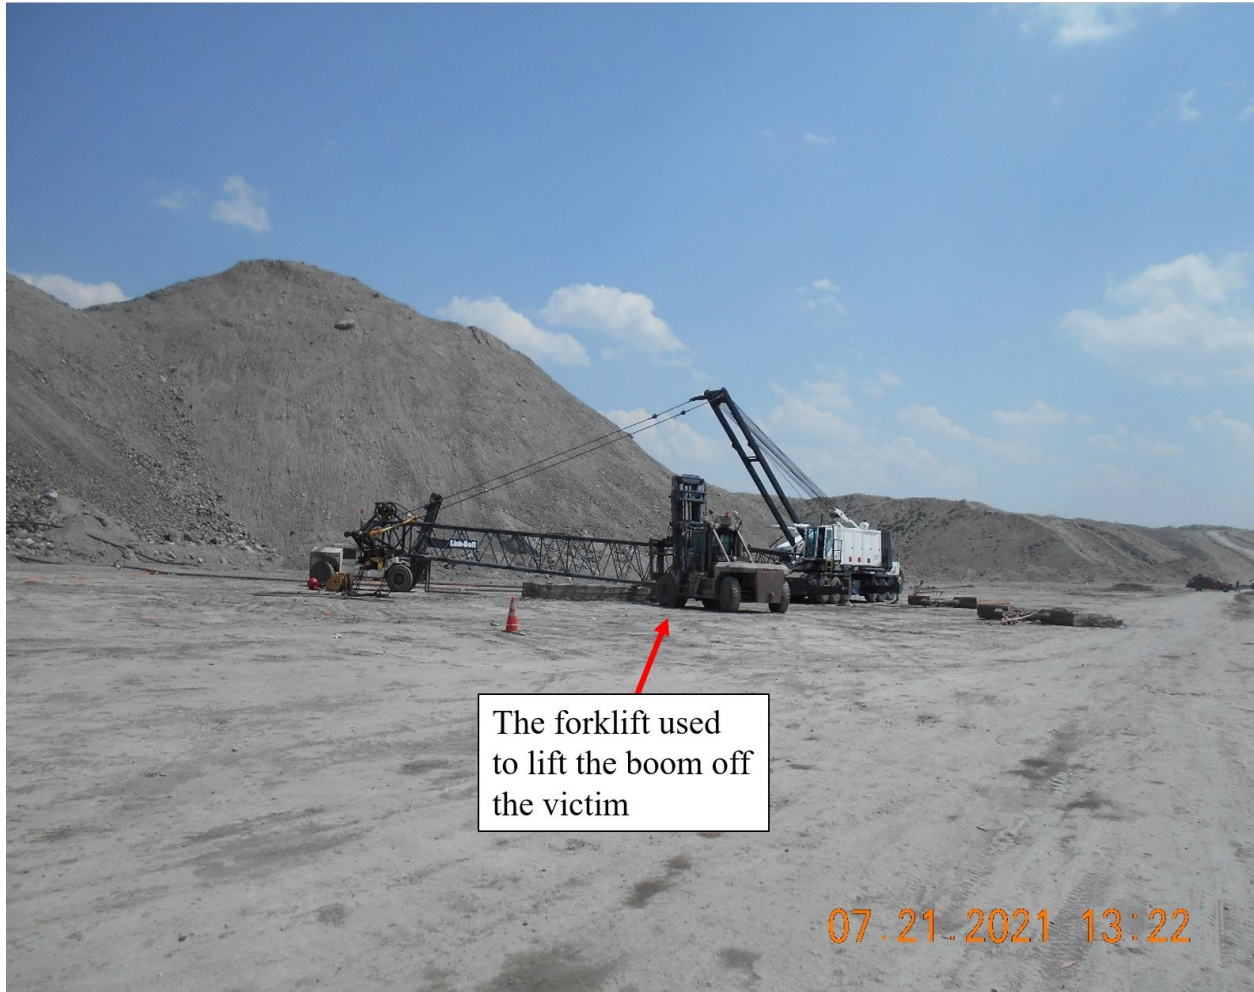
APPENDIX A – Photo of Boom Laid Down and Location of the Forklift

Miller, Kolbeck, Senger, and Brown witnessed the boom collapse and fall on J. Wendland. Senger brought a forklift to the scene to raise the collapsed boom and free J. Wendland. Brown called over the mine radio for help. Kolbeck administered cardiopulmonary resuscitation (CPR). Kolbeck also placed an automatic external defibrillator (AED) on J. Wendland, which advised “no shock” and to continue with CPR. Kolbeck alternated between the CPR and the AED, but the AED never advised a shock.

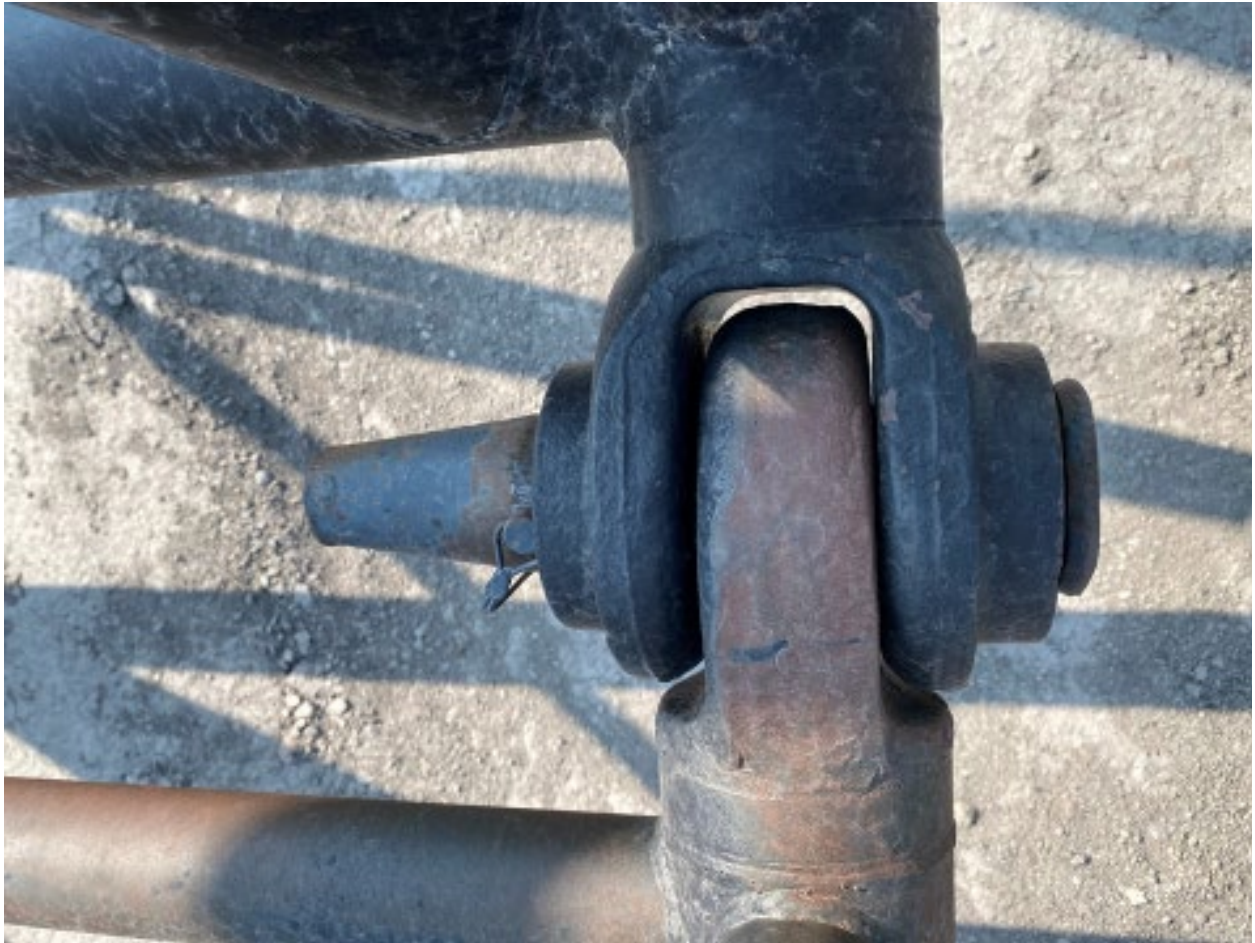
APPENDIX B – Photo of Bottom Left Pin before Removal

Brown positioned himself underneath the boom, kneeling between the two cross beams (ten inches apart), and started hammering on the bottom right pin. Brown successfully removed the bottom right pin and started working on the bottom left pin (see Appendix B) but could not remove it. J. Wendland asked Brown to switch positions so that he (J. Wendland) could attempt to finish removing the bottom left pin. J. Wendland positioned himself underneath the boom, knelt on the ground between the two cross beams, and started hammering on the bottom left pin (see Appendix C). J. Wendland instructed Kolbeck to get into the crane and raise the boom up and down to help loosen the pin, which Kolbeck did. According to Miller, at this point, the pin appeared to be flush with the boom. Miller held a pin driver in place while J. Wendland continued hammering on the pin. When the pin started to move, Miller handed the pin driver to

J. Wendland to finish removing the pin. At approximately 11:45 a.m., the pin dislodged, causing the steel boom structure to fall on J. Wendland.

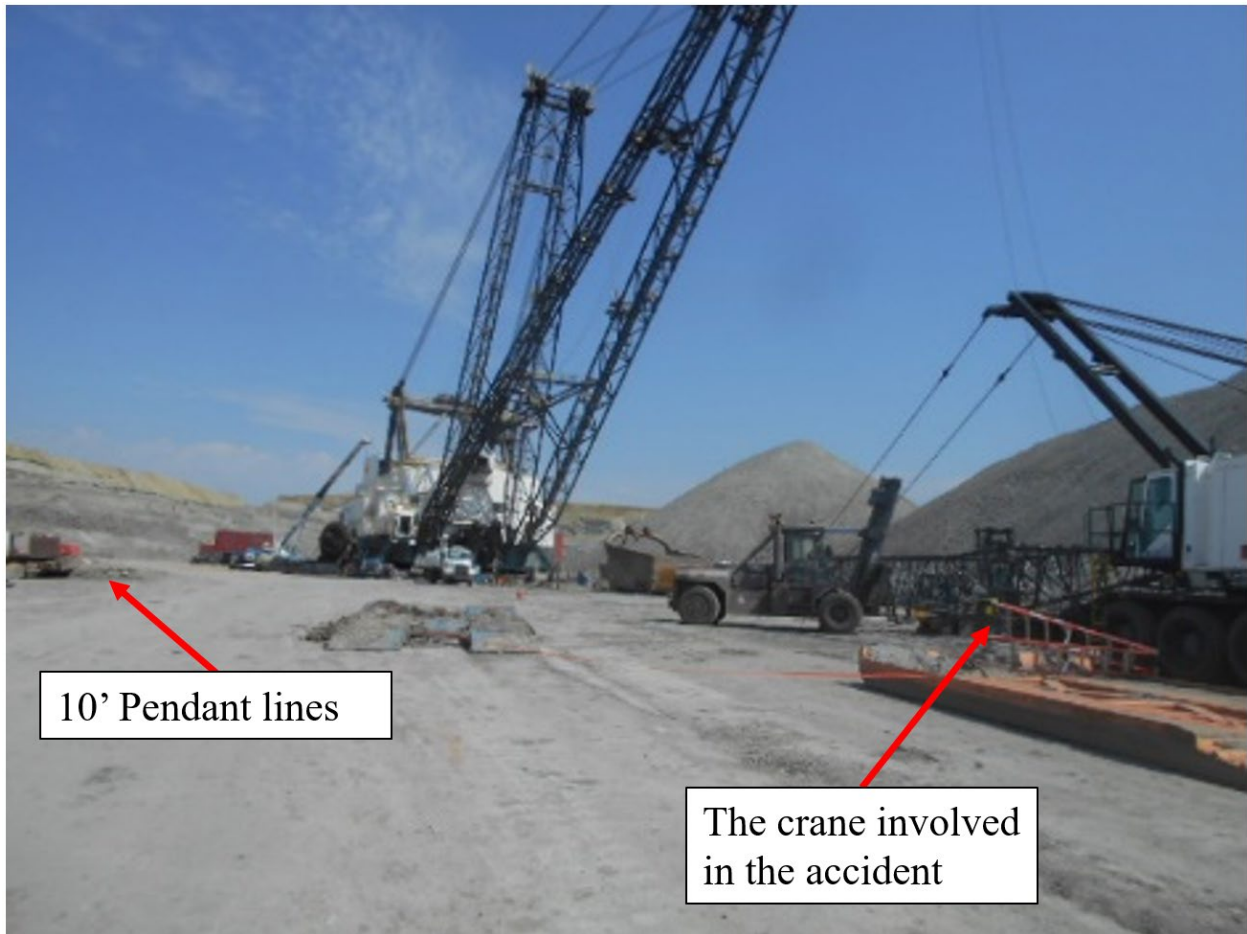
APPENDIX E – Photo of the Crane and Pendant Lines on the #12 Dragline Pad

The accident occurred at the 7 North Pit dragline pad for Dragline #12, a Bucyrus Erie's 2570 (see Appendix E). The dragline pad was dry and relatively flat and smooth. The crane was located on the pad adjacent to the dragline.

All equipment and attachments required to change the boom extension on the crane safely were present on the dragline pad. The two ten-foot-long pendant lines were on a wooden pallet adjacent to the 30-foot boom extension (see Appendix E). Prior to removing the boom pins, temporary pendant lines were not installed and blocking the boom was not performed. Investigators determined that not following these steps in the crane manufacturer's manual contributed to the accident.

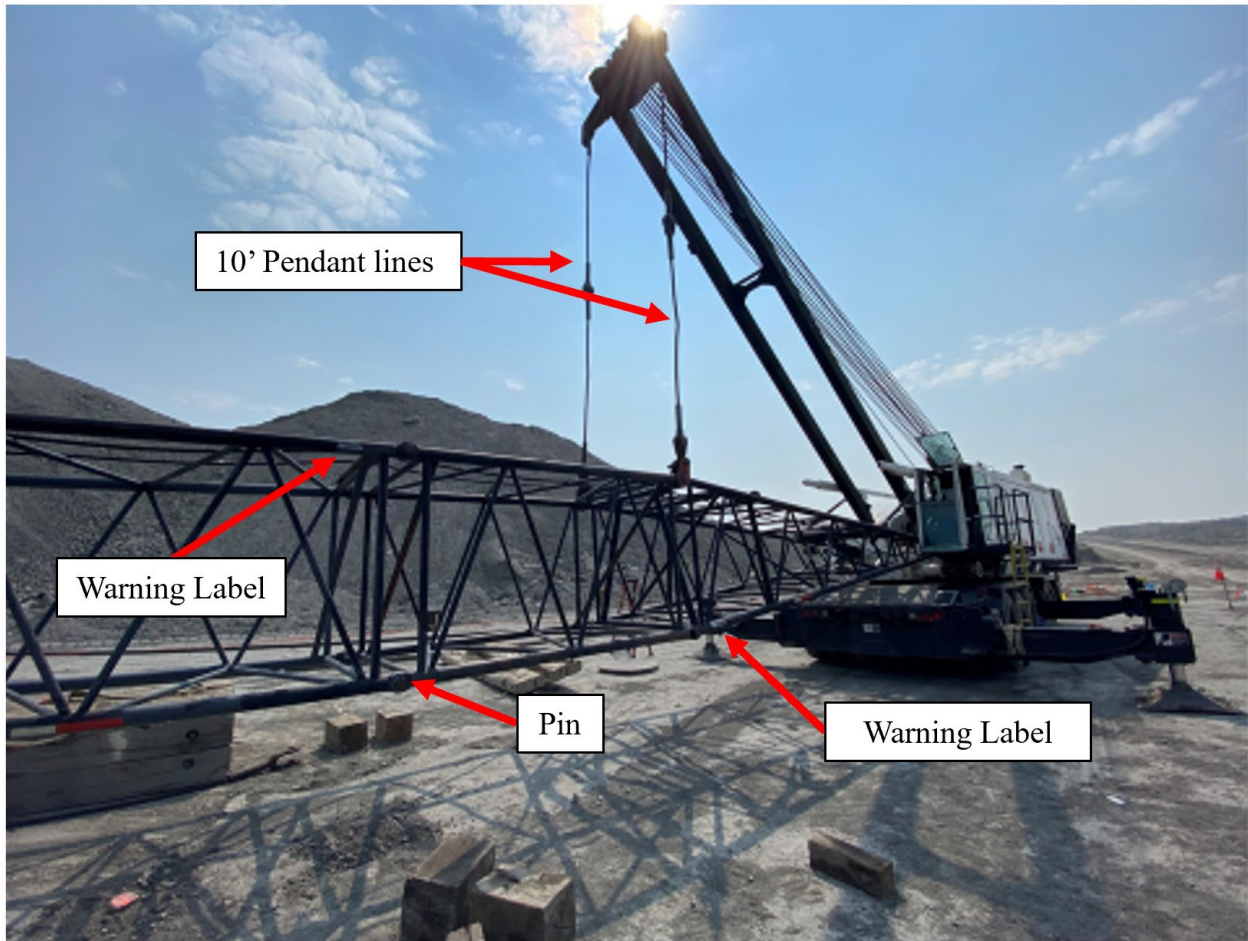
APPENDIX F – Photo of Correct Placement of Pendant Lines

The procedure for changing the boom extensions to the crane as described in the crane manufacturer's manual is to lay the boom down, connect two ten-foot-long pendant lines to the boom (see Appendix F), and place blocks under the boom before removing the pins. A warning label on the boom states, "Avoid injury to yourself. Boom can fall when pins are removed. Do not remove pins until boom is supported properly by blocking or boom ropes are relocated as described in the manufacturer's manual. In the absence of sufficient information in the manual, consult your Link-Belt distributor" (see Appendix G).

On July 21, 2021, at approximately 11:45 a.m., a fatal accident occurred at the 7 North Pit, #12 Dragline Pad, when work was being performed to change boom extensions on the FMC 258 Link-Belt, 200-ton lattice mobile crane, company #374. This work was performed under the suspended boom without the required safety pendant lines and blocking material to securely block the boom in position. When the boom pins were removed, the boom moved and fatally injured a millwright. There were warning labels on each side of the boom stating the danger of: 1) not blocking the boom in position, and 2) not relocating the pendant lines to support the boom.

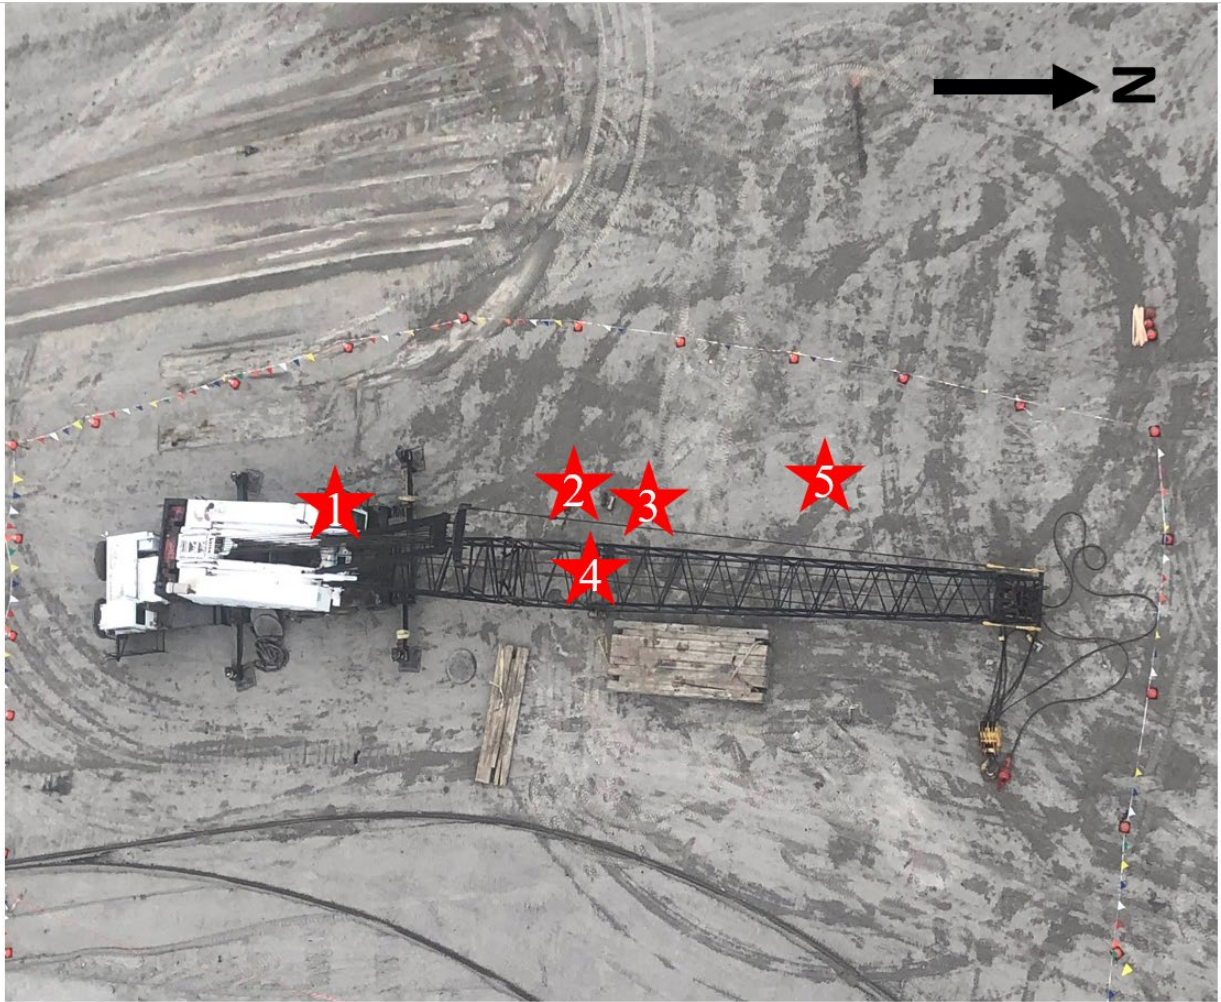
APPENDIX H – Aerial View of the Accident Scene

The four other millwrights said that they relied on J. Wendland's guidance during the task because he had previously performed the boom exchange and was a more experienced millwright. Appendix H shows the locations of the millwrights at the time of the accident. The mine operator did not verify that the millwrights recognized the hazard of boom collapse posed by pulling the boom pins without appropriate blocking (see Appendix I) and without installing the two temporary pendant lines (see Appendix J). Investigators determined that neglecting to take either step contributed to the accident.

- ★ 1 Justin Kolbeck
- ★ 2 Matthew Miller
- ★ 3 Lyle Senger
- ★ 4 Jeffrey Wendland
- ★ 5 Jesse Brown

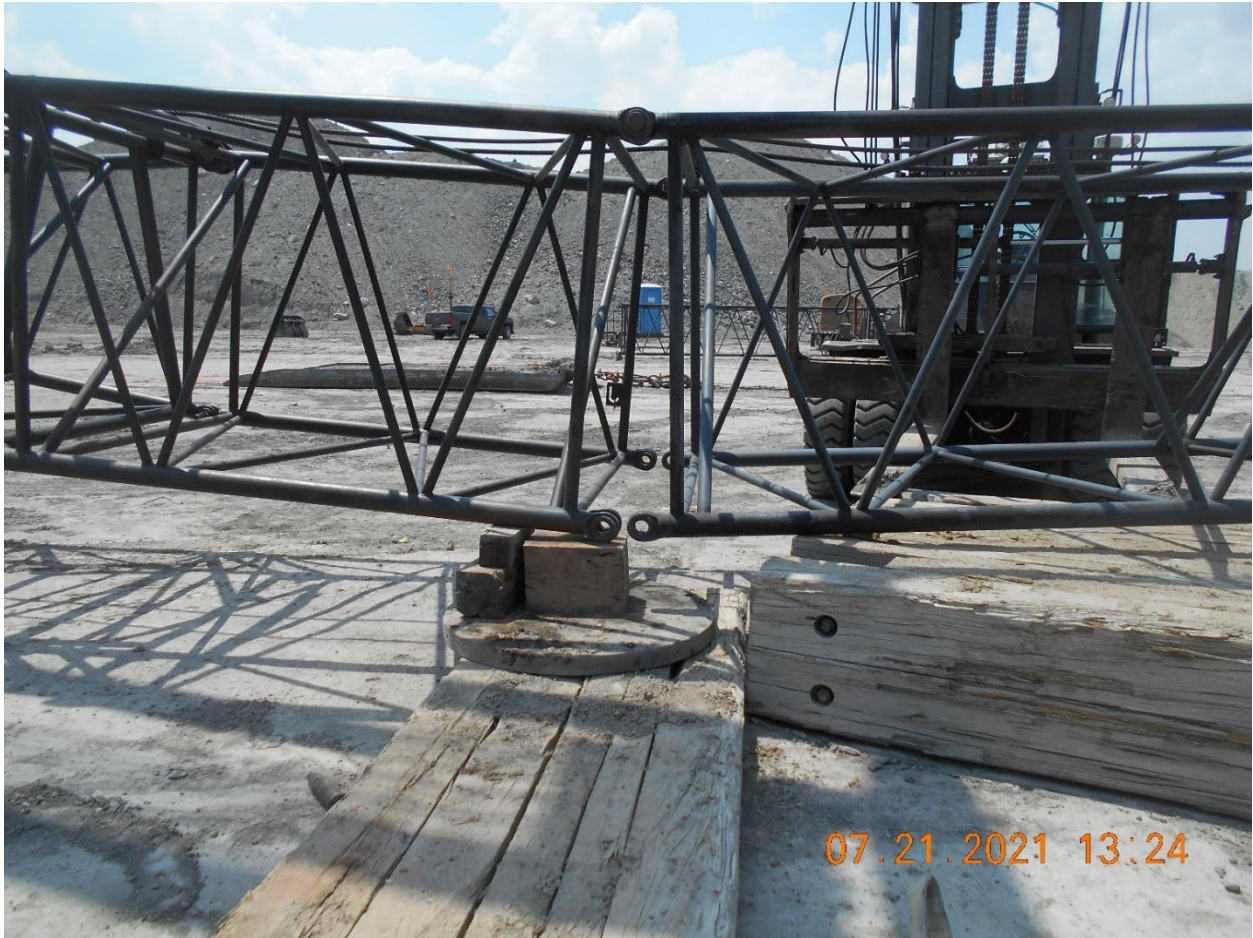
APPENDIX I – Photo of Wooden Blocks Placed after Accident

1. Root Cause: The mine operator did not make sure that miners blocked the equipment against motion before performing work underneath the equipment.

Corrective Action: The mine operator modified the current written procedure to assure that miners block equipment against hazardous motion before performing work underneath the equipment. The mine operator trained all miners on the revised procedure.

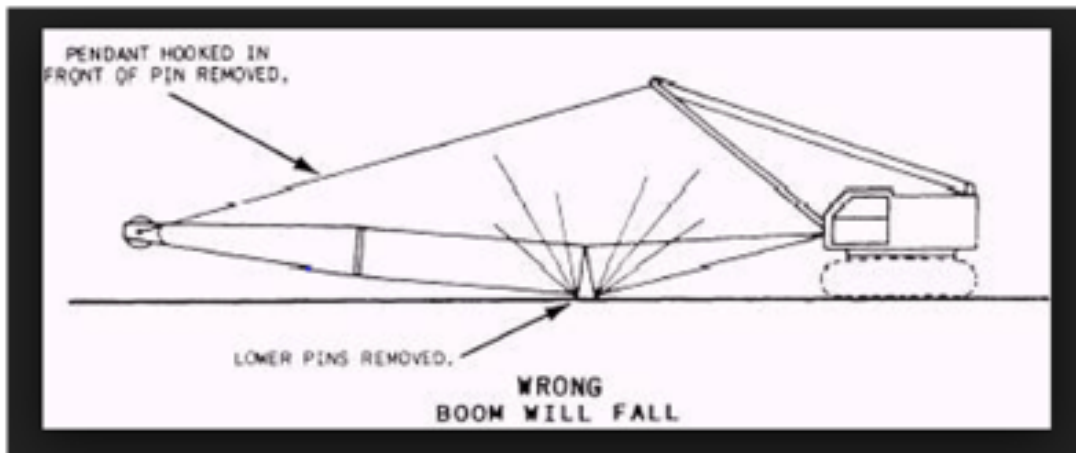
5. When is it permissible to remove pins with boom pendants in tension?

Do not remove any pins, top or bottom, on any section between the uppermost boom section and crane until all sections are supported and pendant lines relieved of tension.
