REPORT OF INVESTIGATION

Surface
(Dimensional Granite)

Fatal Falling, Rolling, or Sliding Rock or Material of Any Kind Accident
July 28, 2021

Boyd/Echols Mill North
Echols Mill Quarries LLC
Elberton, Elbert County, Georgia
ID No. 09-00057

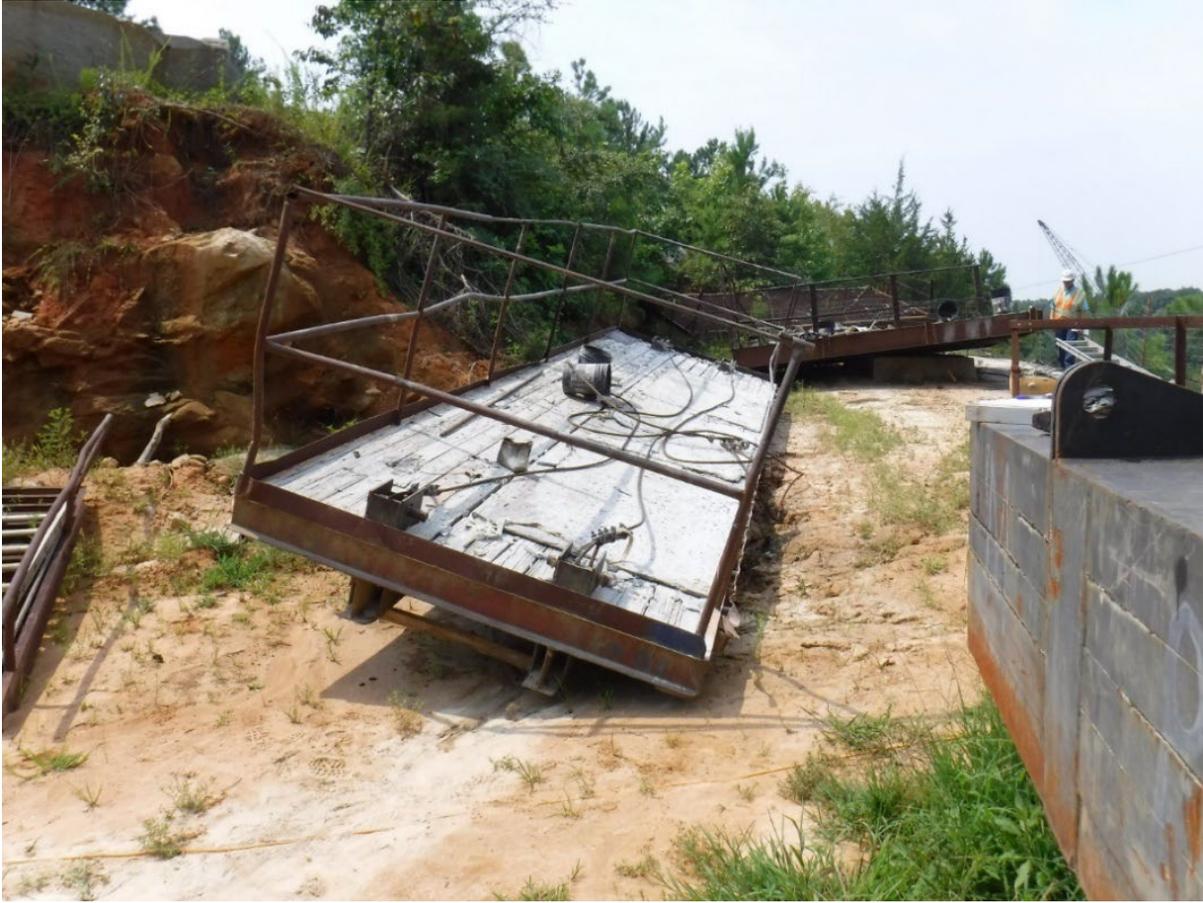
APPENDIX A – Scaffold Used to Access the Working Face

At approximately 9:00 a.m., the contractor restored the electrical power and miners were able to begin production work. Miners lowered the scaffold against the long side of the block being quarried by crane to act as a working platform (see Appendix A). Zavala, Ibarra, Rnas, and Rodriquez accessed the scaffold by ladder, and Zavala measured and marked the block for manual breaking by the three other miners.

This scaffold was used to access the working face of the mining bench. A crane suspends the scaffold along the face of the mining bench.

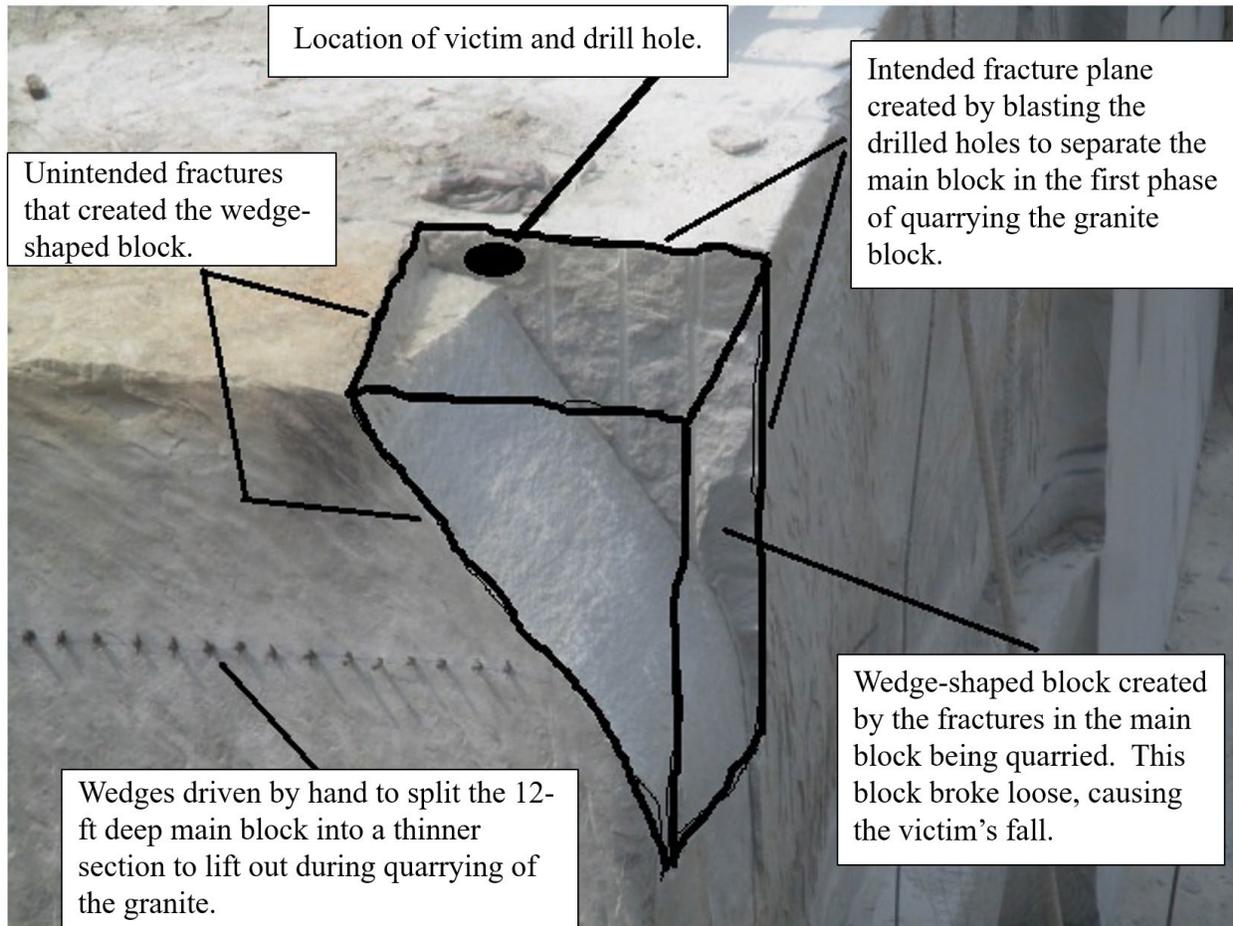
APPENDIX B – Location of the Victim while Drilling

Zavala was not observed wearing fall protection at any time during the shift. At the time of the accident, Zavala was within six feet of the highwall edge, and was beyond the visible crack that the other miners identified. During an examination of the site, investigators could not identify any proper tie-off points for fall protection in the area Zavala was working. Fall protection in serviceable condition was present and available for use at the work site. The mine operator did not have procedures on wearing and using fall protection. Investigators determined that improper work practices in the use of fall protection was a contributing factor in the accident.

Zavala's location as he was drilling on the surface of the block in the wedge that was created by the crack. Annotations in the photograph indicate the drill hole location was within six feet of an edge where a fall would be significant.

Corrective Action: The mine operator developed and implemented written procedures regarding the proper type of fall protection to be used, when to use fall protection, how to don, and how to tie off/anchor the safety line. The mine operator trained all miners in the new procedures.

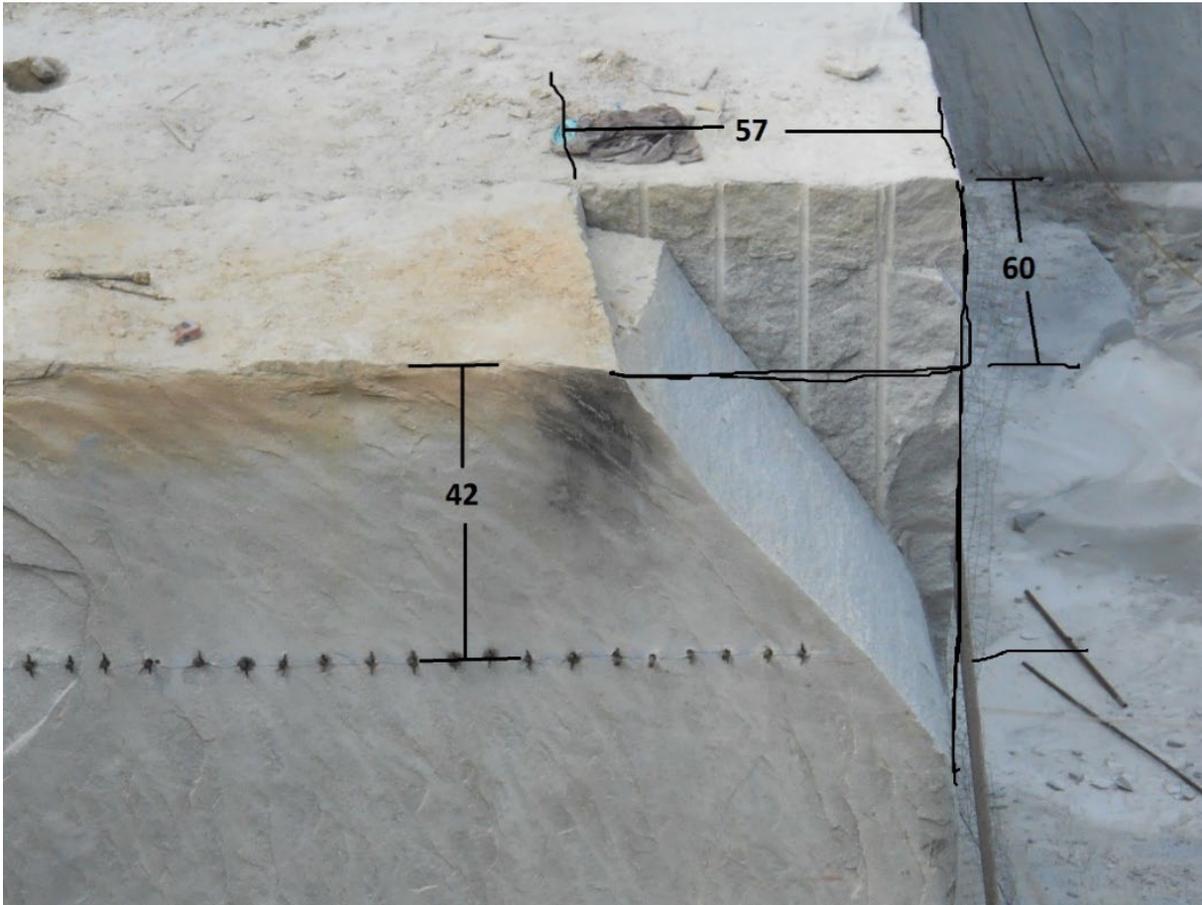
APPENDIX C – Block Wedge Dimensions

Prior to the accident, Zavala was operating a Harper pneumatic hammer drill. Investigators determined that the drill did not contribute to the accident. As Zavala drilled into a granite block, a wedge-shaped block broke and fell.

Dimensions, shown in inches, of the wedge-shaped block that broke and fell, causing Zavala to fall.

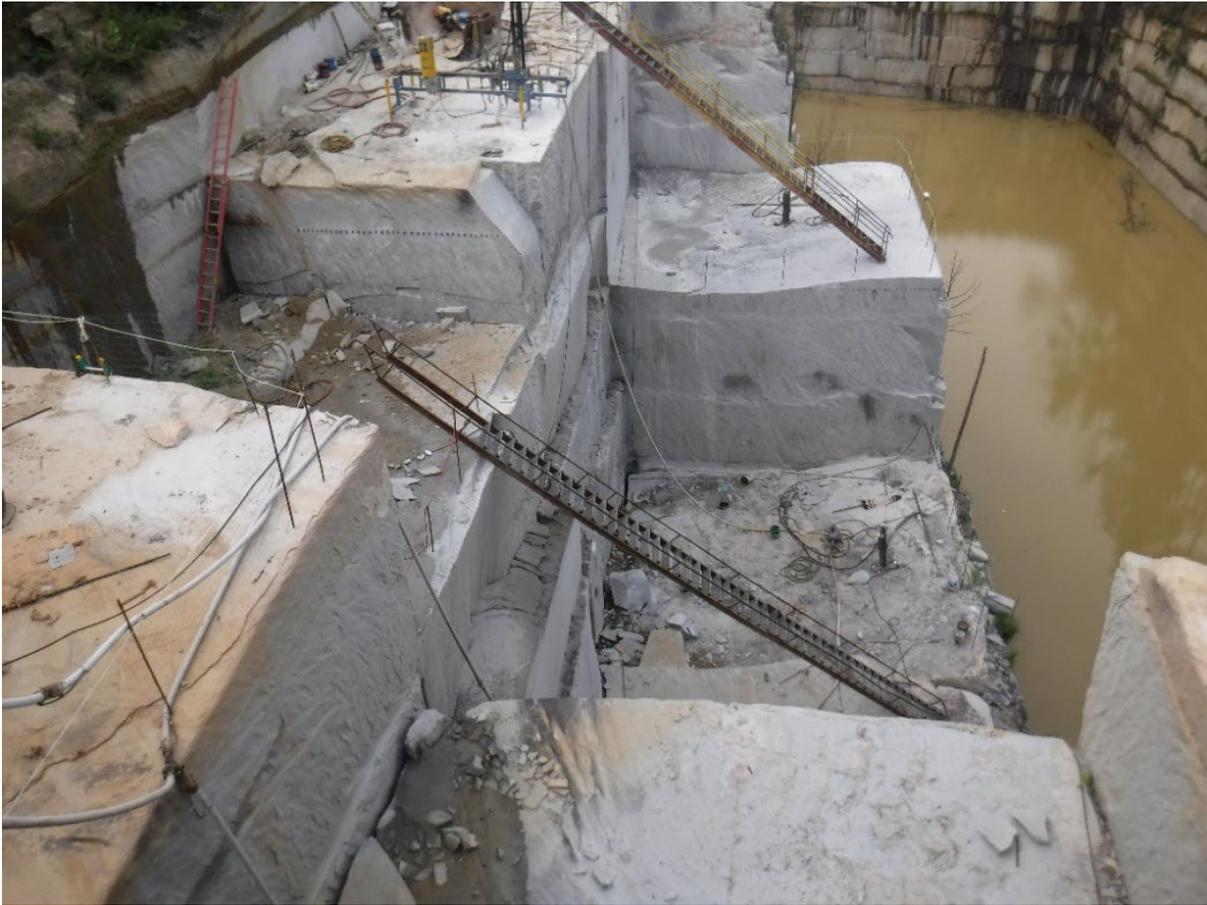
APPENDIX D – View of Accident Scene

At approximately 9:45 a.m., Harris conducted a workplace examination of the area, which included the area being drilled, with no safety hazards identified. Jorge Medellin identified a visible crack in the rock face of the block being quarried, near the free edge of the granite bench. Jorge Medellin discussed safety concerns related to the crack with the miners working on the scaffolding, including Zavala. After marking and instructing the miners to break the block, Zavala moved to the top of the granite bench at the end of the block being quarried and began drilling a hole (see Appendix B). Zavala was not wearing fall protection. The crack had created a wedge-shaped block approximately 57 inches long and 60 inches wide at the free end of the main block being quarried (see Appendix C). At 10:05 a.m., the wedge-shaped block broke and fell, causing Zavala to fall approximately 47 feet to a lower granite bench (see Appendix D).
