REPORT OF INVESTIGATION

Fall of Rib Accident
June 2, 2021

Marion County Mine
Marion County Coal Resources, Inc.
Metz, Marion County, West Virginia
ID No. 46-01433

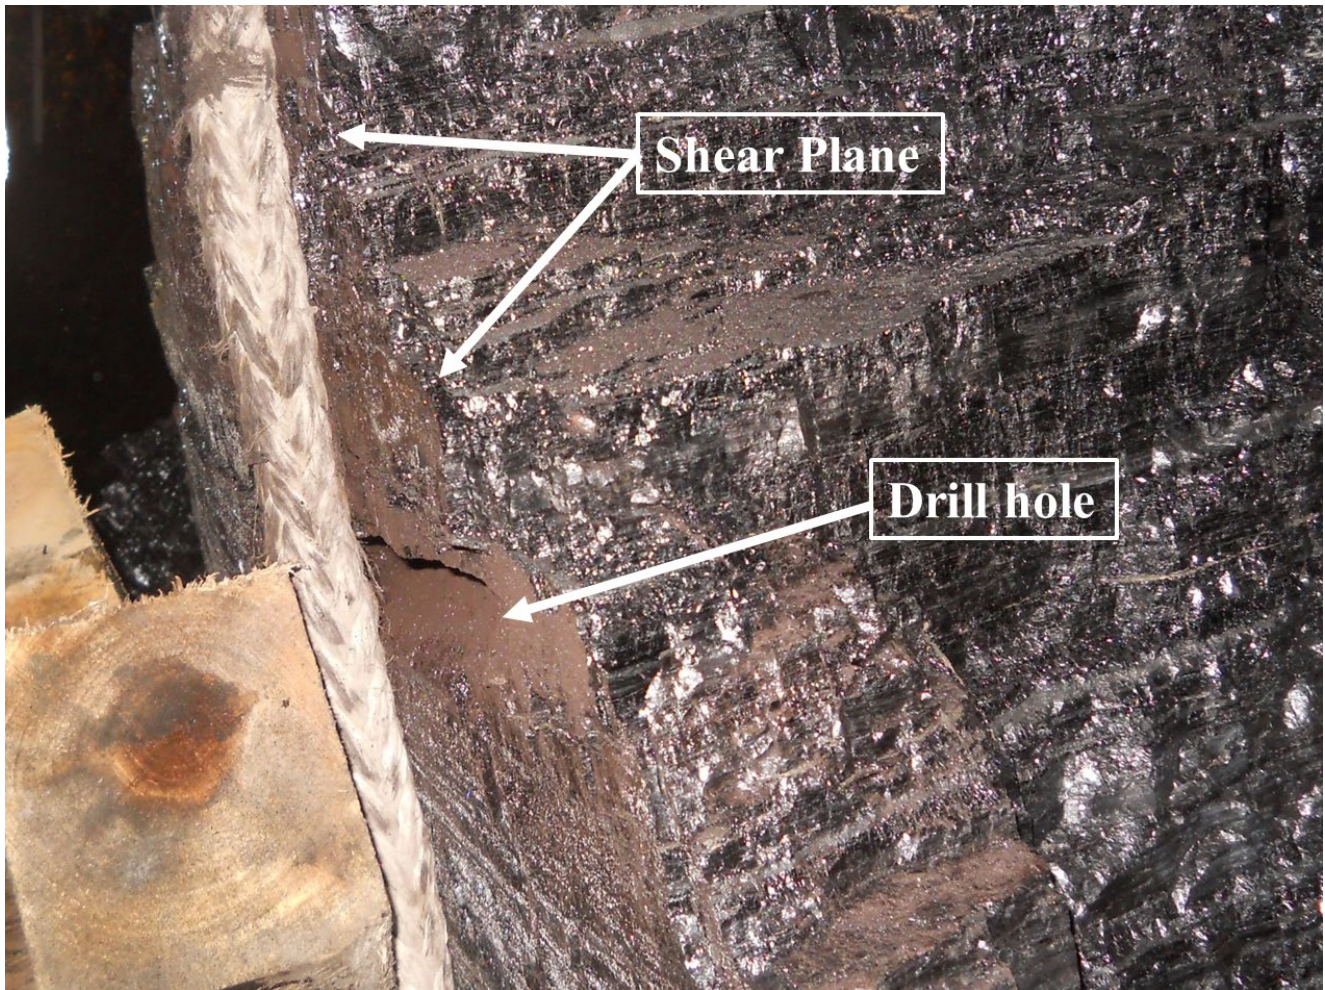
APPENDIX A
Photo of the Drill Hole in the Failed Rib

The crew began mining and advanced the No. 6 entry approximately 20 feet. Aaron Burch, Roof Bolter, traveled outby to retrieve another bolt wrench before completing the fourth row of roof bolts. Dille arrived at the CMM and traveled to the left side roof bolting station. Jayden Graham, Utility Man, started the first rib bolt hole on the left side of the entry when he noticed a crack running vertically towards the roof. The crack was aligned with the rib bolt hole (see Appendix A).

The accident occurred at the inby left corner of the No. 6 entry intersection and the 51 block crosscut on the 9-North Mains section. The crack in the rib was approximately two feet from the rib corner where drilling was being conducted. The size of the rib measured approximately six feet long, four and half feet wide, and two feet thick.

Investigators concluded that Dille did not adequately evaluate all factors and determine the safest corrective action. The rib conditions changed and a crack formed while the rib bolt hole was being drilled. The rib bolt encountered resistance while Dille was trying to push it into the hole, and there were multiple warnings from miners to watch out for the rib and crack.

Corrective Action: The mine operator modified their written training materials to include the various corrective actions available to address hazardous rib conditions. The mine operator trained all affected miners in scaling methods, bolting techniques, and machine capabilities for correcting hazardous rib conditions. In addition, evaluating the location, type of rib hazard, and correct body positioning to limit exposure was also included in the training.

Corrective Action: The mine operator developed new policies and procedures and revised the roof control plan to install two additional rib bolts in the upper portion of ribs to support locations that will become rib corners. In areas where the mine operator cannot install additional rib bolts, the mine operator will cut the rib corners before the miners are exposed to the corner.

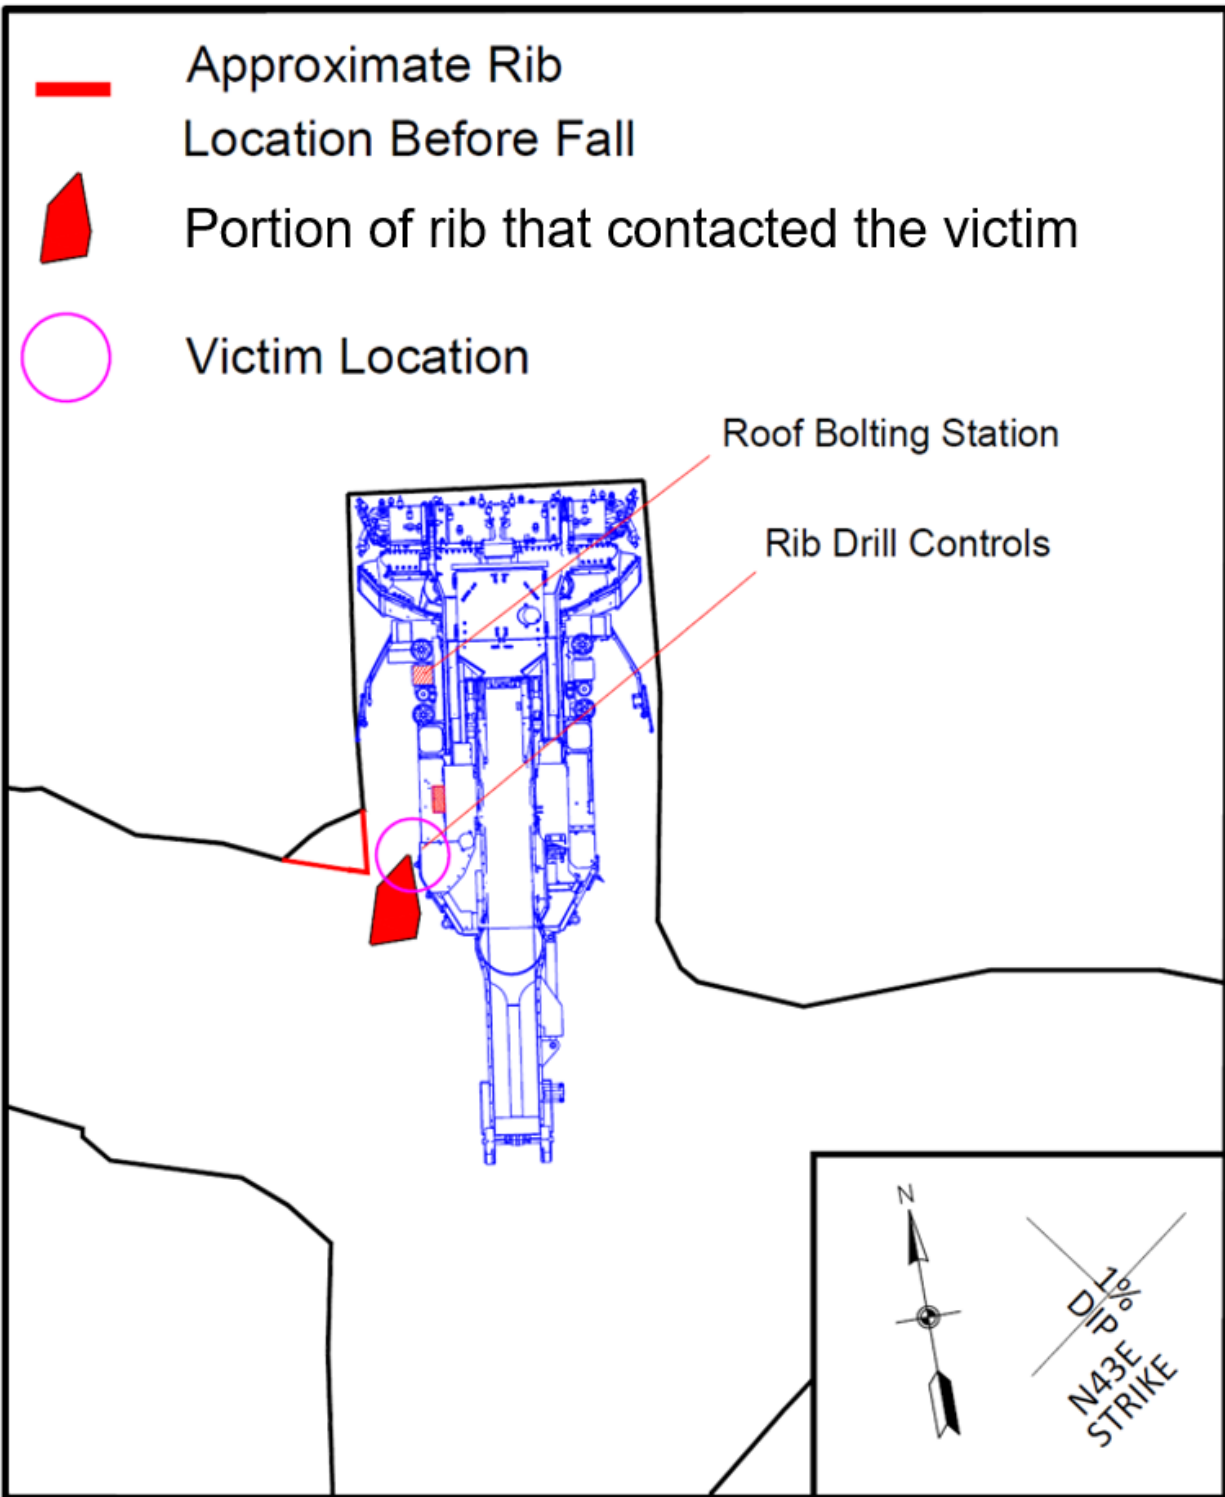
APPENDIX B
Drawing of the Accident Scene

Graham stopped drilling and motioned for Dille to come to the rib bolting station to evaluate the crack. The rib bolting station is six feet outby the roof bolting station. Graham and Dille discussed the crack. Dille decided to take over drilling the hole from Graham. When Dille had finished drilling the rib bolt hole, Dille started to install the rib bolt. Josh Snoderly, Continuous Mining Machine Operator, noticed a shift in the rib, stopped the CMM, and verbally warned Dille. Dille acknowledged Snoderly, but continued placing the rib bolt in the hole by hand. Burch told Dille that the rib looks bad. The rib bolt went into the hole approximately one foot before encountering resistance. Graham flagged Dille while he was trying to put the bolt in the hole, but Dille did not acknowledge Graham. Dille stopped and took a small step backward which placed his back against the CMM. Within seconds, the upper portion of the crosscut rib corner sheared off, and pinned Dille against the CMM (see Appendix B). The piece of rib that fell measured approximately six feet long, four and half feet wide, and two feet thick.

The mine operator did not support or otherwise control the mine rib corner at the intersection of the No. 6 entry and 51 block on the 9-North Mains section. On June 2, 2021, a section foreman was fatally injured while installing a rib bolt with the continuous mining machine when the corner of the mine rib sheared off and pinned him against the mining machine. A crack was present in the rib approximately two feet from the rib corner where drilling was being conducted. The section foreman was in the process of installing the 1st rib bolt on the left side of the entry when the rib failure occurred. The size of the rib measured approximately six feet long, four and half feet wide, and two feet thick.

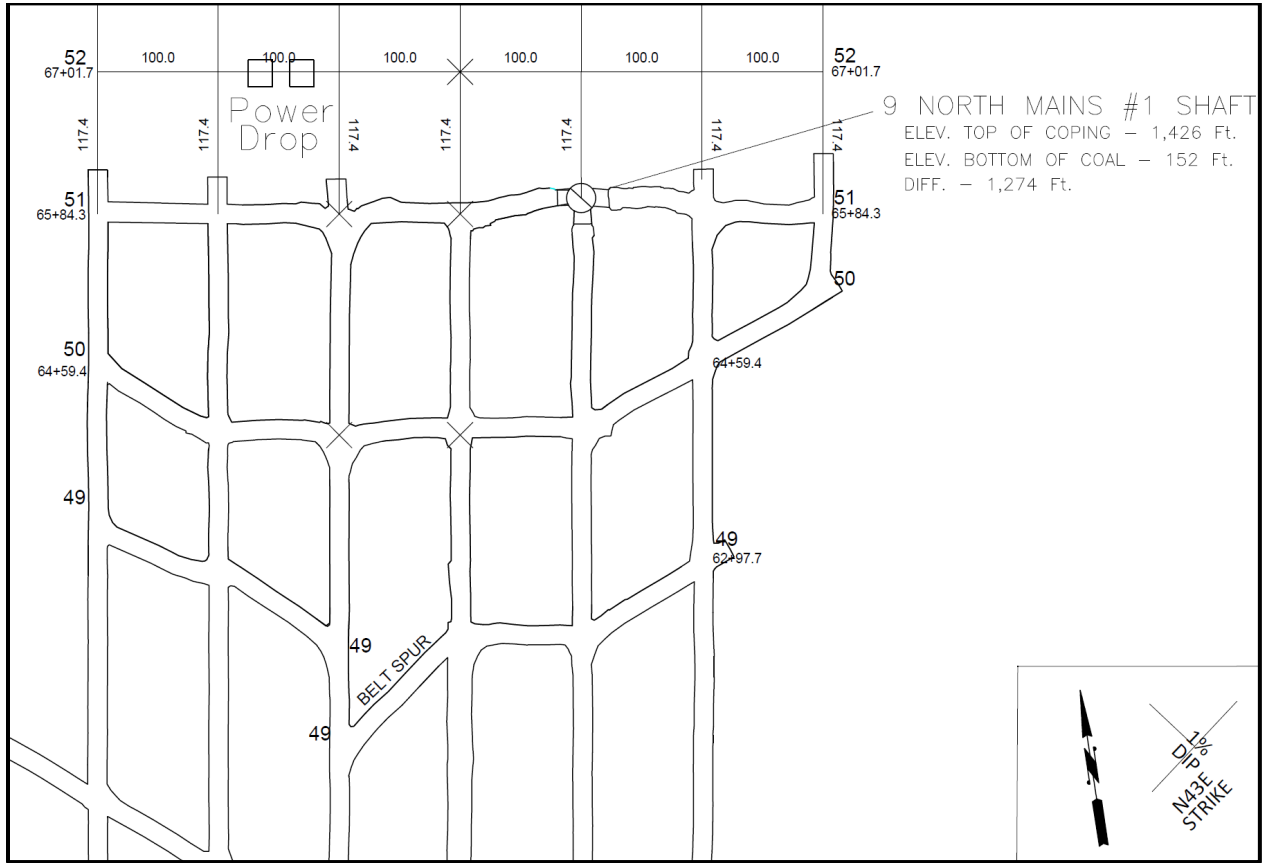
APPENDIX D 9-North Section Map

Normal mining height on this section is approximately 96 inches. The mining height at the accident scene measured 112 inches and consisted of approximately 92 inches of coal and 20 inches of rock binder near the roof line. The mine operator developed the entries with additional height to decrease resistance and improve future airflow to the shaft located in the No. 5 entry (see Appendix D).
